Operator: HIGHPOINT OPERATING CORPORATION
Location Name: Anschutz Equus Farms 4-62-33 NWNW
Loc ID: 437854
Inspection: 713900536

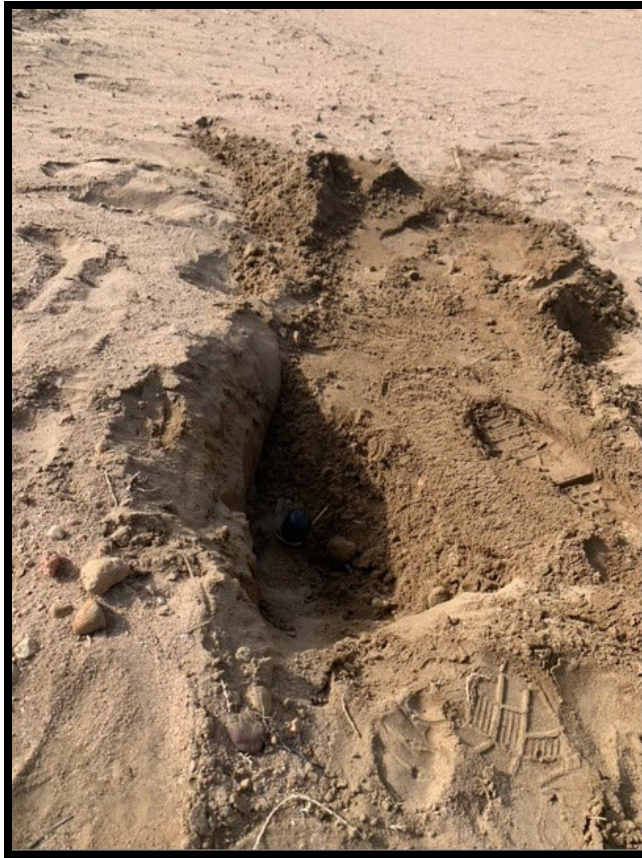
Exhibit A

CA: Electrical wires were observed daylighting on the production pad and black piping was stored in the interim area on the East side of the well location. Comply with Rule 606 to remove all debris.

CA Resolution: Operator has reported that the identified electrical wires and black piping observed during the inspection have been appropriately addressed to comply with Rule 606.
