**Operator: BONANZA CREEK ENERGY OPERATING COMPANY LLC**

**Location Name: PRONGHORN-65N61W 9SWNW**

**Loc ID: 332260**

**Inspection: 708201165**

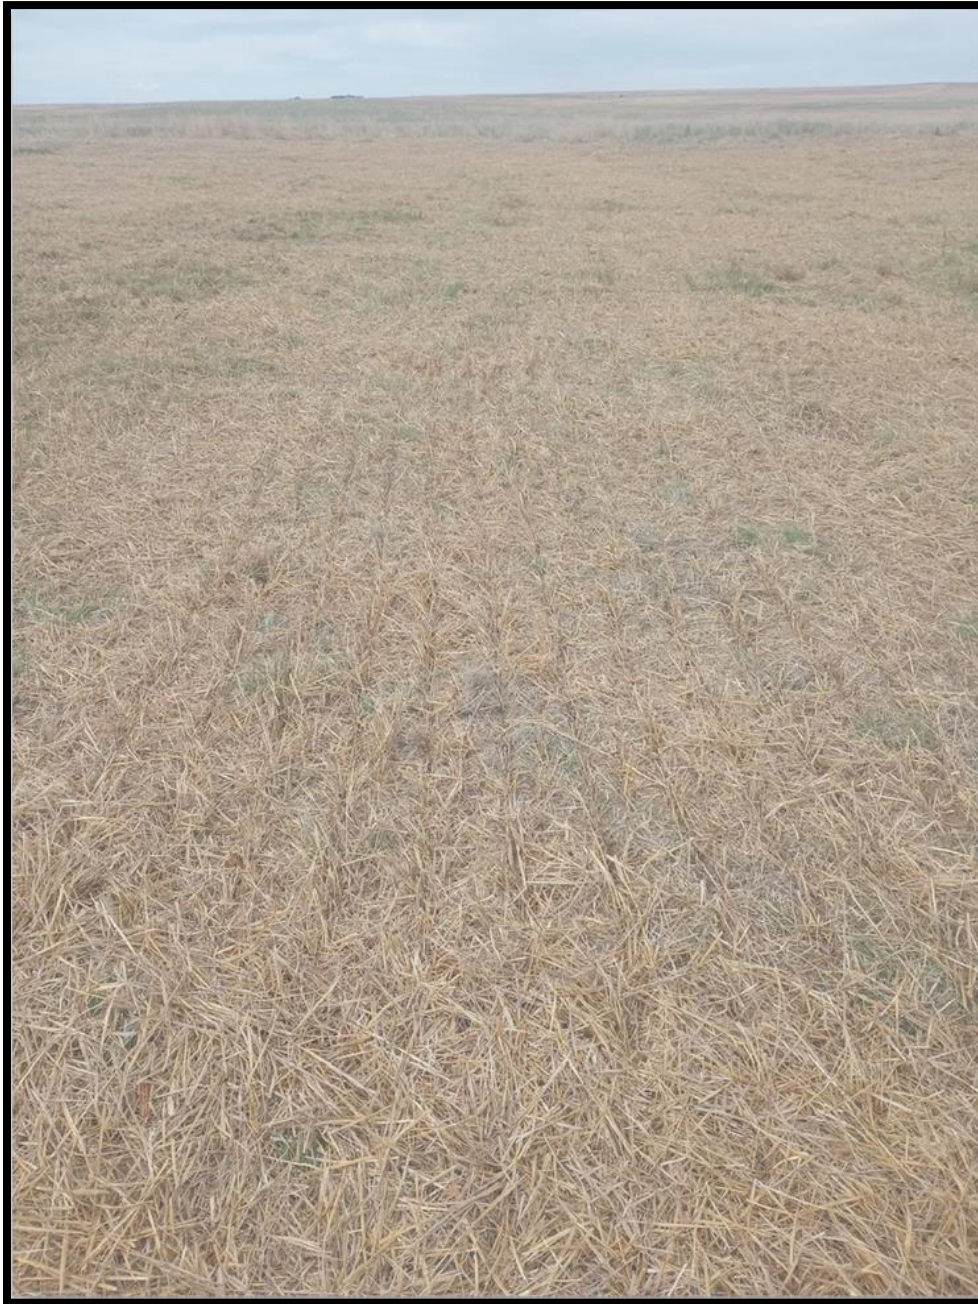
**Exhibit A**

**CA:** This location does not comply with Rule 1004. During this inspection, it was observed that the reclaimed areas have desirable vegetation throughout, however, there are areas of nonuniform vegetation cover resulting in bare soils. Additional reclamation activities are required. Refer to attached inspection photos. Comply with Rule 1004. Reseed disturbance areas using a seed mixture requested by the surface owner, or a mixture prescribed by the local county NRCS. Establish vegetation with total perennial, non-invasive uniform plant cover of at least eighty (80) percent of reference area levels. Ensure erosion controls are implemented to stabilize the seeded soil. Operator shall continue to monitor and manage this site until the location meets Rule 1004 standards, including stormwater and weed management.

**CA Resolution:** Operator has reported that the location has been appropriately mowed to address any weeds and undesirable vegetation. It has also been noted that the area has been seeded, and straw crimped to provide stabilization and promote more uniform future growth. Bare areas have also been addressed. Location currently complies with Rule 1004.
