Inspection Photos

API: 017-06622

Operator: **WILLIFORD ENERGY COMPANY**

Inspection Date: 5/30/2024

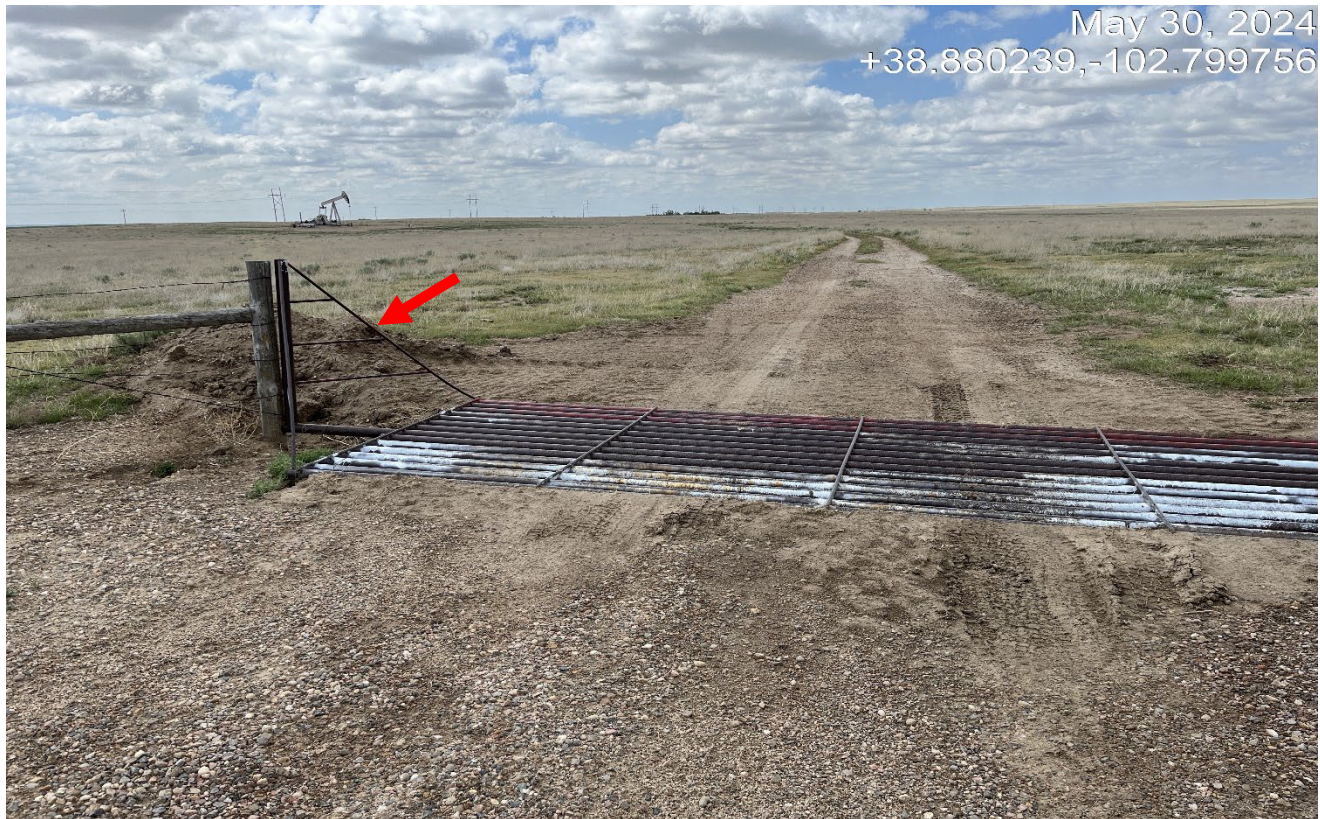
Photo 1. The cattleguard at the beginning of the access road has been cleaned out but the material was set to the side and needs to be removed.

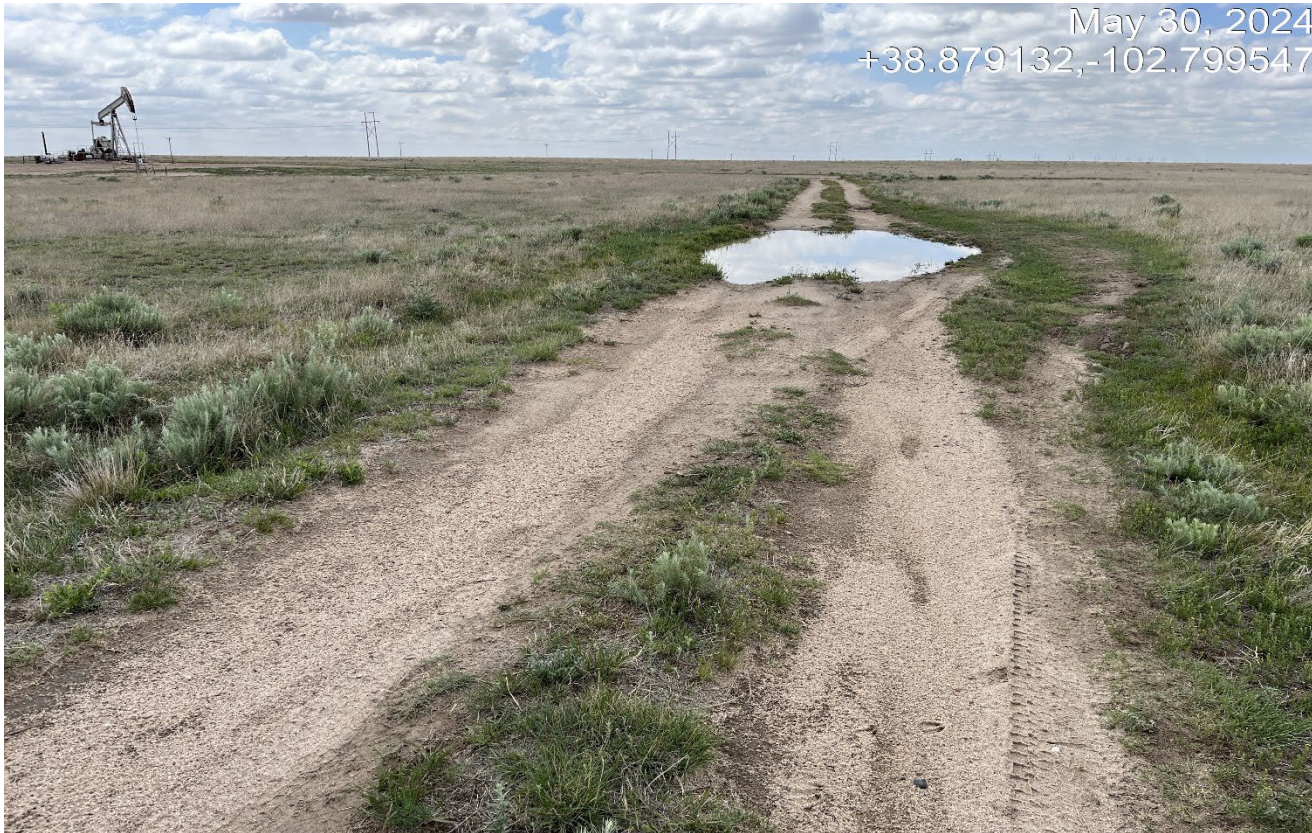
Photo 2. Facing southeast along the access road. Vehicles are causing unnecessary disturbance driving outside of the access road due to stormwater pooling on the road. The access road must be maintained and shall not drive outside of the access road boundary.

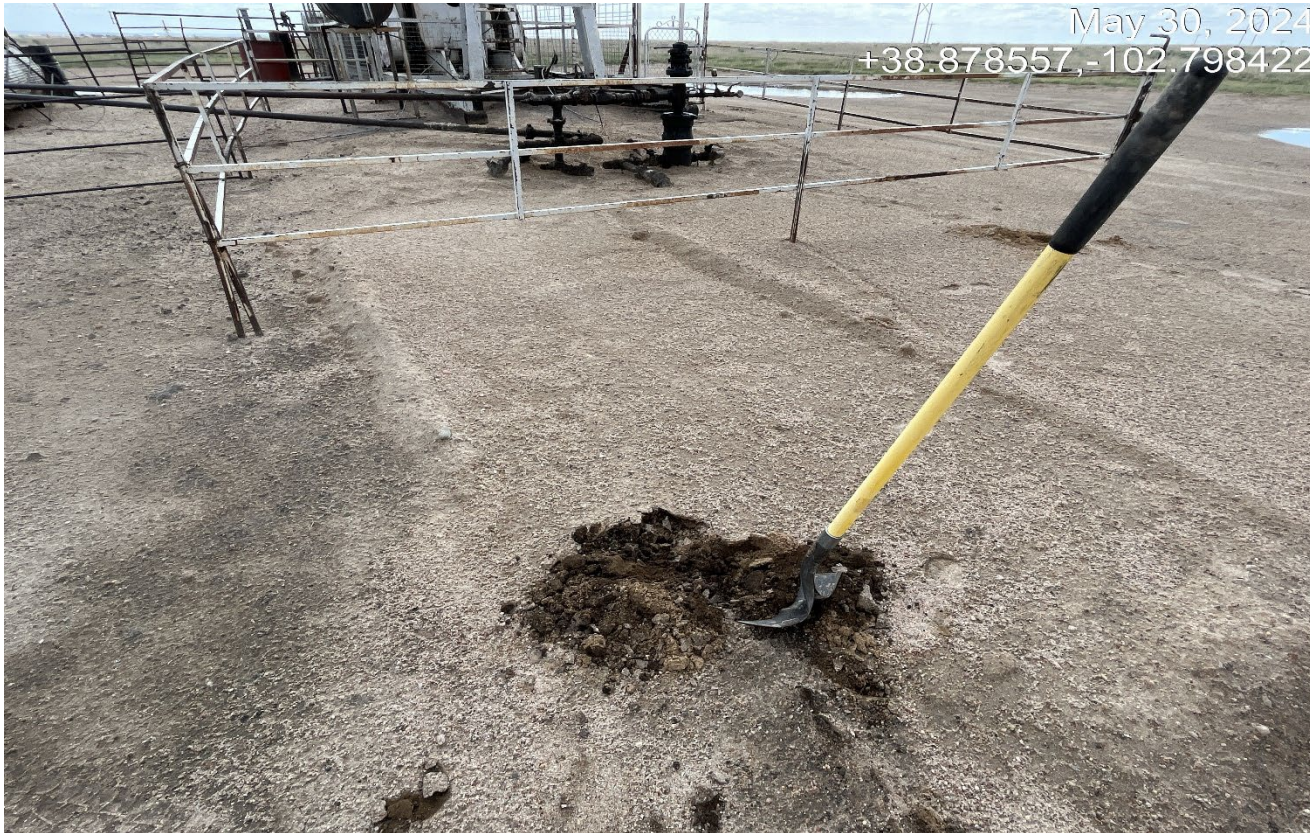
Photo 4. It appears there was sand spread on top of the spill which was not cleaned up per the rules.

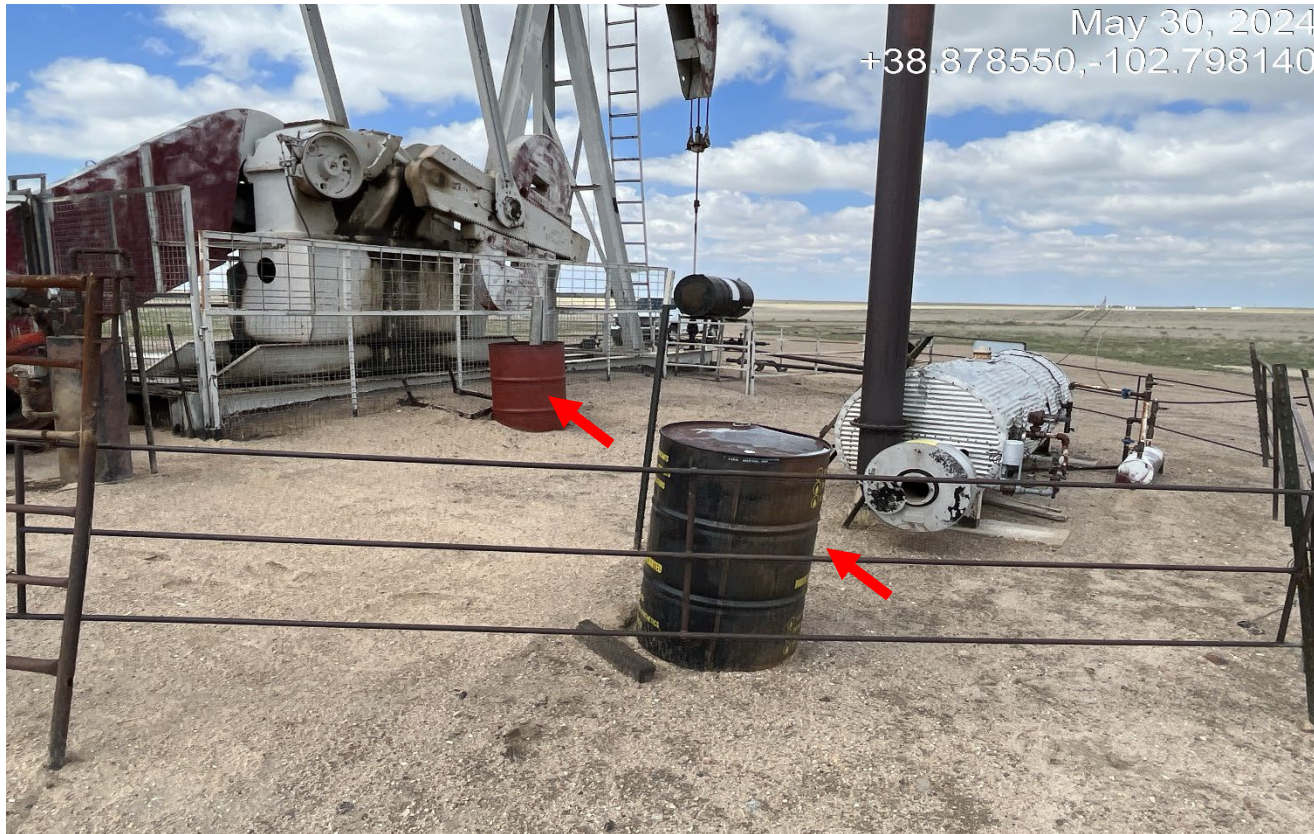
Photo 6. There are chemical barrels with no secondary containment. There is fresh sand spread around the pumjack where oil staining was previously observed.

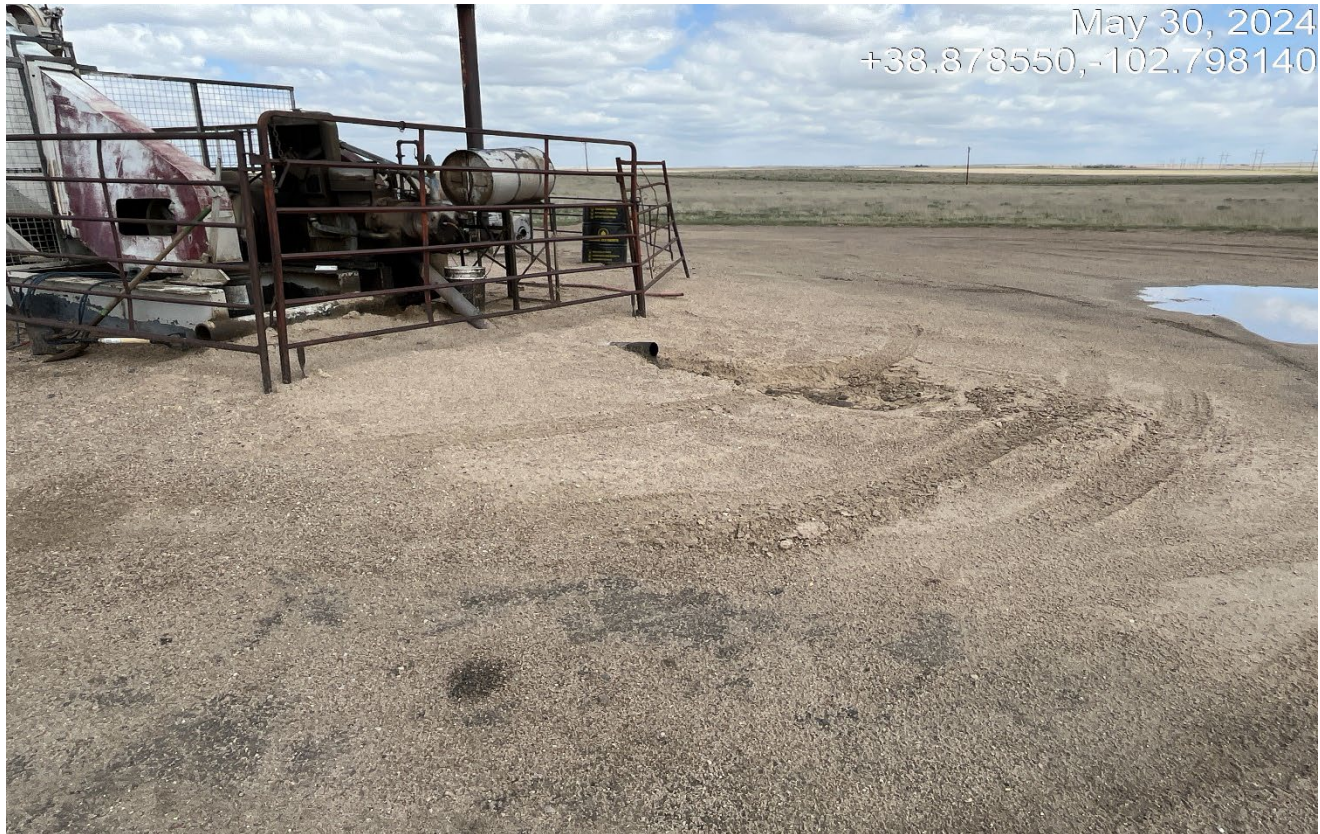
Photo 7. Facing at the backside of the pumpjack where exhaust is located. There is fresh sand spread around the exhaust pipe where oil staining was previously observed.

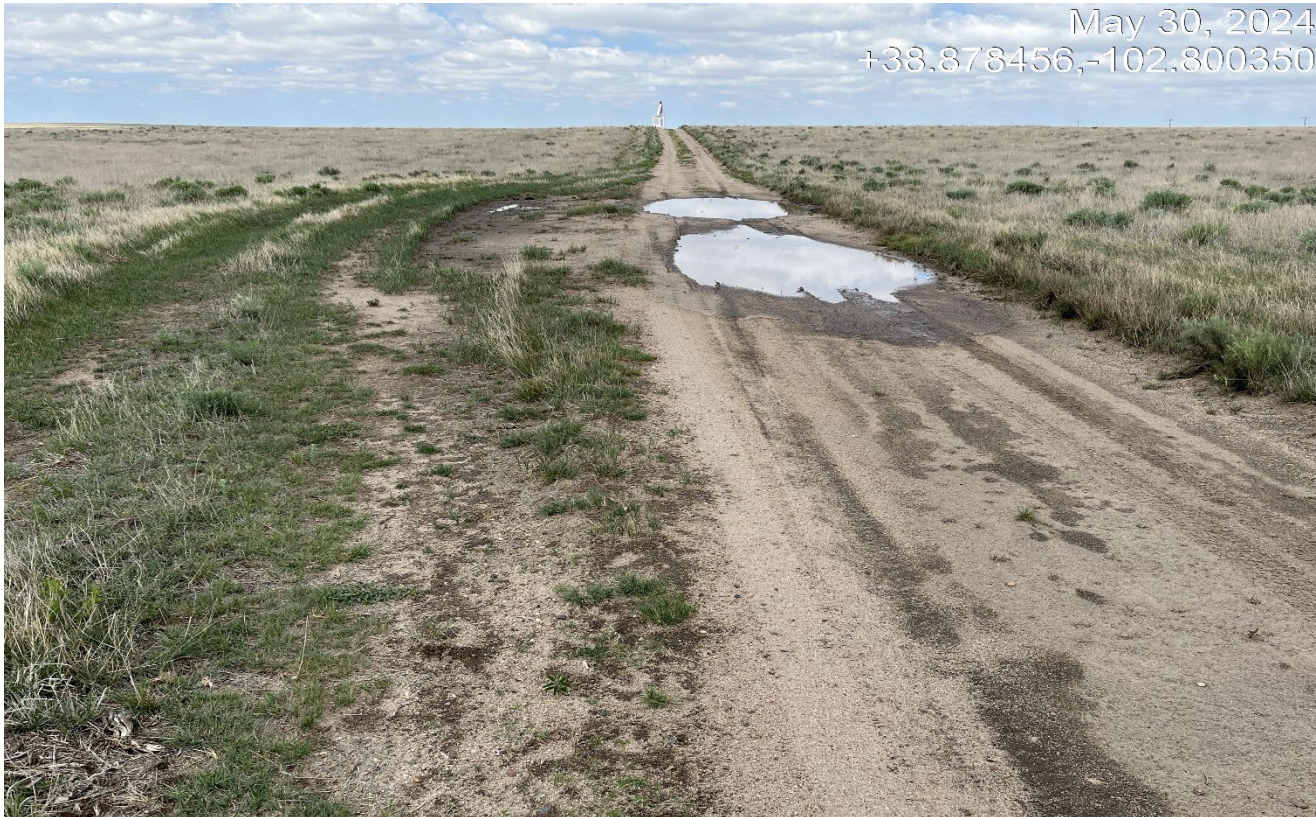
Photo 8. Facing west along the access road. Vehicles are causing unnecessary disturbance driving outside of the access road due to stormwater pooling on the road. The access road must be maintained and shall not drive outside of the access road boundary.
