Operator: EXTRACTION OIL & GAS INC

Location Name: Arellano 10-L Facility

Loc ID: 440776

Inspection: 708201213

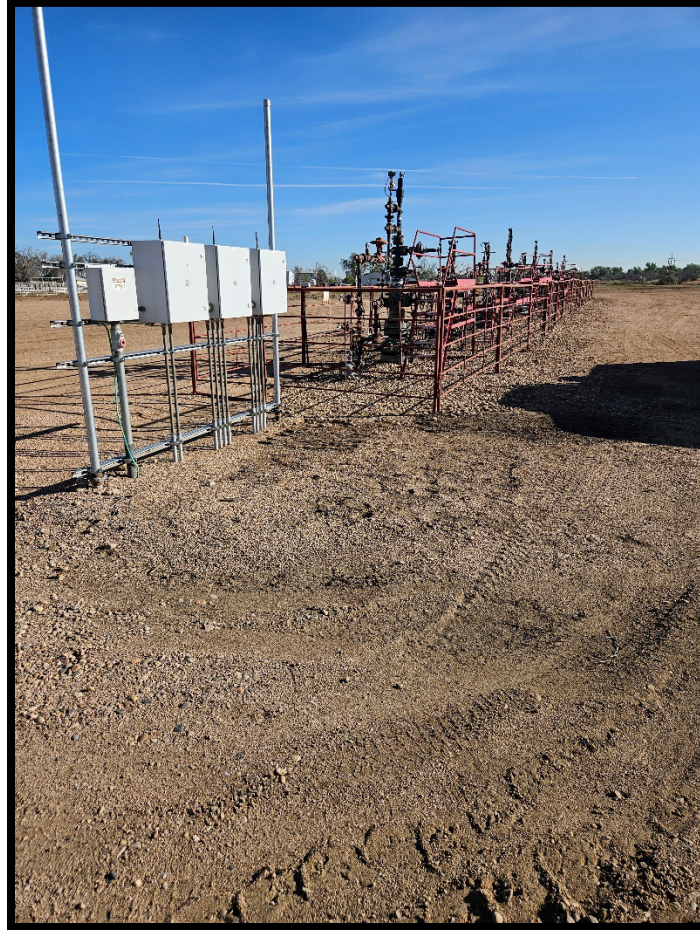
Exhibit A

CA: Unused equipment observed throughout. Refer to attached inspection photos for examples. Comply with Rule 606.

CA Resolution: Operator has reported that identified unused equipment observed on location has been addressed and cleared to comply with Rule 606.

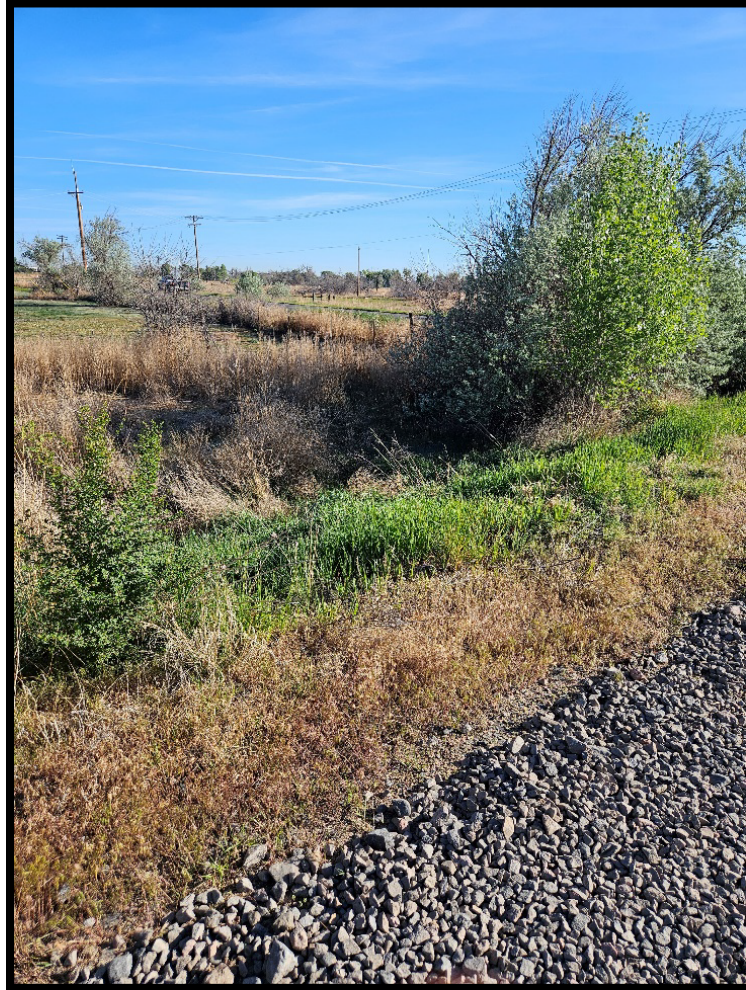
Exhibit A

CA: Trash and debris observed throughout equipment and the location. Refer to attached inspection photos for examples. Comply with Rule 606.

CA Resolution: Operator has reported that identified trash/debris observed on location has been addressed and cleared to comply with Rule 606.

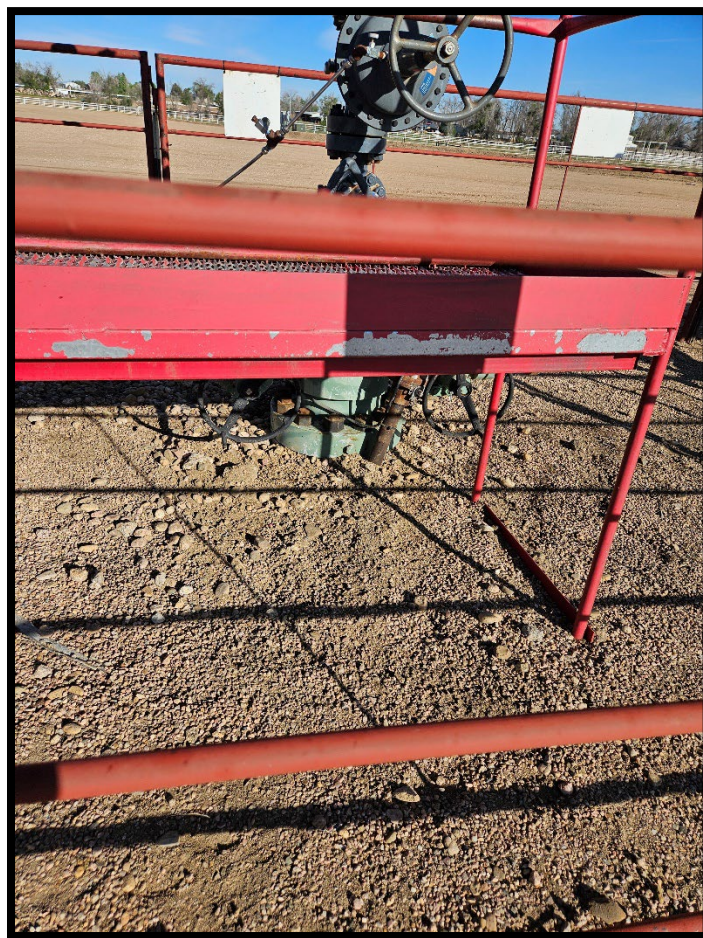
Exhibit A

CA: Drips and drabs (stained soil) observed throughout equipment. Refer to attached inspection photos for examples. Properly dispose of oily waste in accordance with Rule 905.e.

CA Resolution: Operator has reported that the identified areas with stained soil have been appropriately cleaned and stained soil has been disposed of to comply with Rule 905.e.

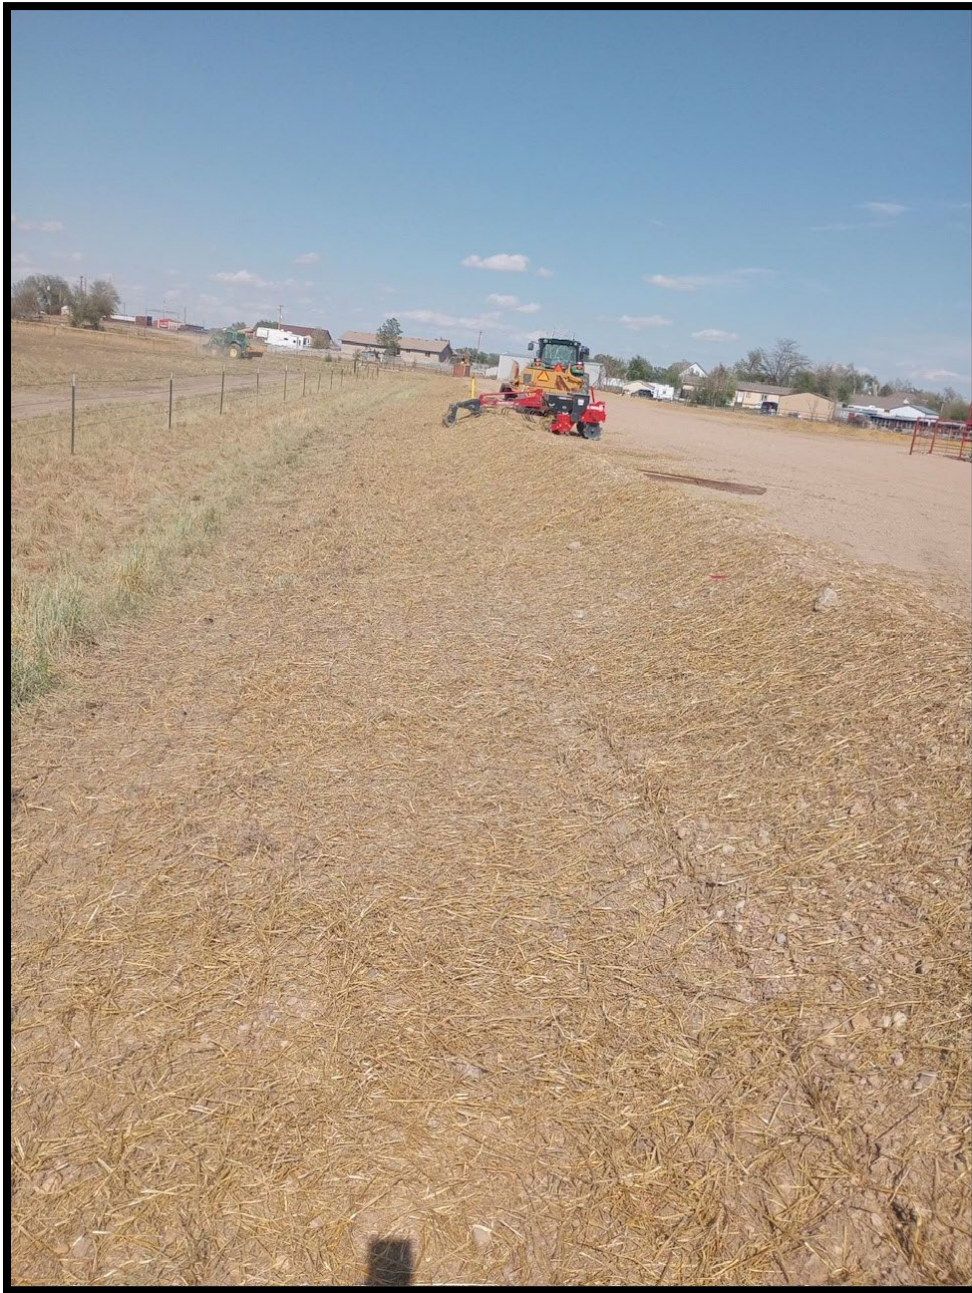
Exhibit A

CA: This location does not comply with Rule 1003. During this inspection, it was observed that interim areas do not appear to be progressing towards reclamation/vegetative standards with evidence of undesirable vegetation (e.g. kochia) and Colorado List C Noxious weed (field bindweed) observed on the production areas. Refer to FIR (#708201214) for additional reclamation comments at Location (#440761). Refer to attached inspection photos for additional. Comply with Rule 1003. Perform reclamation in accordance with Rule 1003. Establish vegetation with total perennial, non-invasive uniform plant cover of at least eighty (80) percent of reference area levels. Use a seed mixture requested by the surface owner, or a mixture prescribed by the local county NRCS. Ensure erosion controls are implemented to stabilize the seeded soil and continue to monitor and manage this site until the location meets Rule 1003 standards.

CA Resolution: Operator has reported that the location has been seeded, and straw crimped to provide stabilization and promote more uniform future growth. Operator also noted that the location was sprayed prior to interseeding actions to address weeds/additional undesirable vegetation. Location currently complies with Rule 1003.
