Operator: BCEI
Location Name: Antelope G-29
Loc ID: 422161
Inspection: 696306429

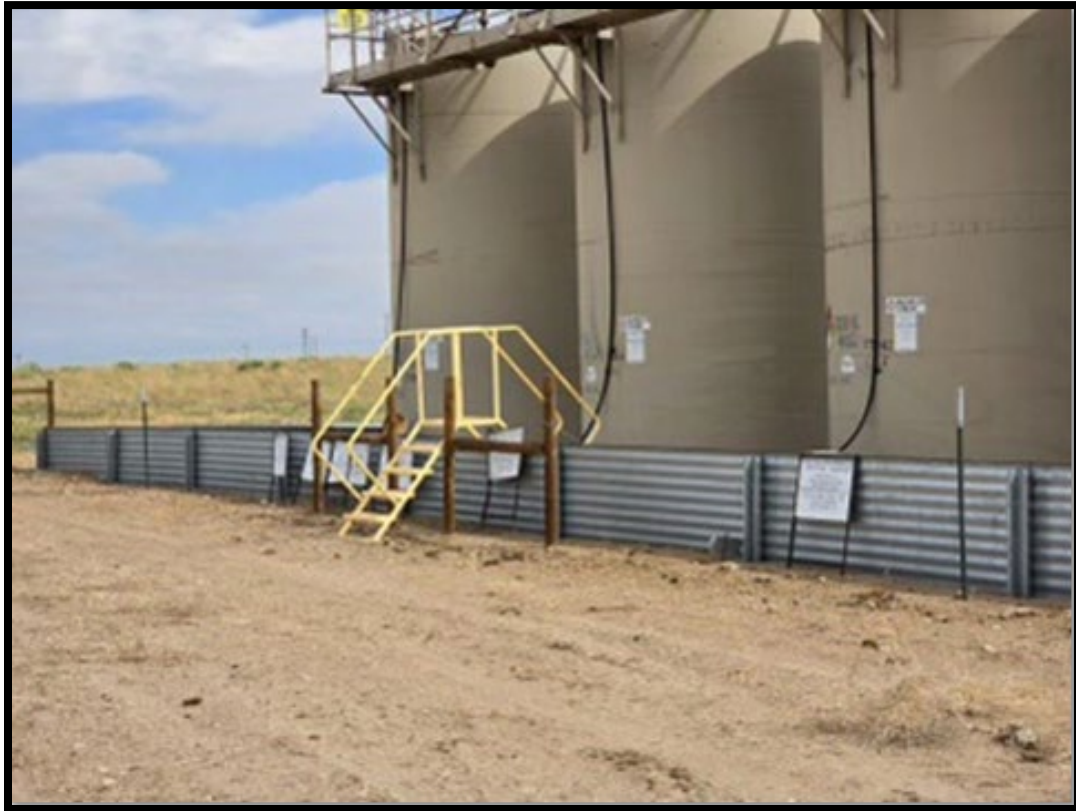
Exhibit A

CA: Tumbleweed Debris at Separators and Wellheads; see photos. Comply with Rule 606.

CA Resolution: Operator has reported that identified tumbleweeds and debris has been appropriately cleared from the location to comply with Rule 606.

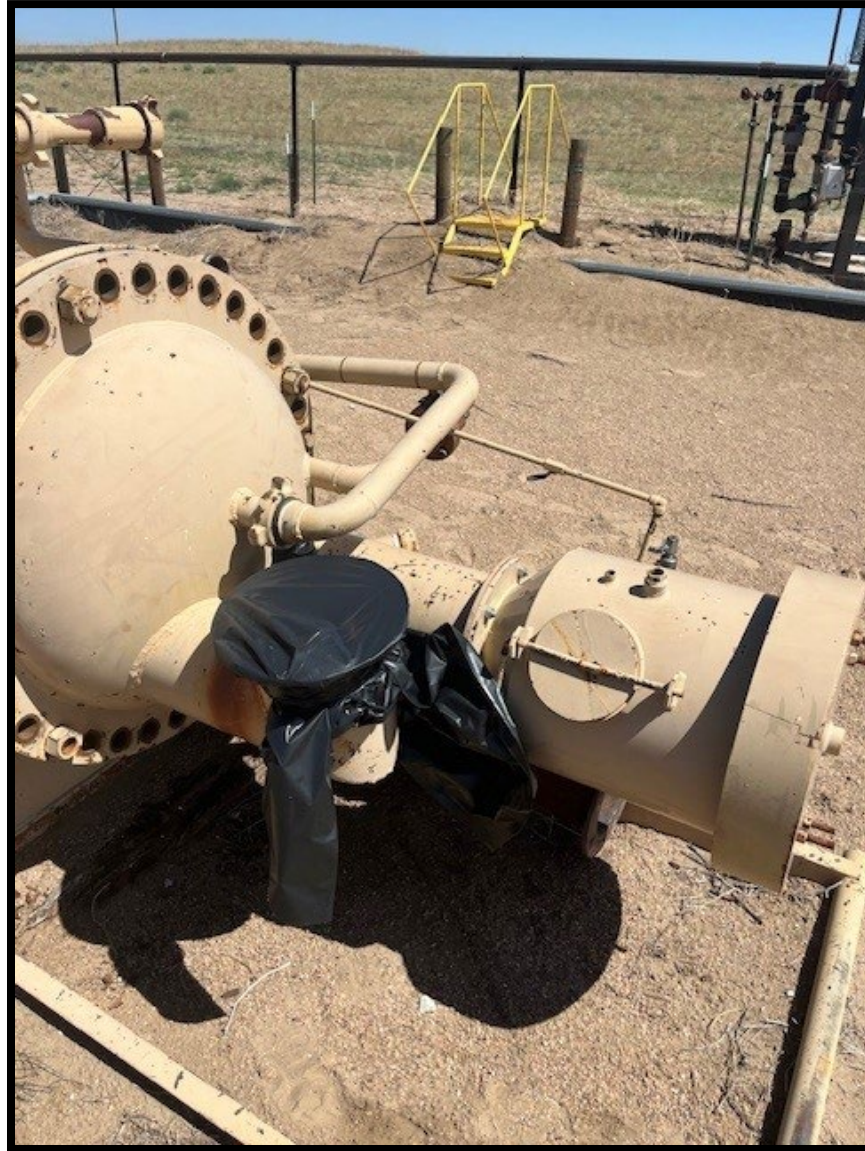
Exhibit A

CA: Unmarked Risers at various Wellheads and Separators. Upon removing a flowline or crude oil transfer line from use with the intent to abandon, an operator must immediately apply OOSLAT to the risers. OOSLAT must stay in place at all times during the process of abandoning the flowline or crude oil transfer line until the operator removes the riser. Comply with Rule 1105.b.

CA Resolution: Operator has reported that various risers have now been appropriately marked to comply with Rule 1105.b.
