# Final Reclamation and Stormwater Inspection

Operator: Extraction Oil & Gas Inc - 10459

Location ID: 463225

Location Name: Hippen 32-2,13; Pezoldt UU

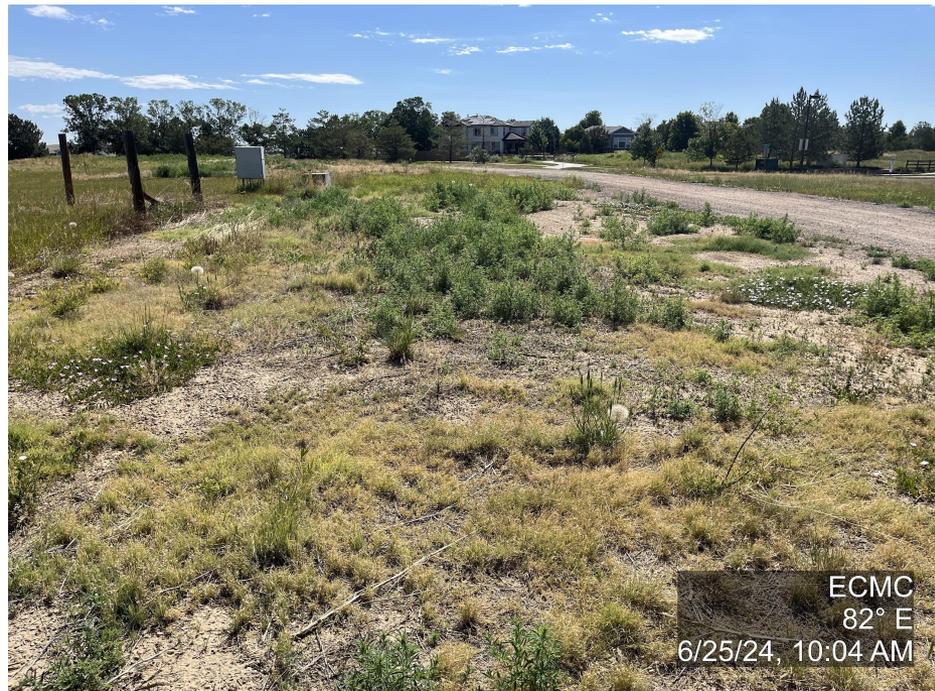
**Photo 1.** The photo was taken at the tank battery location facing East. The photo illustrates bare soil, Kochia, field bindweed and Saltgrass dominate the location.

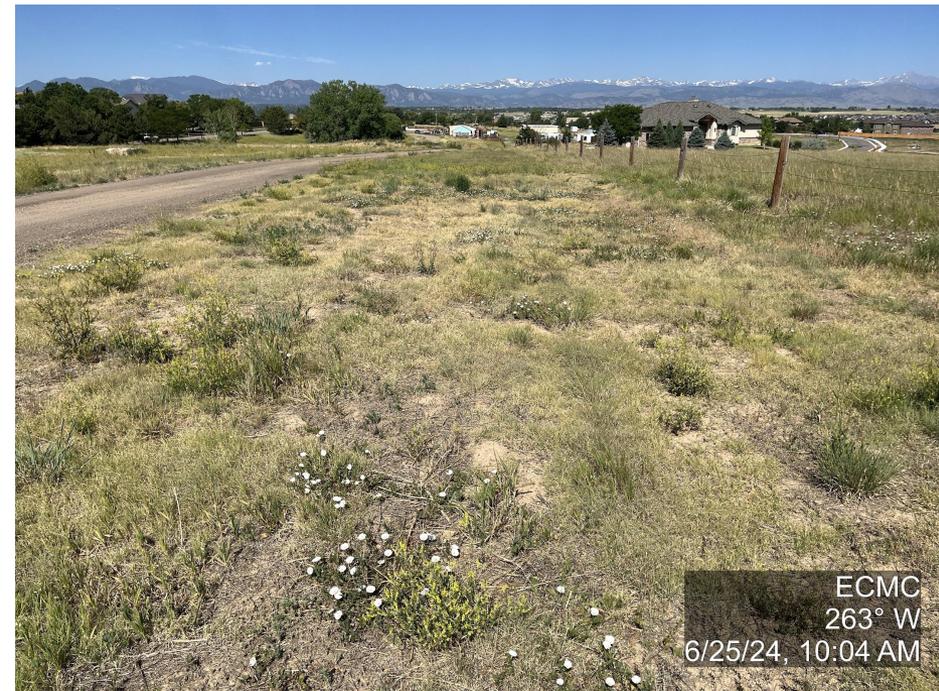
**Photo 2.** The photo was taken at the tank battery location facing West. Refer to the comment for photo 1.

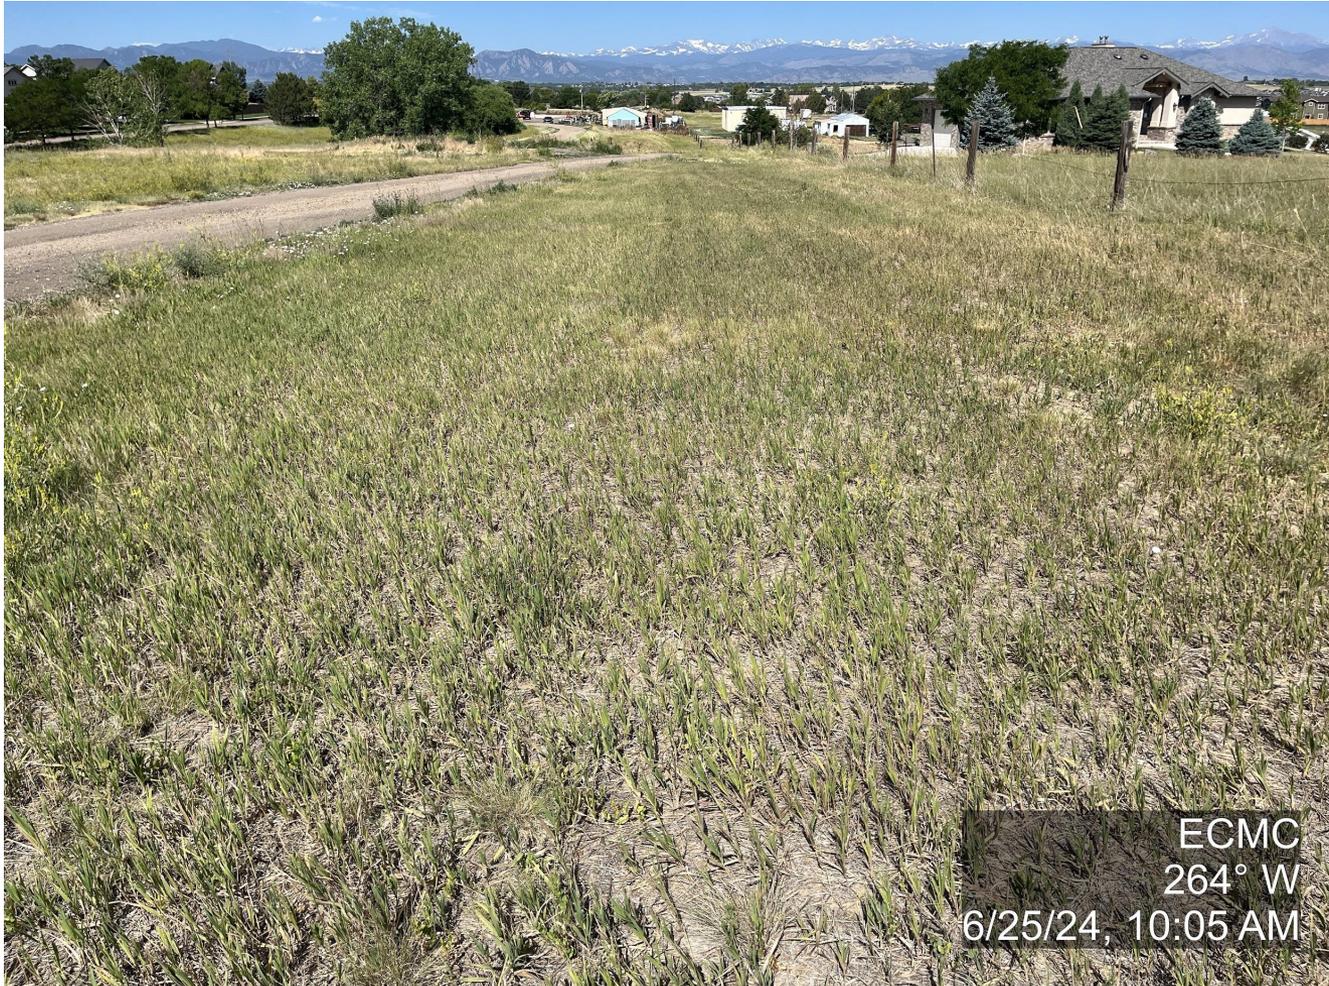
**Photo 3.** The reference photo was taken near the tank battery location facing West. The photo illustrates reference areas along the gravel road are dominated by Smooth Brome.
