Operator: BCEI
Location Name: Antelope I-29
Loc ID: 422173
Inspection: 696306431

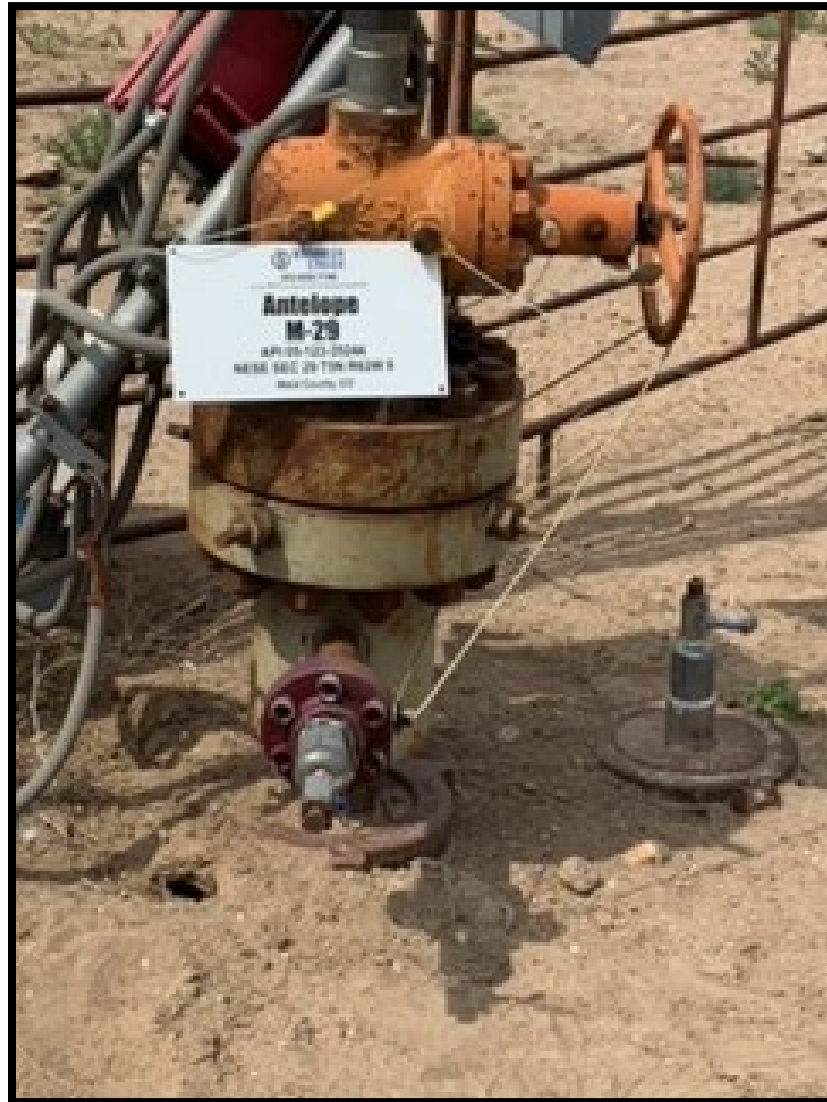
Exhibit A

CA: All Wellhead Signs have faded no longer visible; see photos. Install sign to comply with Rule 605.d.

CA Resolution: Operator has reported that Wellhead signage has been updated and installed appropriately to comply with Rule 605.d.

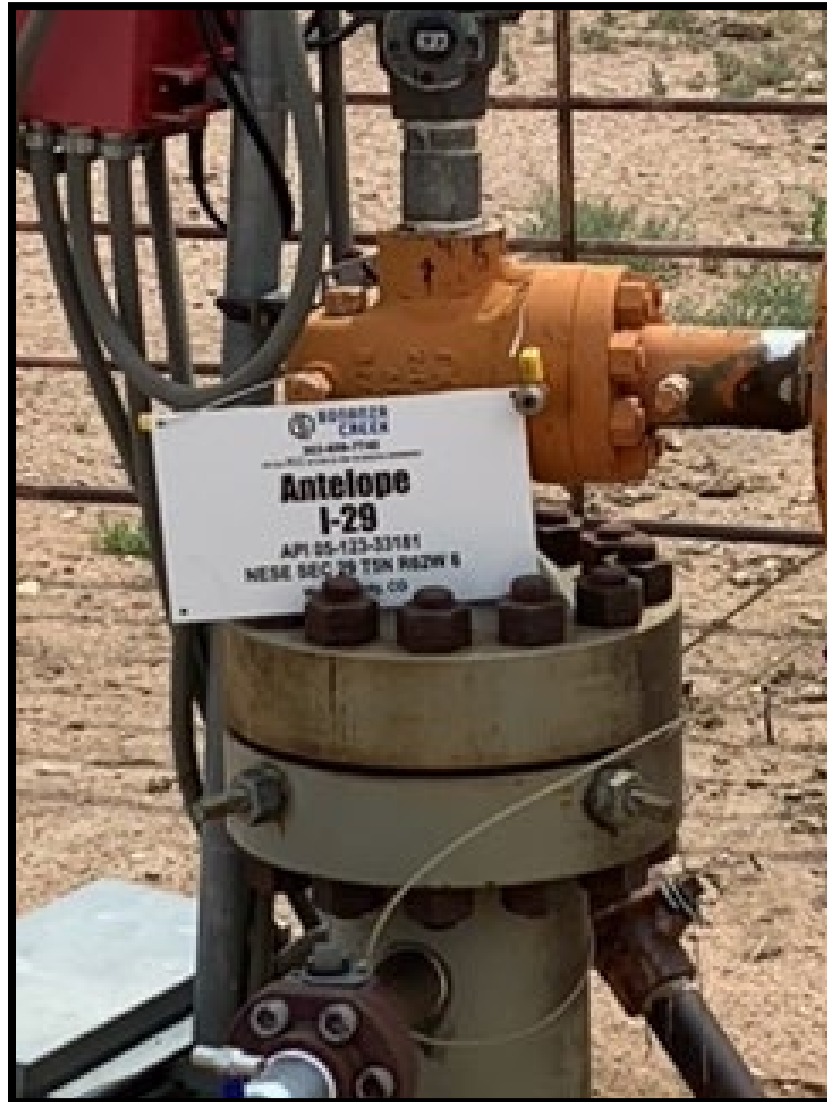
Exhibit C

CA: Unmarked Risers at various Wellheads and Separators. Upon removing a flowline or crude oil transfer line from use with the intent to abandon, an operator must immediately apply OOSLAT to the risers. OOSLAT must stay in place at all times during the process of abandoning the flowline or crude oil transfer line until the operator removes the riser. Comply with Rule 1105.b.

CA Resolution: Operator reported that identified risers have been marked appropriately, and shared additional photo regarding a marked riser to comply with Rule 1105.b.
