**Operator: BONANZA CREEK ENERGY OPERATING COMPANY LLC**

**Location Name: Antelope I-17**

**Loc ID: 420880**

**Inspection: 696306475**

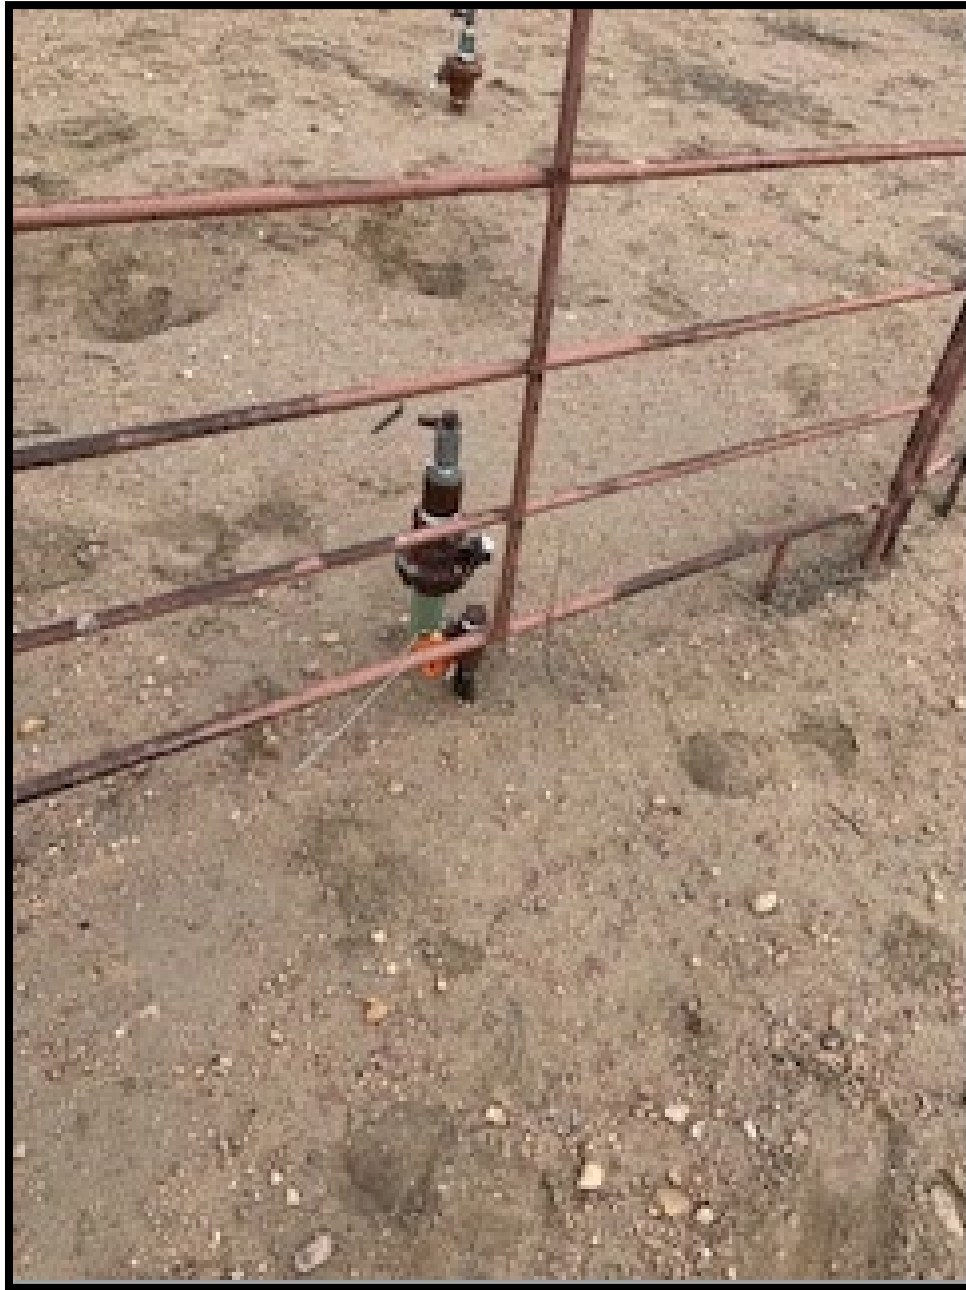
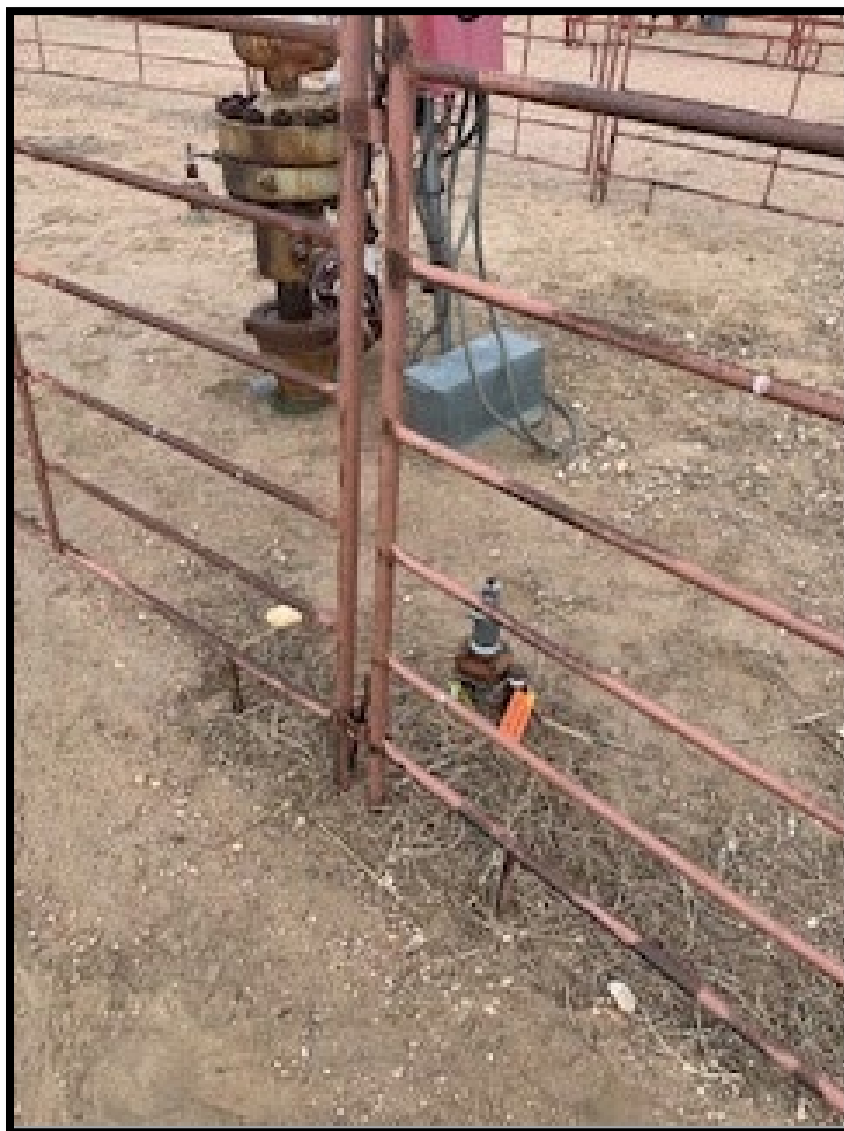
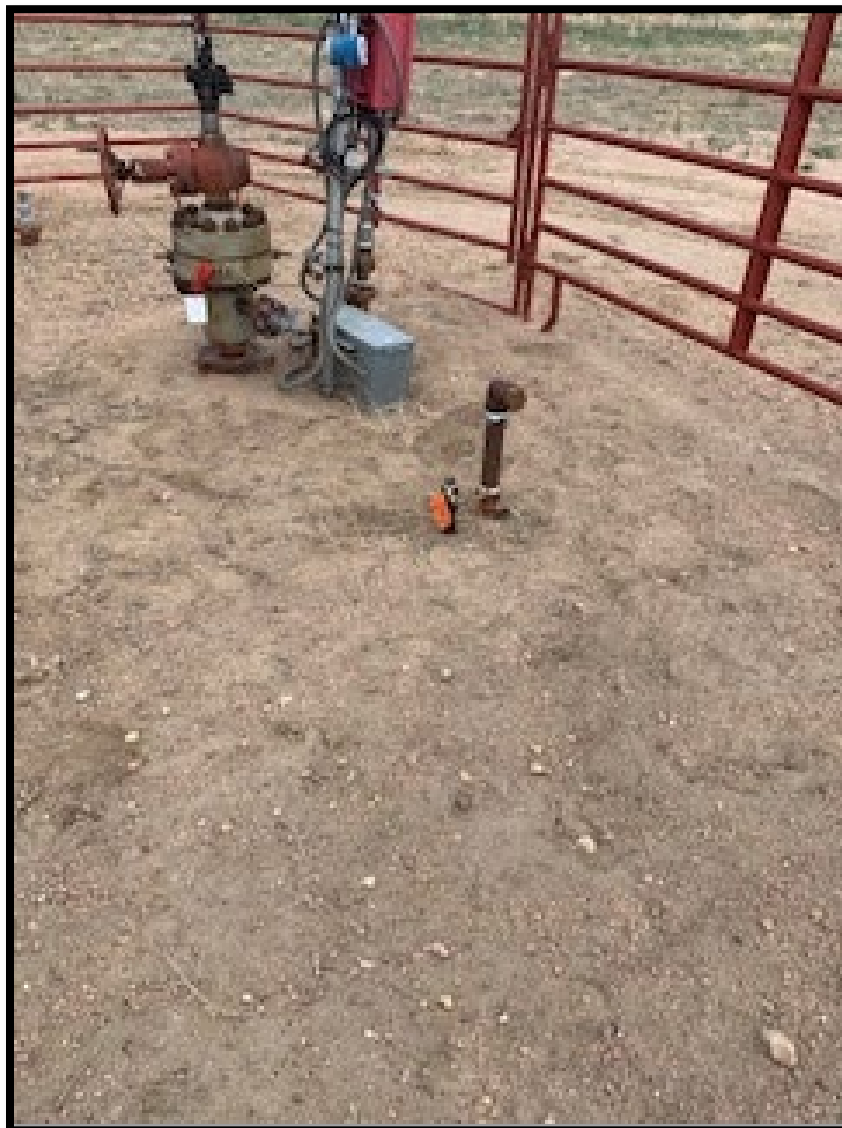
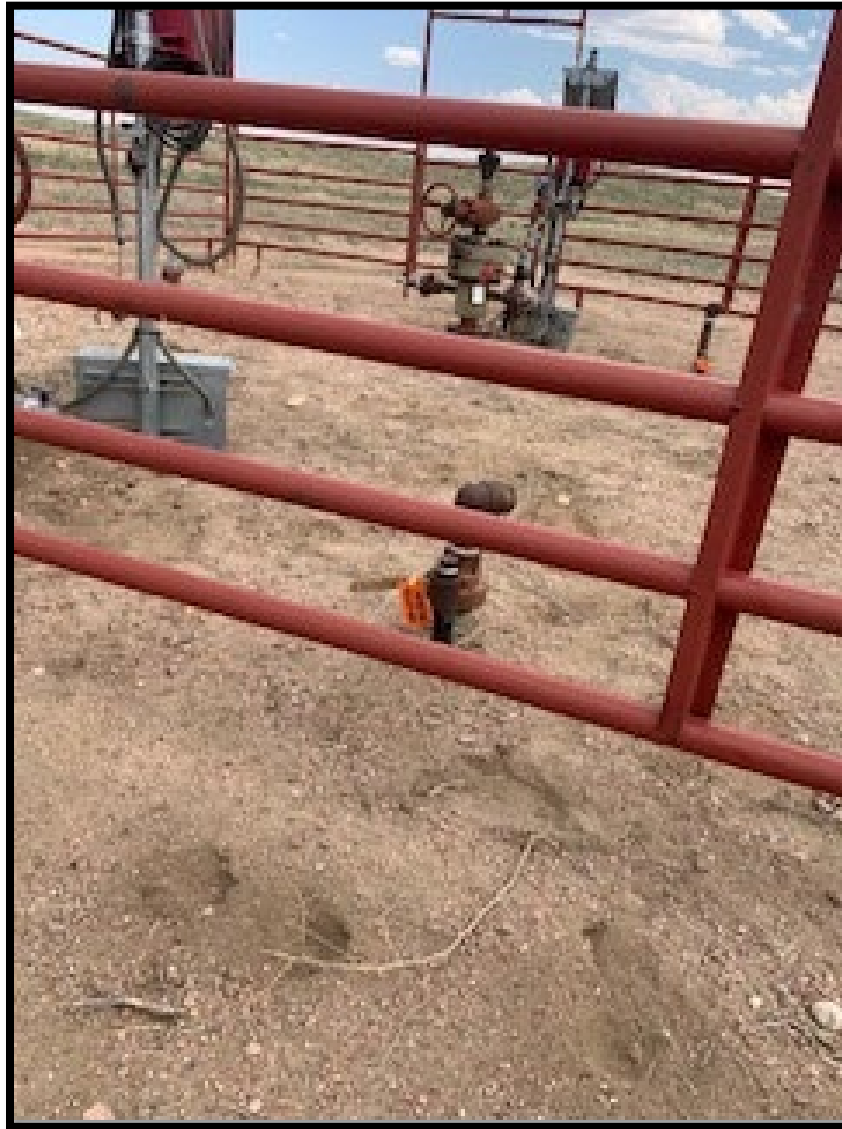
**CA:** Unmarked 1" Risers at Wellheads; see photos Upon removing a flowline or crude oil transfer line from use with the intent to abandon, an operator must immediately apply OOSLAT to the risers. OOSLAT must stay in place at all times during the process of abandoning the flowline or crude oil transfer line until the operator removes the riser. Comply with Rule 1105.b.

**CA Resolution:** Operator has reported that identified risers have been appropriately marked to comply with Rule 1105.b.

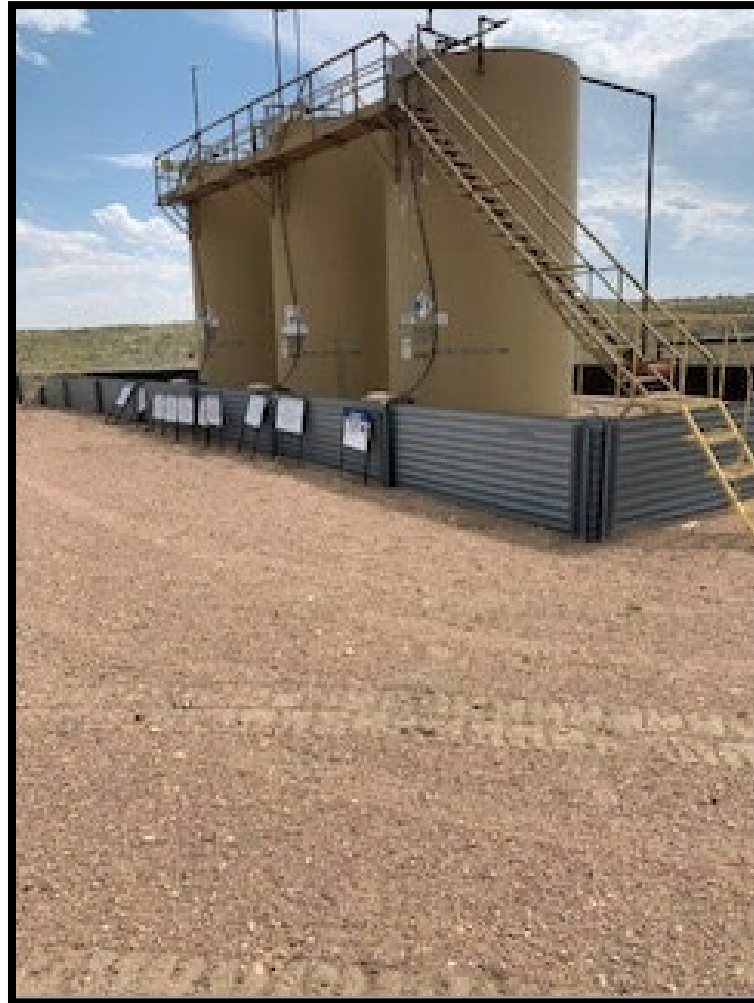
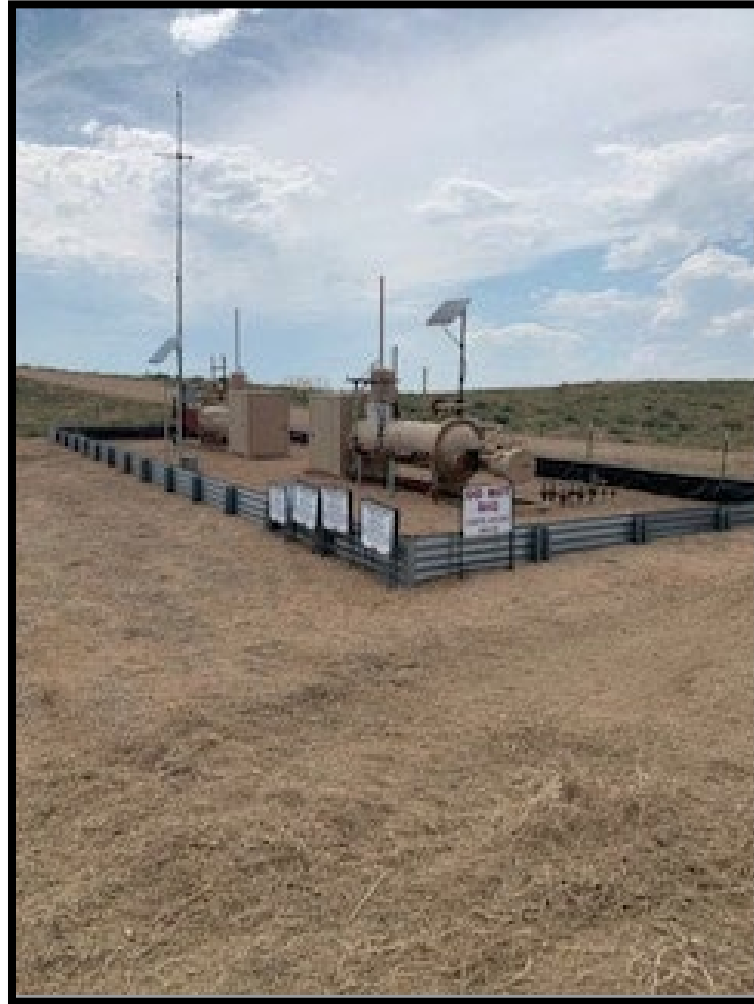
**CA:** Tumbleweed Debris at Wellheads and Separators, Comply with Rule 606,

**CA Resolution:** Operator has reported that identified debris/tumbleweeds have been addressed/cleared from the location to comply with Rule 606.
