WELL NAME: BILBO FEDERAL 11-24, API #: 071-009804, INSP. # 695109872

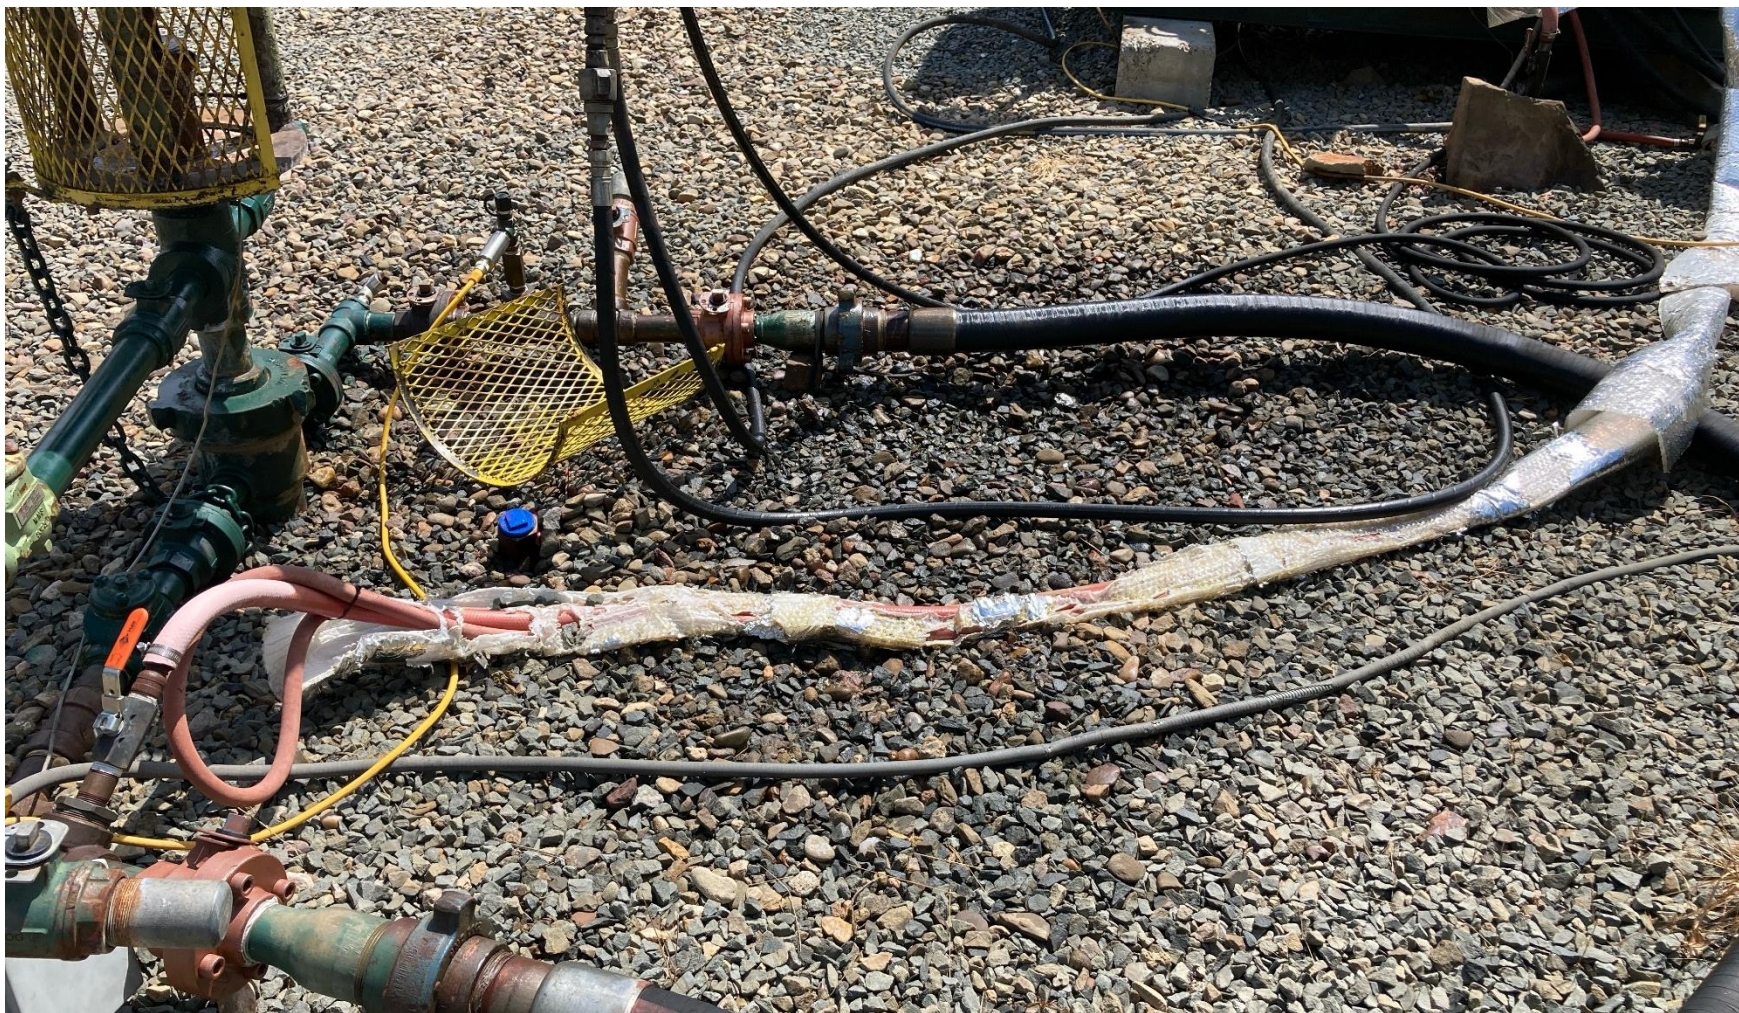
PHOTO 4: IT APPEARS THAT THE DRIVEHEAD OR HYDRAULIC LINES ARE LEAKING CAUSING AN AREA OF IMPACTED SOIL NEAR WELLHEAD. **FIX LEAK AND REMOVE OR TREAT IMPACTED MATERIALS.**
