**Operator: BCEI**

**Location Name: ANTELOPE 23-19 Pad**

**Loc ID: 420769**

**Inspection: 696306490**

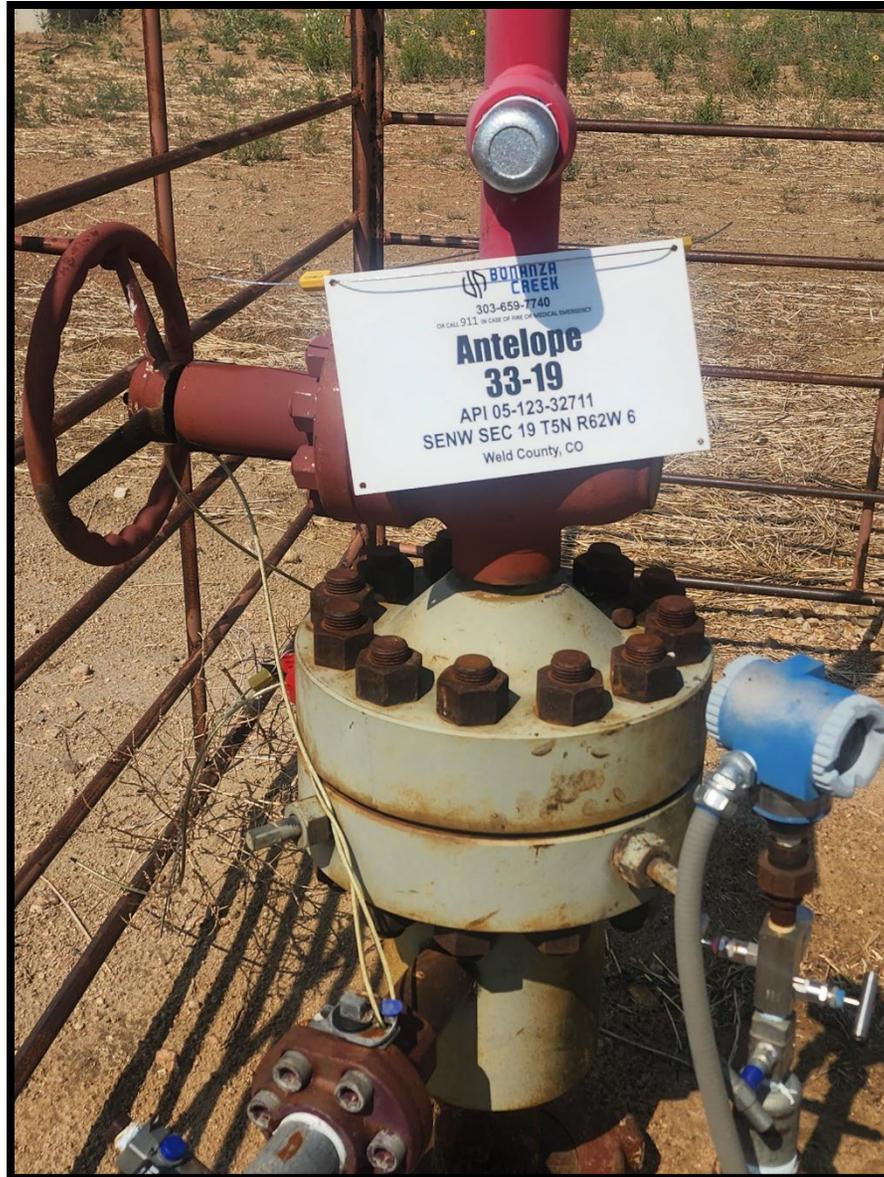
Exhibit A

**CA:** All 4 remaining Wellhead Signs have faded no longer visible; see photos. Install sign to comply with Rule 605.d

**CA Resolution:** Operator has reported that the identified Wellhead signs have now been appropriately replaced/installed to comply with Rule 605.d.
