Operator: HPR

Location Name: Anschutz Equus Farms 4-62-33 NWNW

Loc ID: 437854

Inspection: 713900536

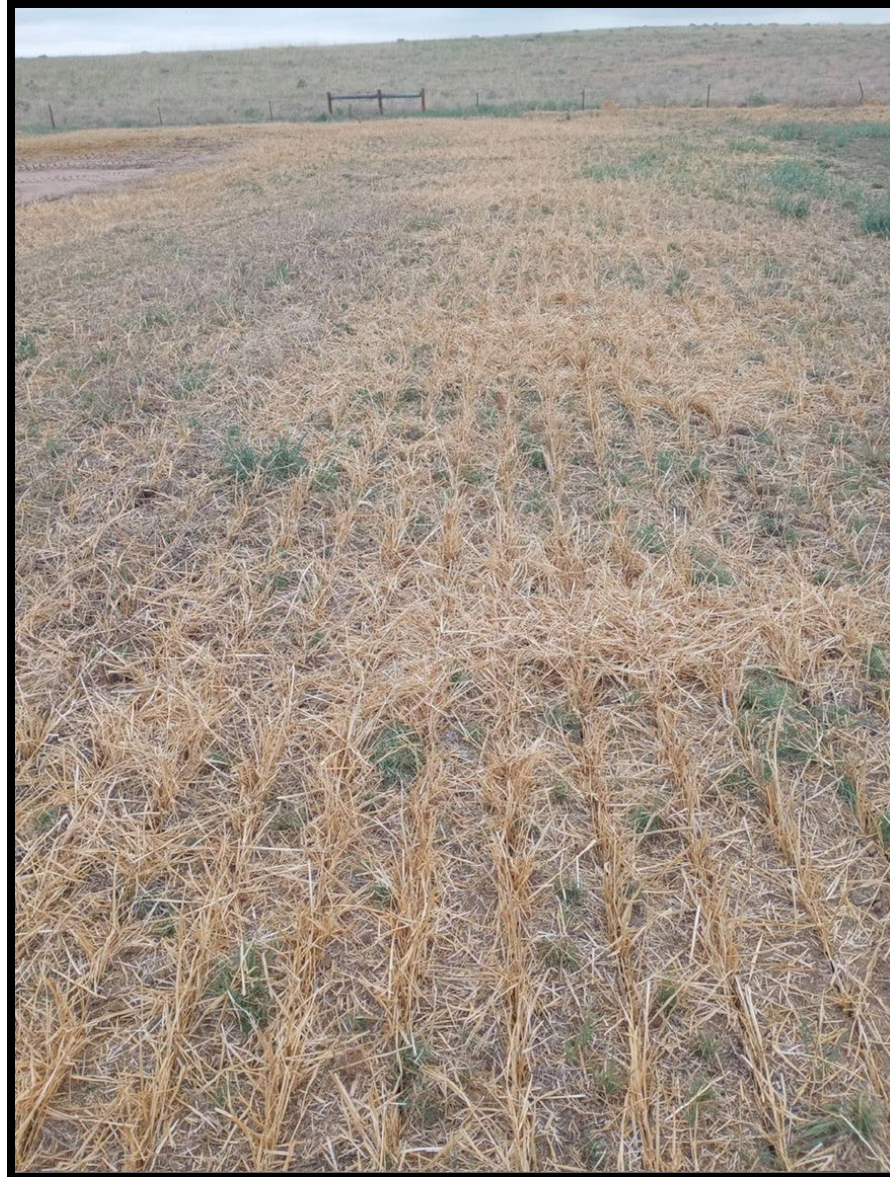
Exhibit A

CA: Appears interim reclamation activities have been performed to reduce disturbance areas only needed for production operations. Vegetation throughout the interim areas has not met Rule 1003 standards and will remain IN-PROCESS. Operator shall continue to monitor and manage this site until the location meets Rule 1003 standards, including stormwater and weed management. Operator shall submit a Form 4 Interim Reclamation Complete notice when the location meets Rule 1003 standards. ECMC may conduct inspections prior to receiving said notice to ensure compliance with Rule 1003.

CA Resolution: Operator has provided photo documentation to show that weeds and undesirable vegetation have been addressed. The area has been reseeded, and straw crimped to provide stabilization and promote more uniform future growth. Location currently complies with Rule 1003.
