Deadman Gulch Unit Hotchkiss Federal 20-12D ECMC Field Inspection Document # 708302167

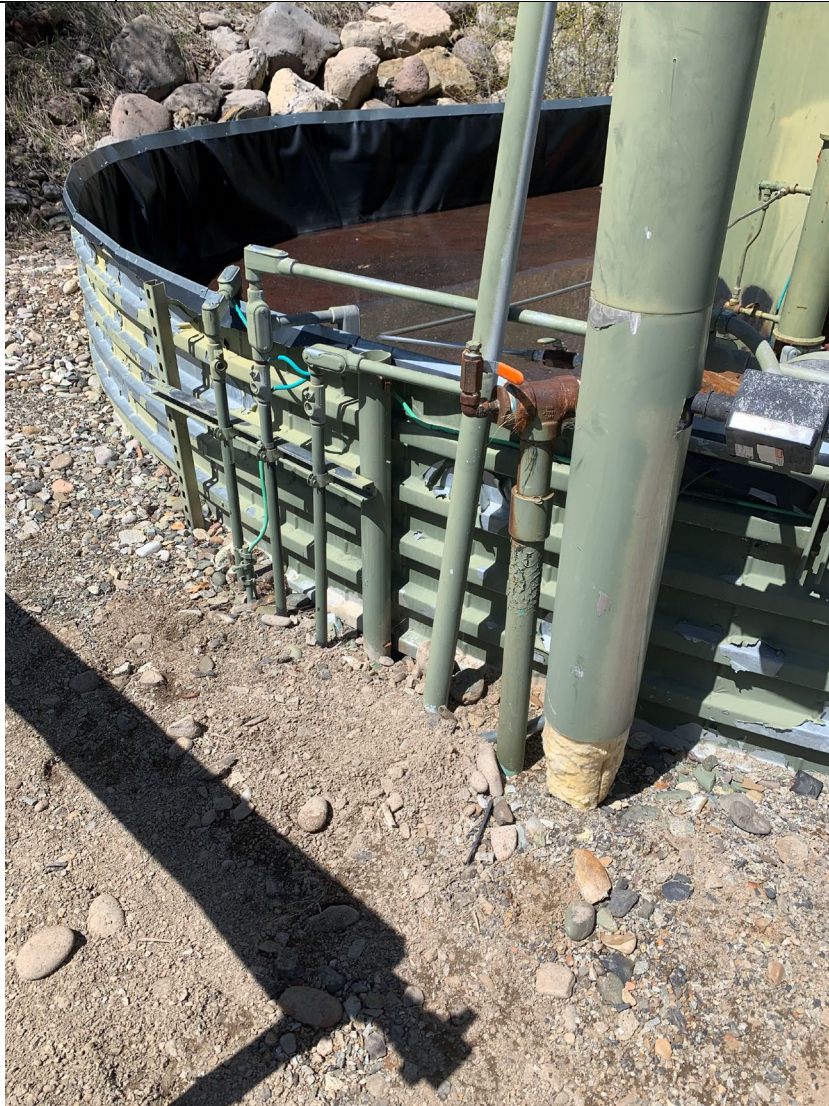
Description:	Unused stainless steel tubing and heat trace lines at tank battery.
Corrective Action:	Remove unused equipment from location to comply with Rule 606.
Operator Comment:	Unused tubing and lines have been removed.

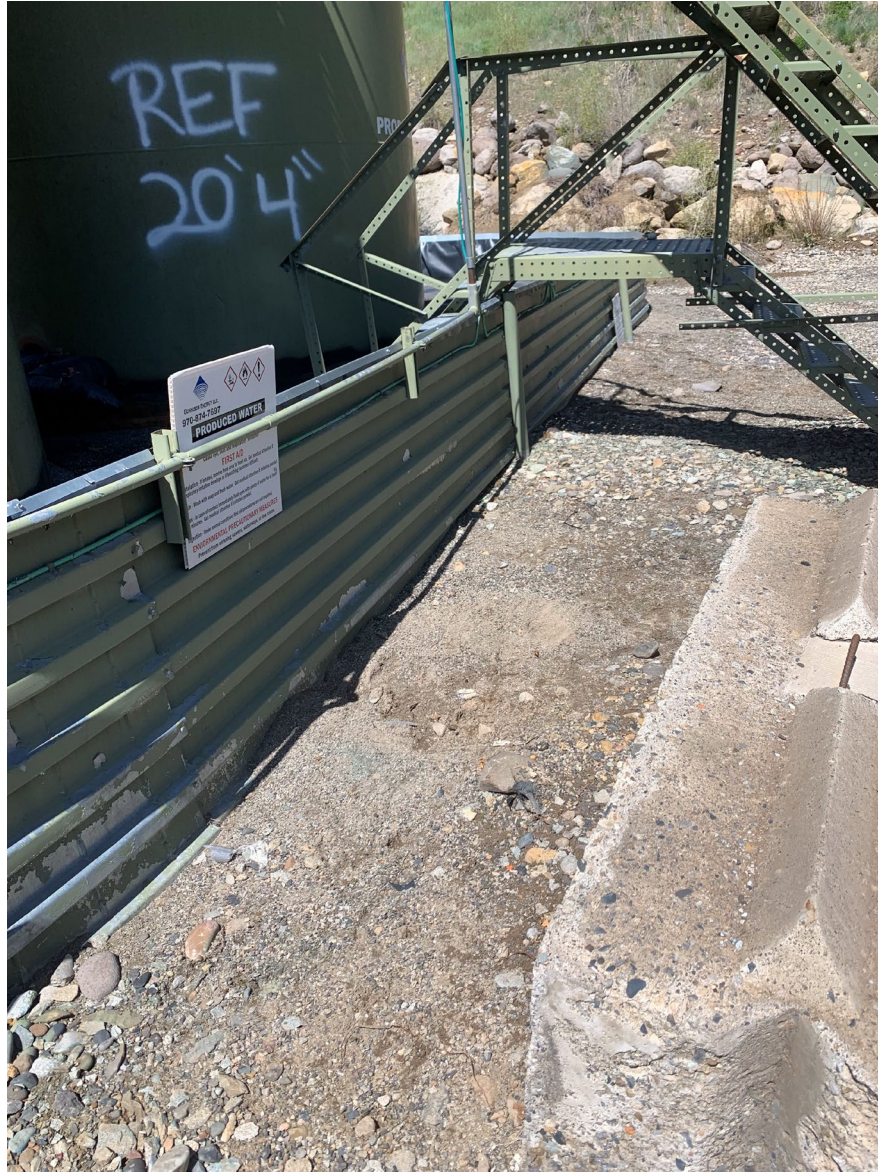
Description:	Barrel jacket/container stored near tank battery.
Corrective Action:	Remove stored supplies/equipment from location to comply with Rule 606.
Operator Comment:	Equipment removed

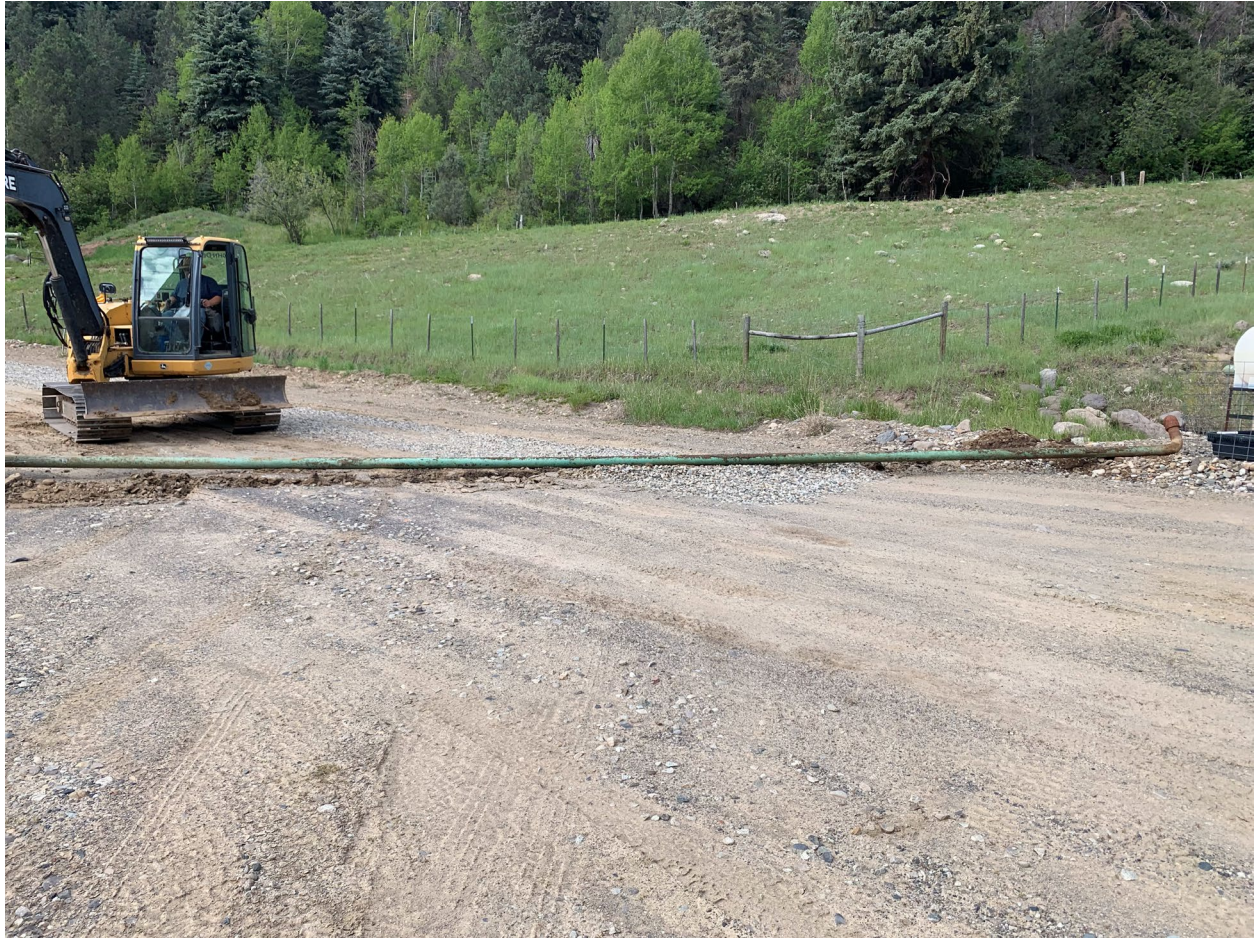
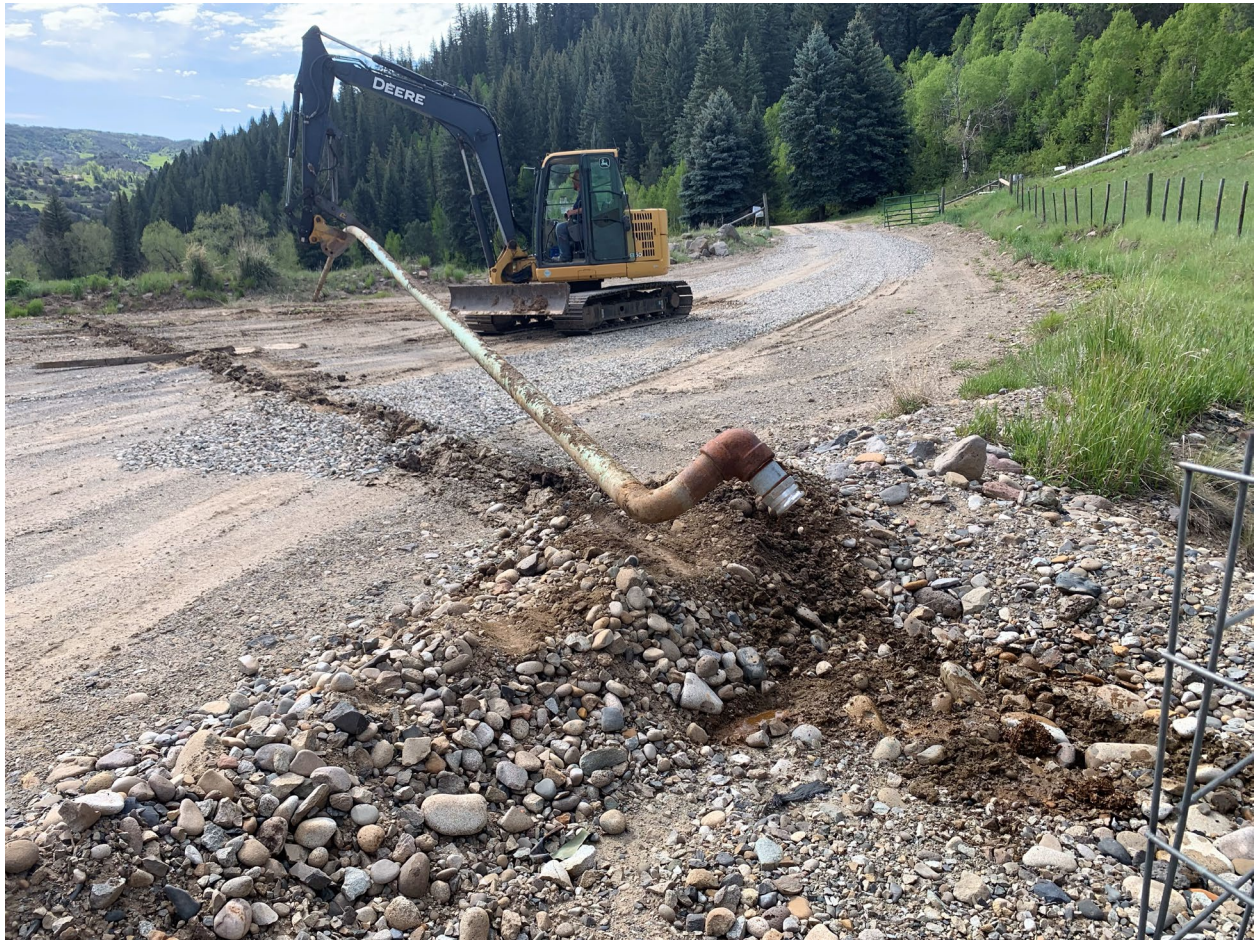
Description:	4 inch line near chemical tanks at separator is open-ended and poses a wildlife entry hazard.
Corrective Action:	Secure line to comply with Rule 608.e.
Operator Comment:	Line has been removed
