WELL LOCATION CERTIFICATE

CE 5-68 11-10-7H
BISON OIL & GAS IV

Q: NE4
SECTION: 11
TOWNSHIP: 5N
RANGE: 68W
6TH. P.M.
LARIMER COUNTY, CO

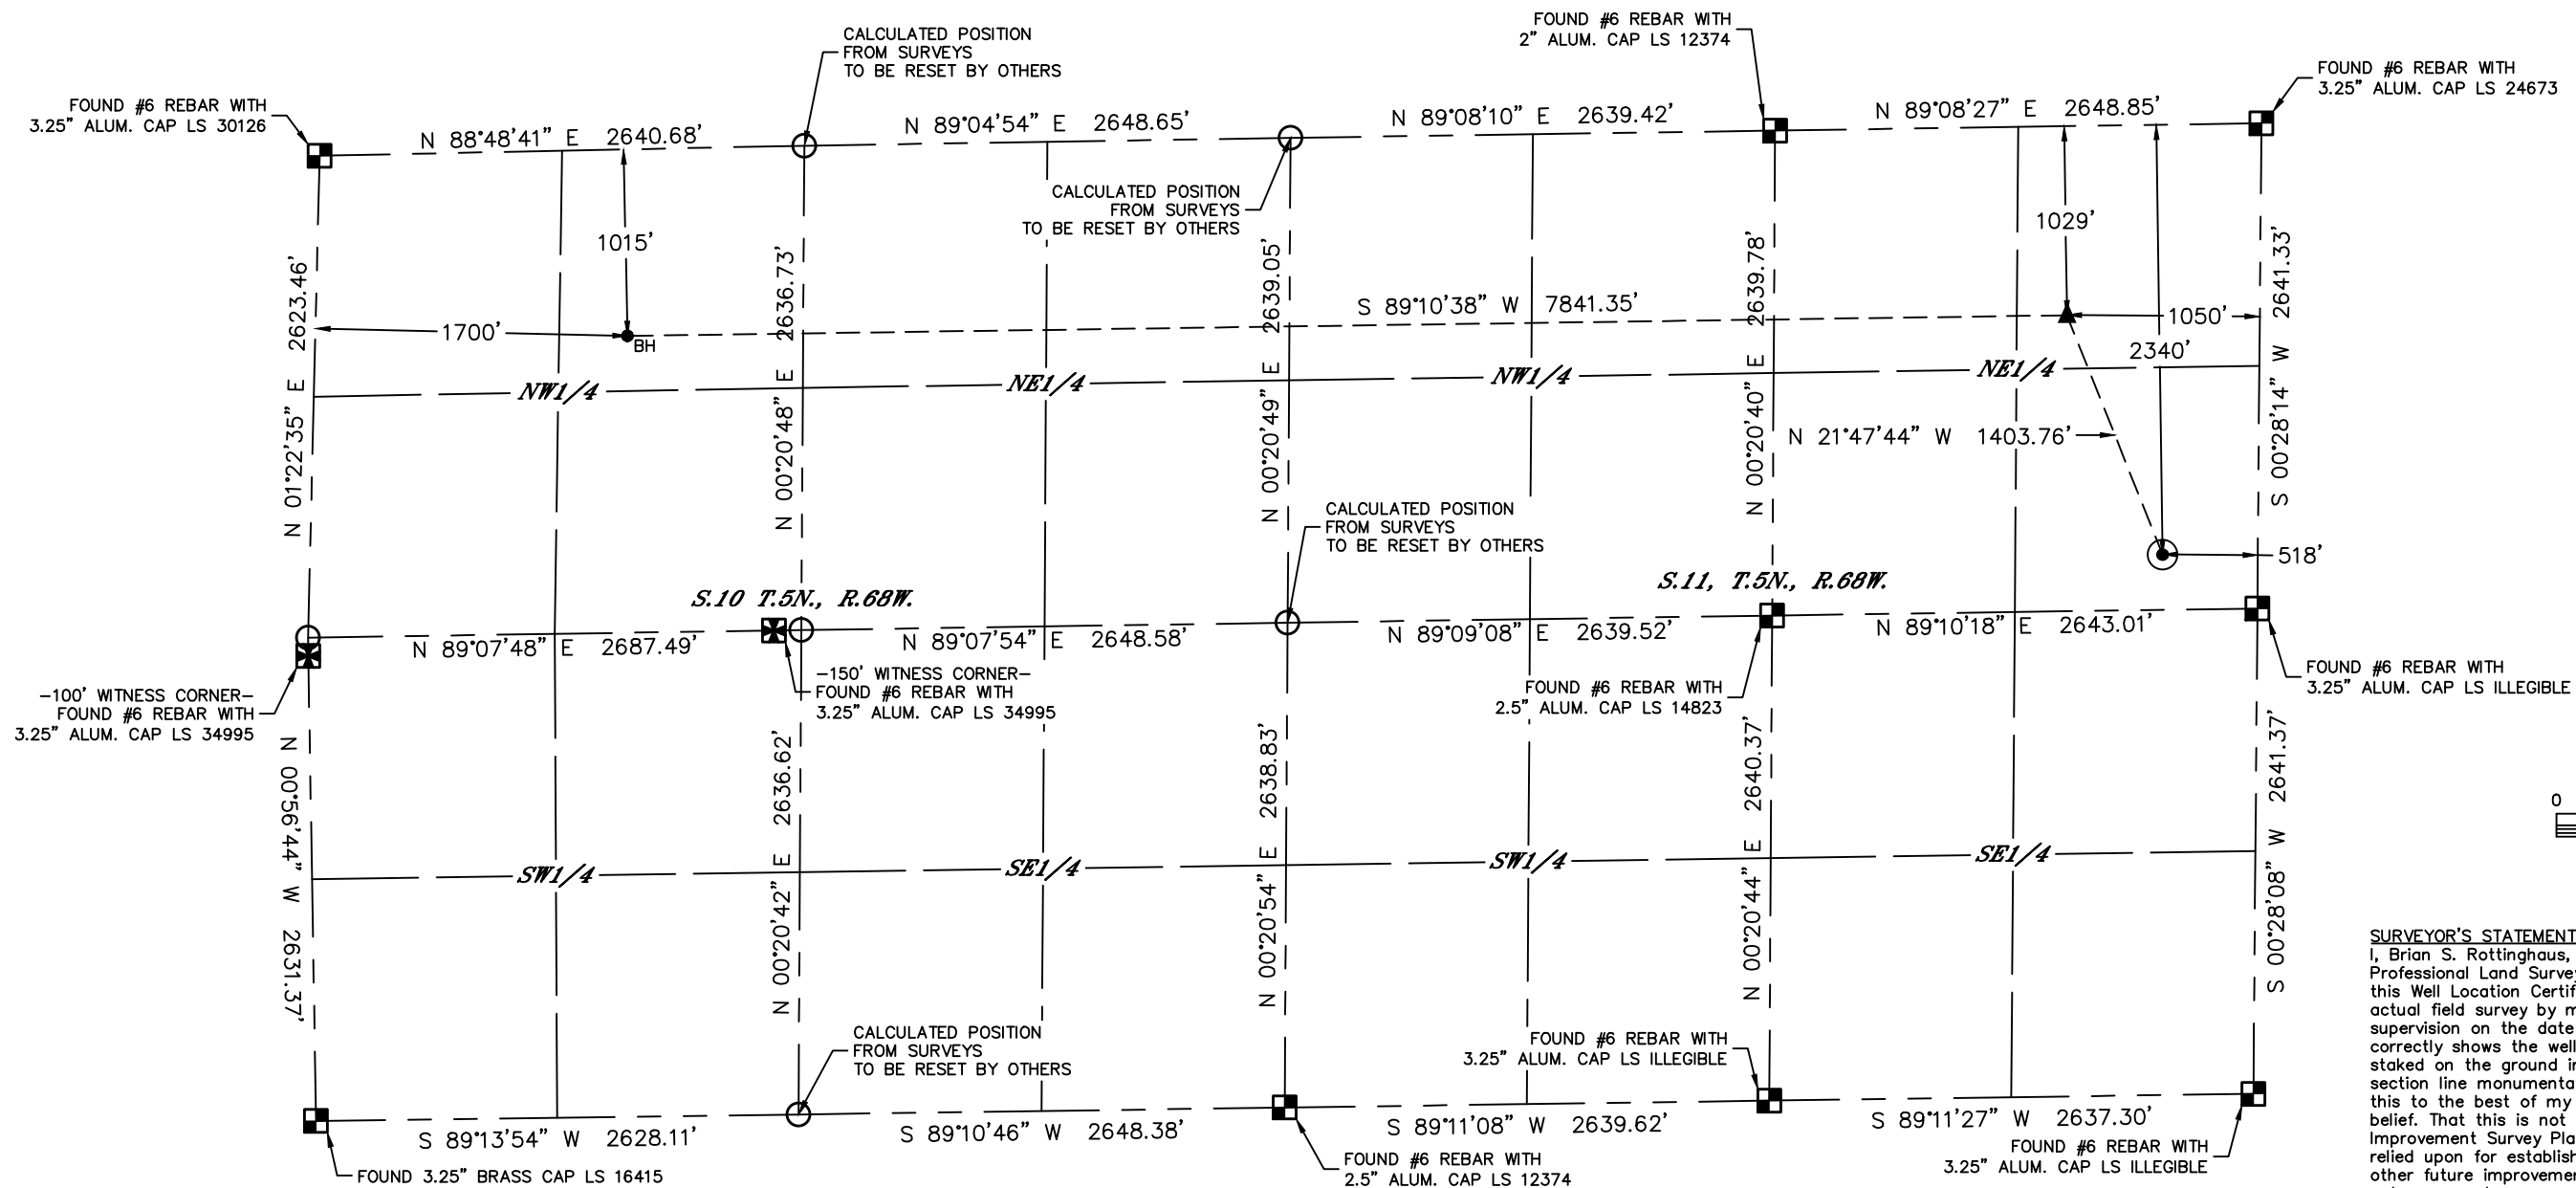
SURVEYOR'S STATEMENT
 I, Brian S. Rottinghaus, a Colorado Licensed Professional Land Surveyor, do hereby state that this Well Location Certificate was prepared from an actual field survey by me or under my personal supervision on the date shown hereon, and correctly shows the well surface hole location as staked on the ground in relation to the existing section line monumentation as indicated hereon, all this to the best of my knowledge, information and belief. That this is not a Land Survey Plat or an Improvement Survey Plat, and that it is not to be relied upon for establishment of fence, building, or other future improvement lines. This certificate is not a guaranty or warranty, either expressed or implied.

CLIENT: BISON OIL & GAS IV					LANDMAN: IAN HOGAN				
INSTRUMENT OPERATOR: CASEY KOHOUT					SURVEY DATE: 6/10/2022			SURFACE USE: CROP LAND	
SHL FOOTAGE		SHL LAT °	SHL LONG °	SHL PDOP	SHL ELEV (FT.)	SHL 1/4/1/4	SHL S-T-R		
2340	FNL	518	FEL	40.41529	-104.96605	1.7	4979	SENE	11-5-68
BHL FOOTAGE		BHL LAT °	BHL LONG °	BHL S-T-R	EP LAT °	EP LONG °	EP S-T-R		
1015	FNL	1700	FWL	40.41869	-104.99604	10-5-68	40.41887	-104.96789	11-5-68
