WELL LOCATION CERTIFICATE

CE 5-68 11-10-8H
BISON OIL & GAS IV

Q: NE4
SECTION: 11
TOWNSHIP: 5N
RANGE: 68W
6TH. P.M.
LARIMER COUNTY, CO

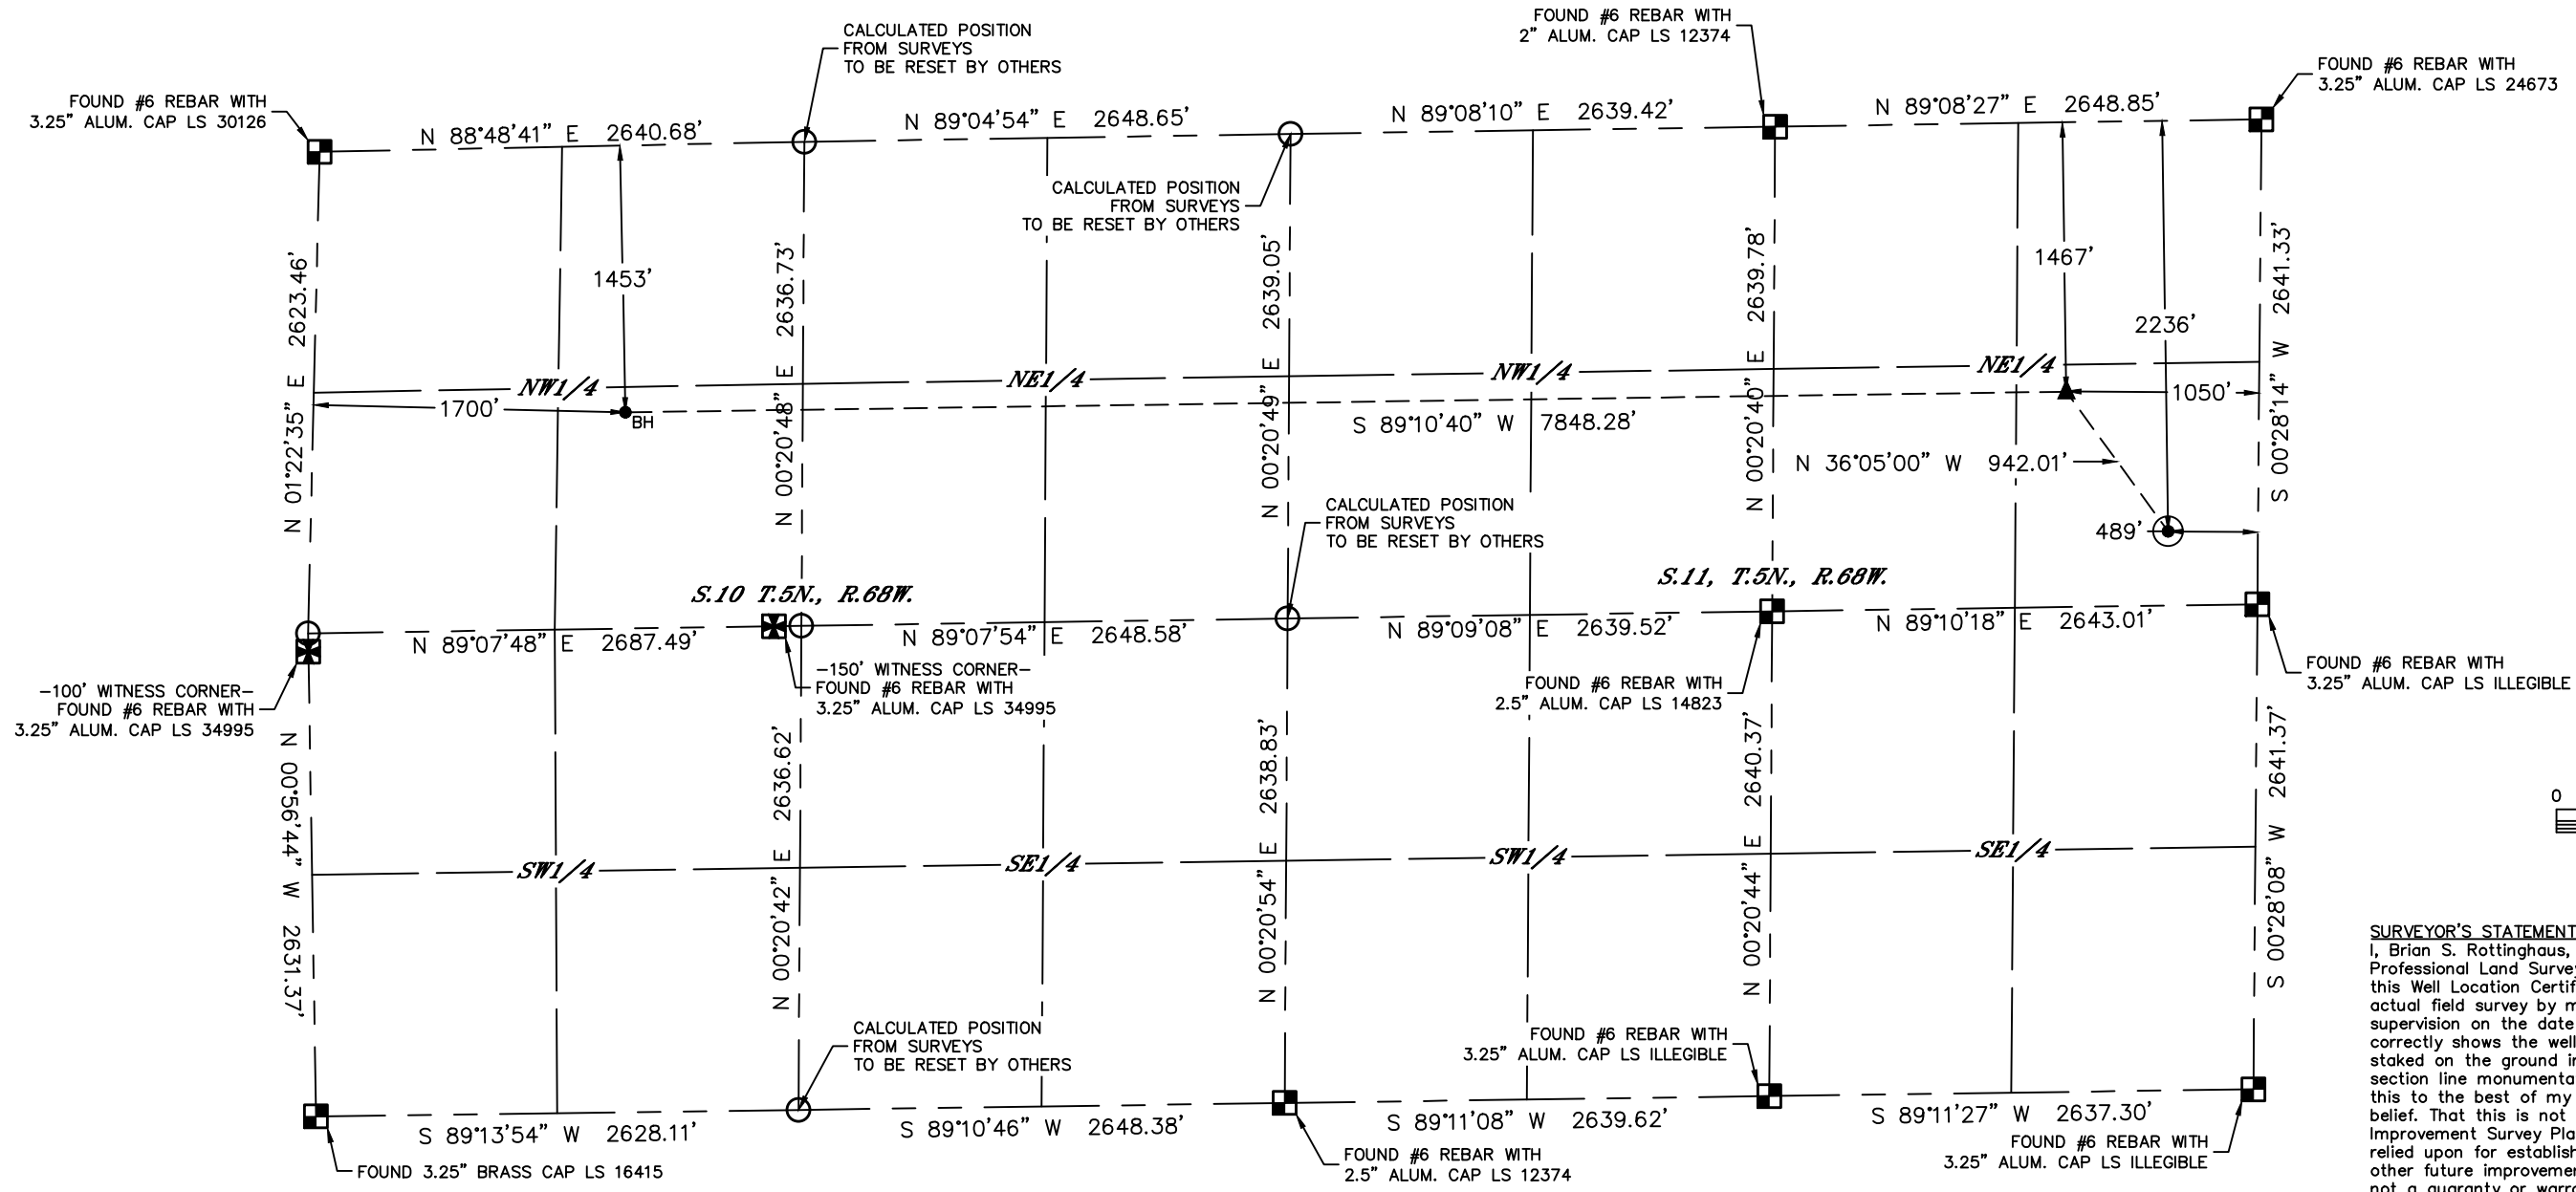
SURVEYOR'S STATEMENT
 I, Brian S. Rottinghaus, a Colorado Licensed Professional Land Surveyor, do hereby state that this Well Location Certificate was prepared from an actual field survey by me or under my personal supervision on the date shown hereon, and correctly shows the well surface hole location as staked on the ground in relation to the existing section line monumentation as indicated hereon, all this to the best of my knowledge, information and belief. That this is not a Land Survey Plat or an Improvement Survey Plat, and that it is not to be relied upon for establishment of fence, building, or other future improvement lines. This certificate is not a guaranty or warranty, either expressed or implied.

CLIENT: BISON OIL & GAS IV				LANDMAN: IAN HOGAN			
INSTRUMENT OPERATOR: CASEY KOHOUT				SURVEY DATE: 6/10/2022			
SHL FOOTAGE		SHL LAT°	SHL LONG°	SHL PDOP	SHL ELEV (FT.)	SHL 1/4/1/4	SHL S-T-R
2236	FNL	489	FEL	40.41557	-104.96594	1.7	4981
						SENE	11-5-68
BHL FOOTAGE		BHL LAT°	BHL LONG°	BHL S-T-R	EP LAT°	EP LONG°	EP S-T-R
1453	FNL	1700	FWL	40.41749	-104.99609	10-5-68	40.41767
							-104.96791
							11-5-68
