Final Reclamation and Stormwater Inspection

Operator: PDC ENERGY INC- 69175

Location ID: 309676

Weld County, CO

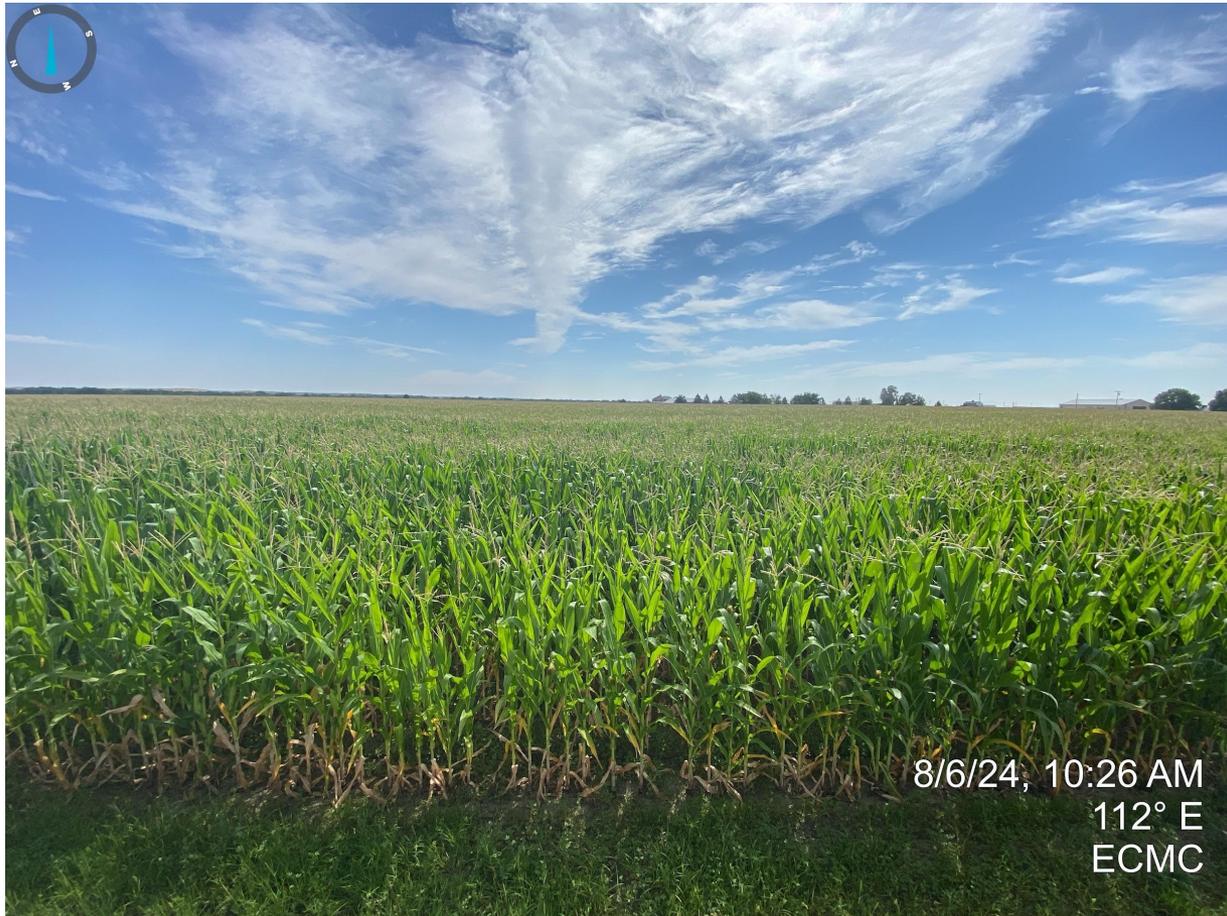
Photo 1. The well location (Location ID 309676 with API 123-25209) meets final reclamation regulations and standards. Unable to find evidence of oil and gas activities and/or disturbances. Well location and access road appear reflective of reference crop areas. Former well location is immediately adjacent to an active lease road for active wells.

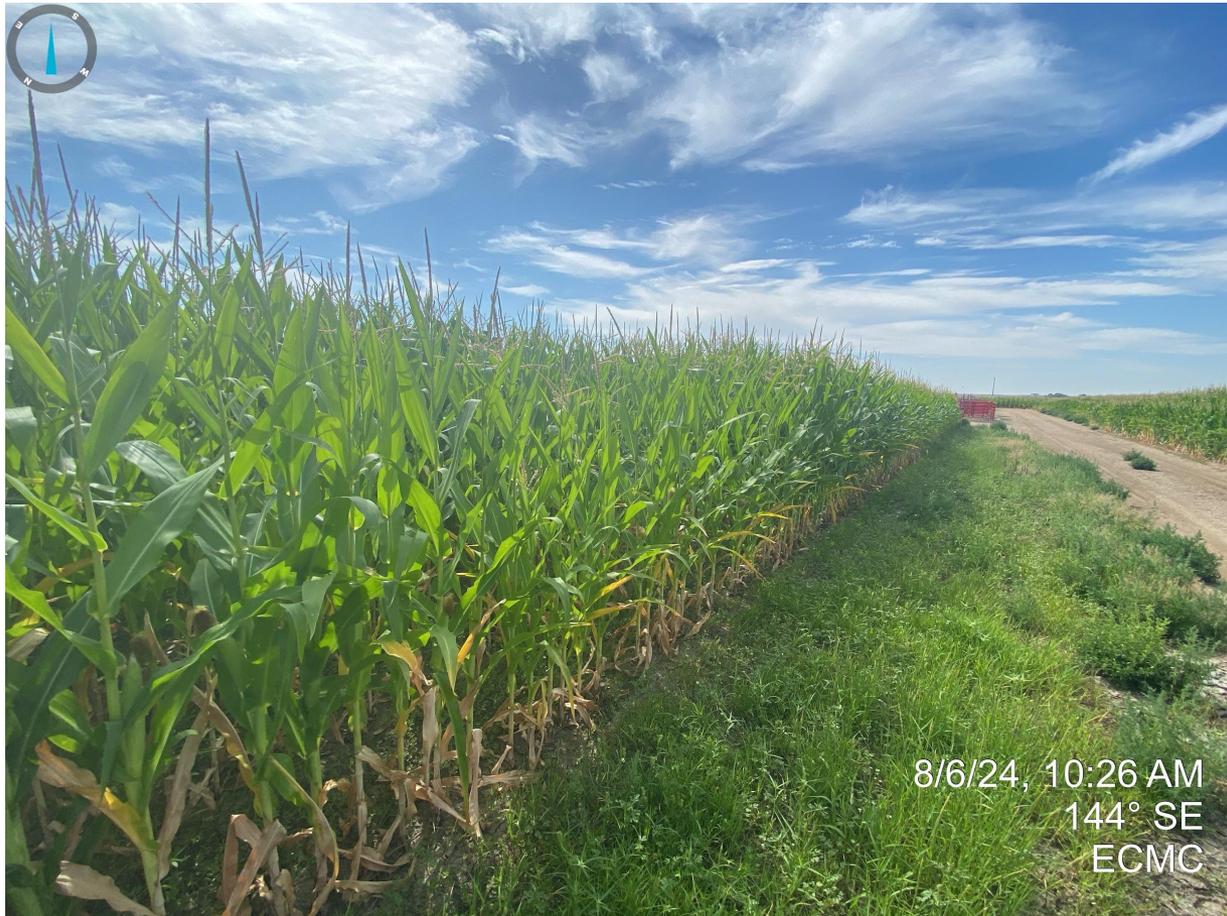
Photo 2. Facing southeast; see comments in Photo 1.

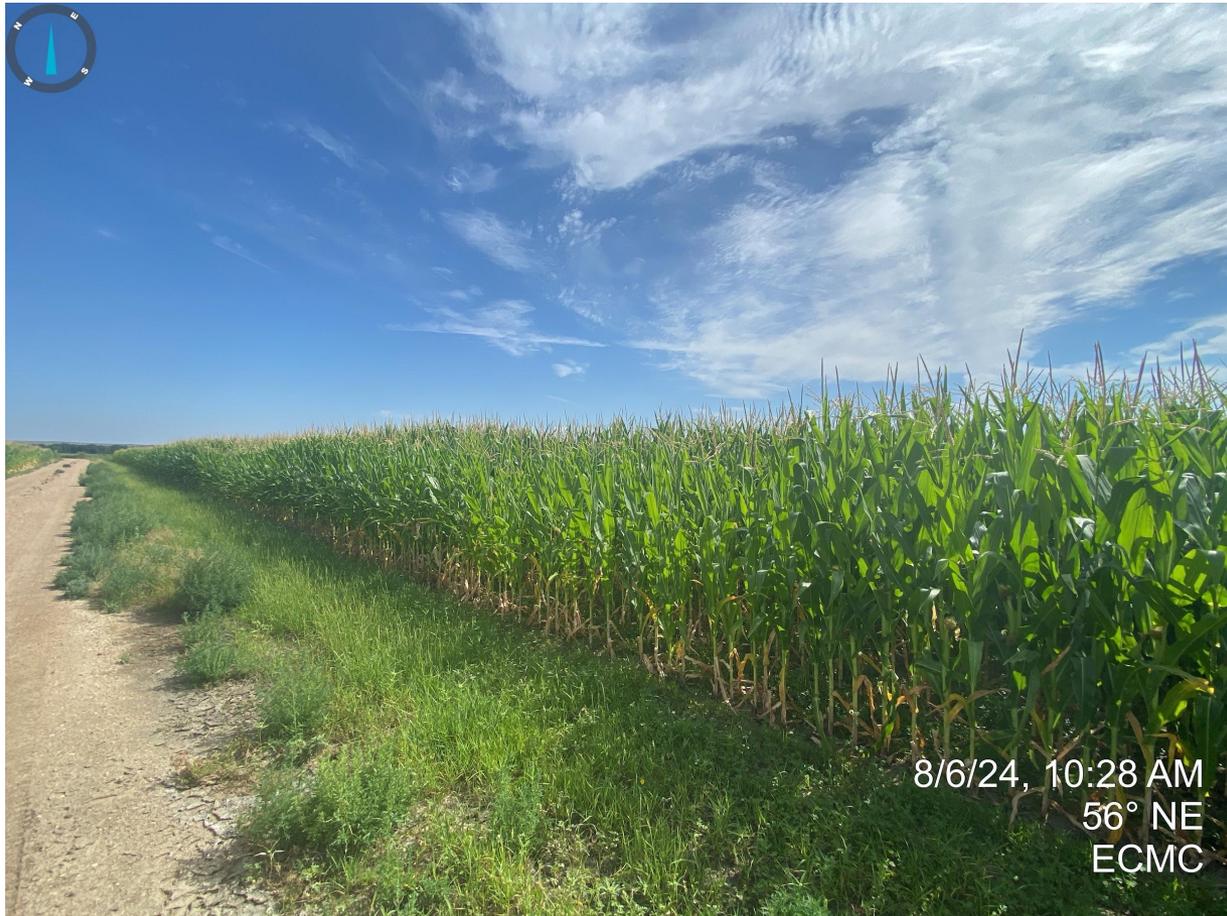
Photo 3. Facing northeast; see comments in Photo 1.

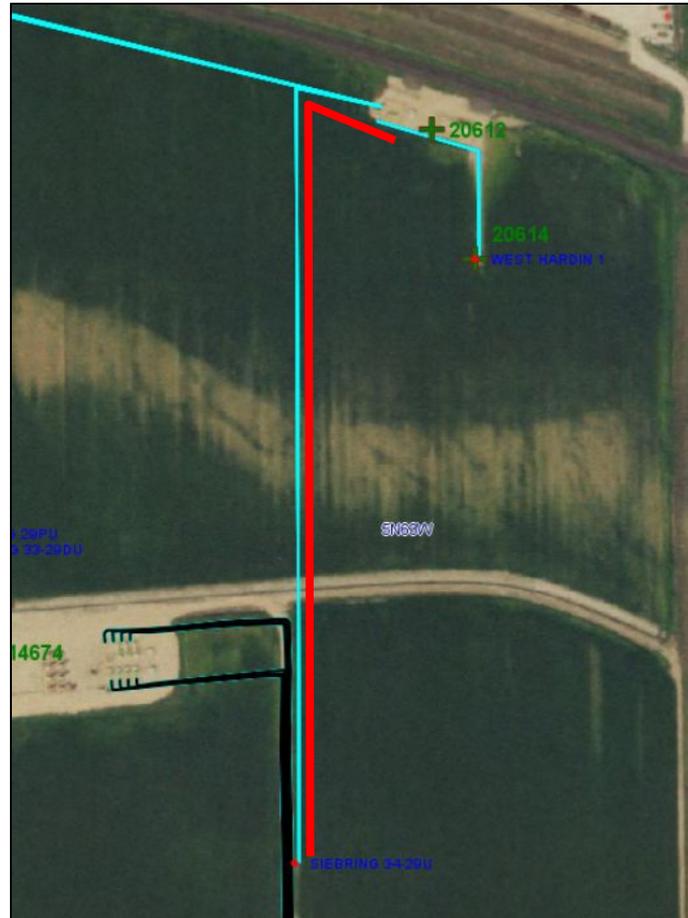
Photo 4. Red line illustrates off-location flowline from the subject well (API 123-25209) to the associated tank battery (to the north). Operator is required to submit a Form 44 Off-Location Flowline Abandonment Notice per Rule 1105.f.(2), therefore, this location will remain "In-Process" until ECMC receives the required notice.
