Operator: 8 North

Location Name: Silverback 36-A Pad

Loc ID: 443555

Inspection: 696300989

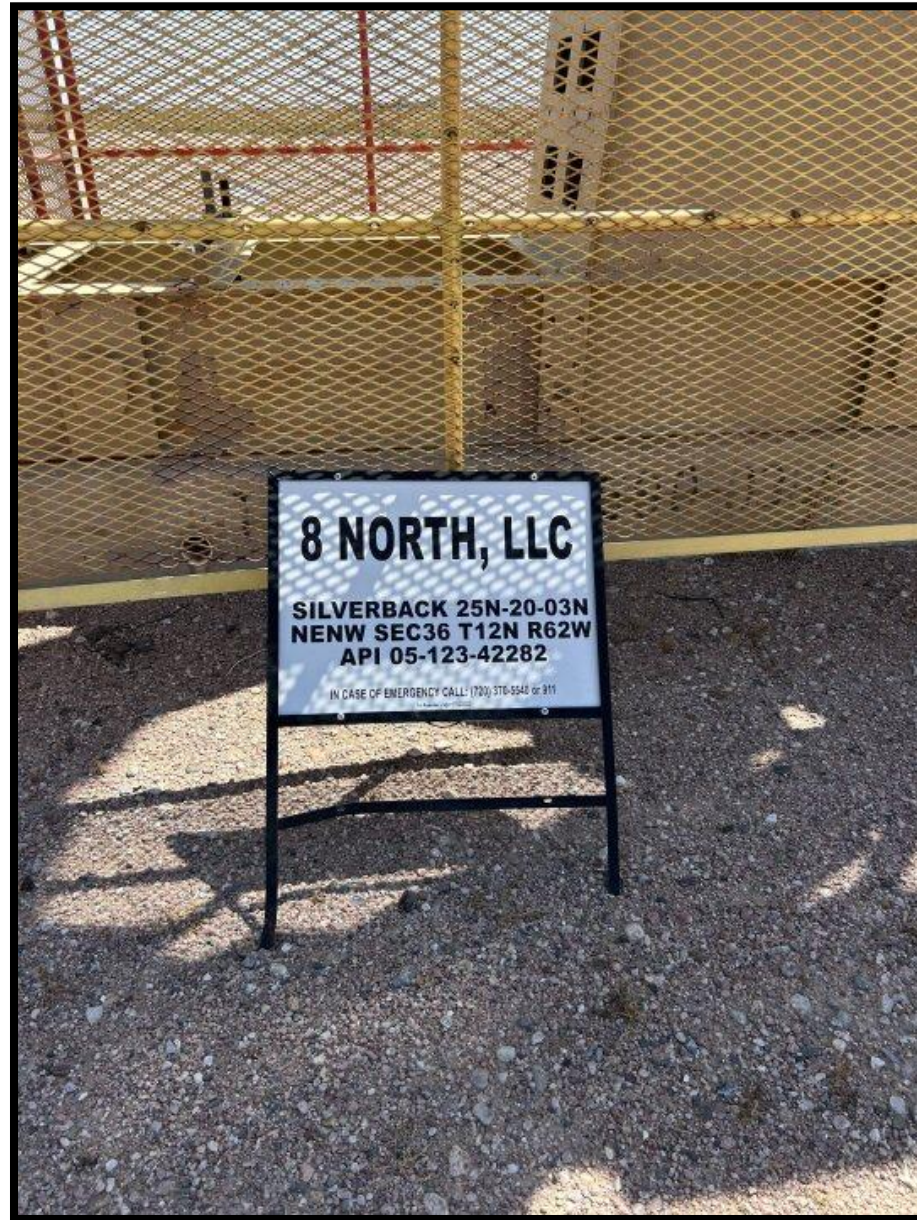
Exhibit A

CA: Both Wellheads are missing the wellhead signs: Install sign to comply with Rule 210.b

CA Resolution: Operator has provided photo evidence showing that signs have been installed on both wellheads to comply with Rule 210.b.
