**Operator:** 8 North

**Location Name:** SHABLE PC GK 19-99HZ

**Loc ID:** 416924

**Inspection:** 684905120

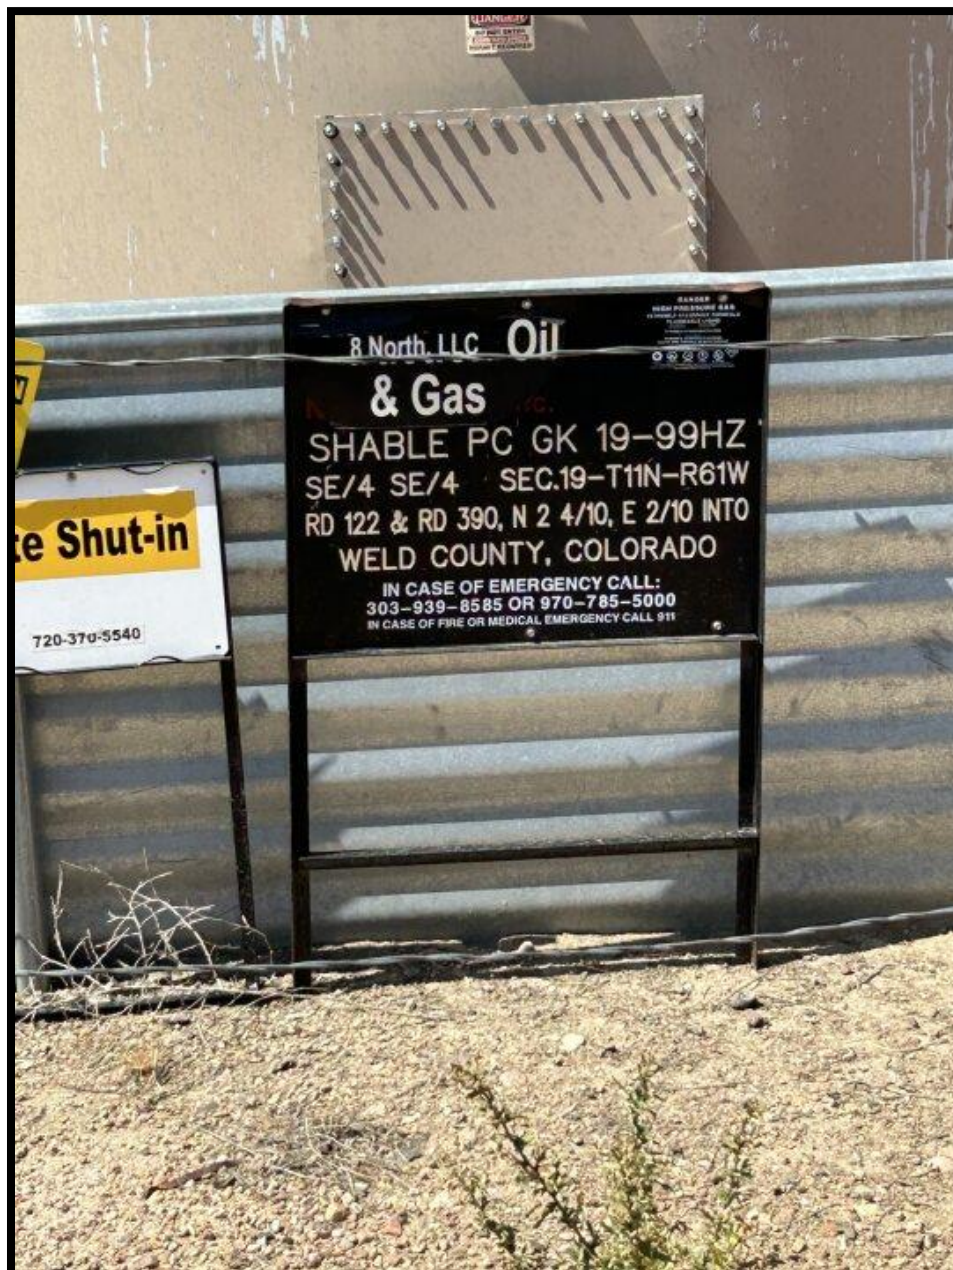
Exhibit A

**CA:** Stained soil at wellhead, around H<sub>2</sub>S scavenger containment, around engine. Corrective Action: Comply with rule 603.f

**CA Resolution:** Operator has provided photo evidence showing that the stained soil at the affected areas has been removed to comply with the 600 series.
