Operator: 8 NORTH LLC

Location Name: KALIA-611N61W 11SWNW

Loc ID: 302348

Inspection: 696300860

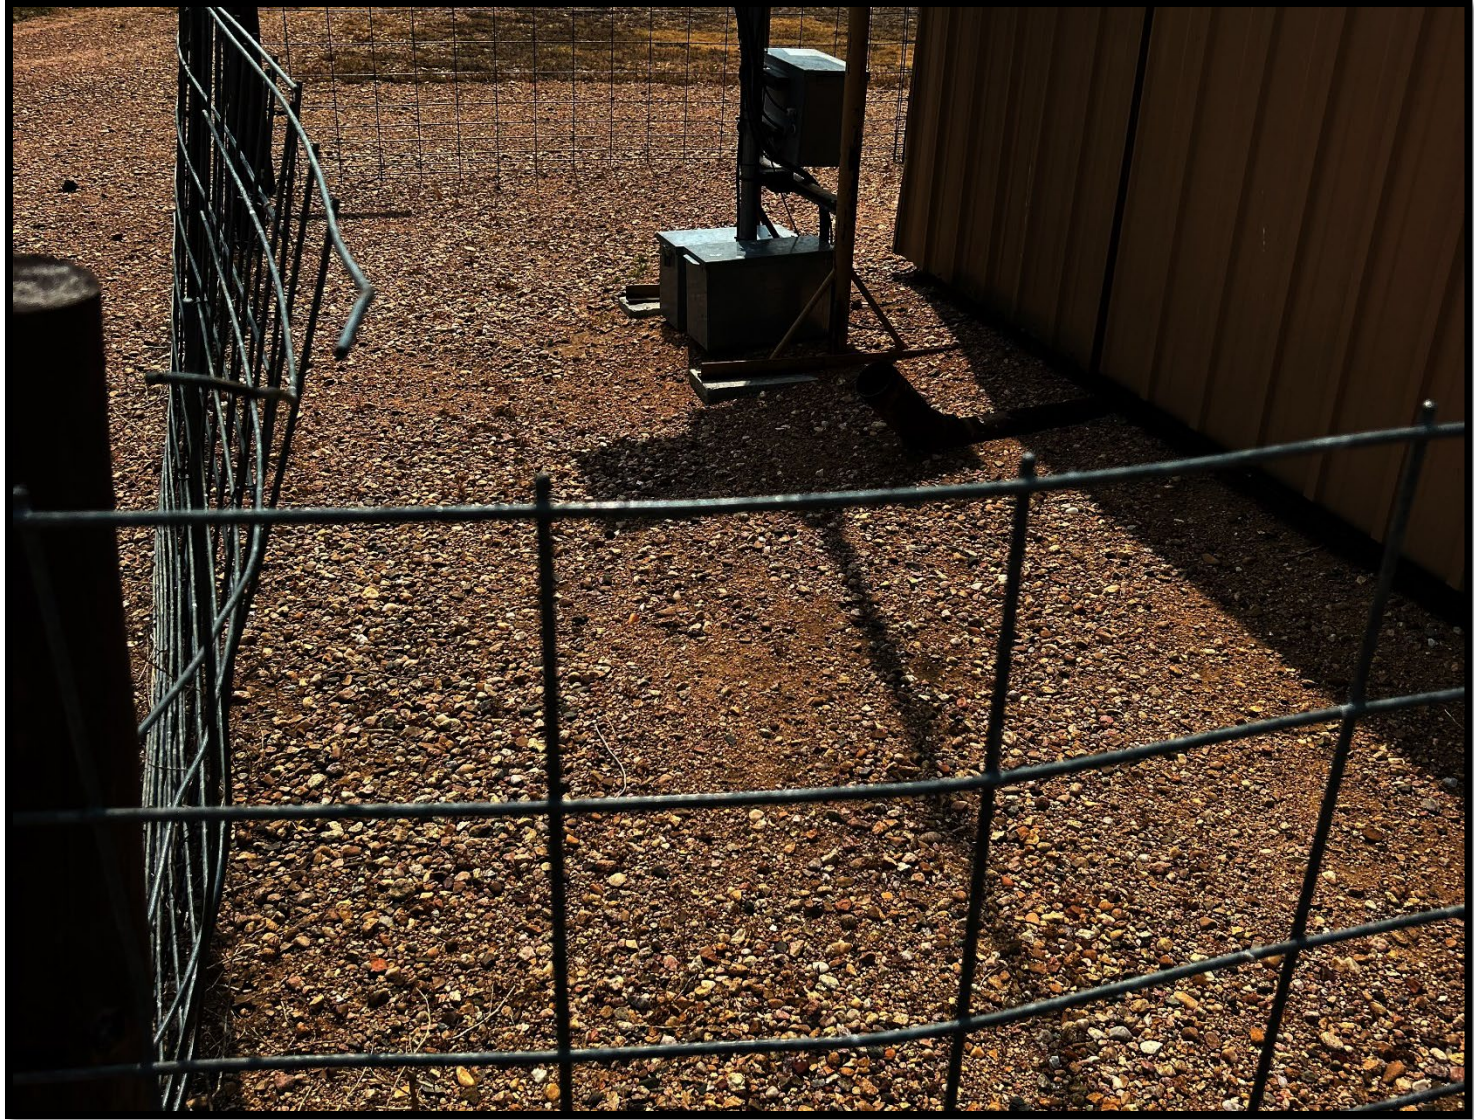
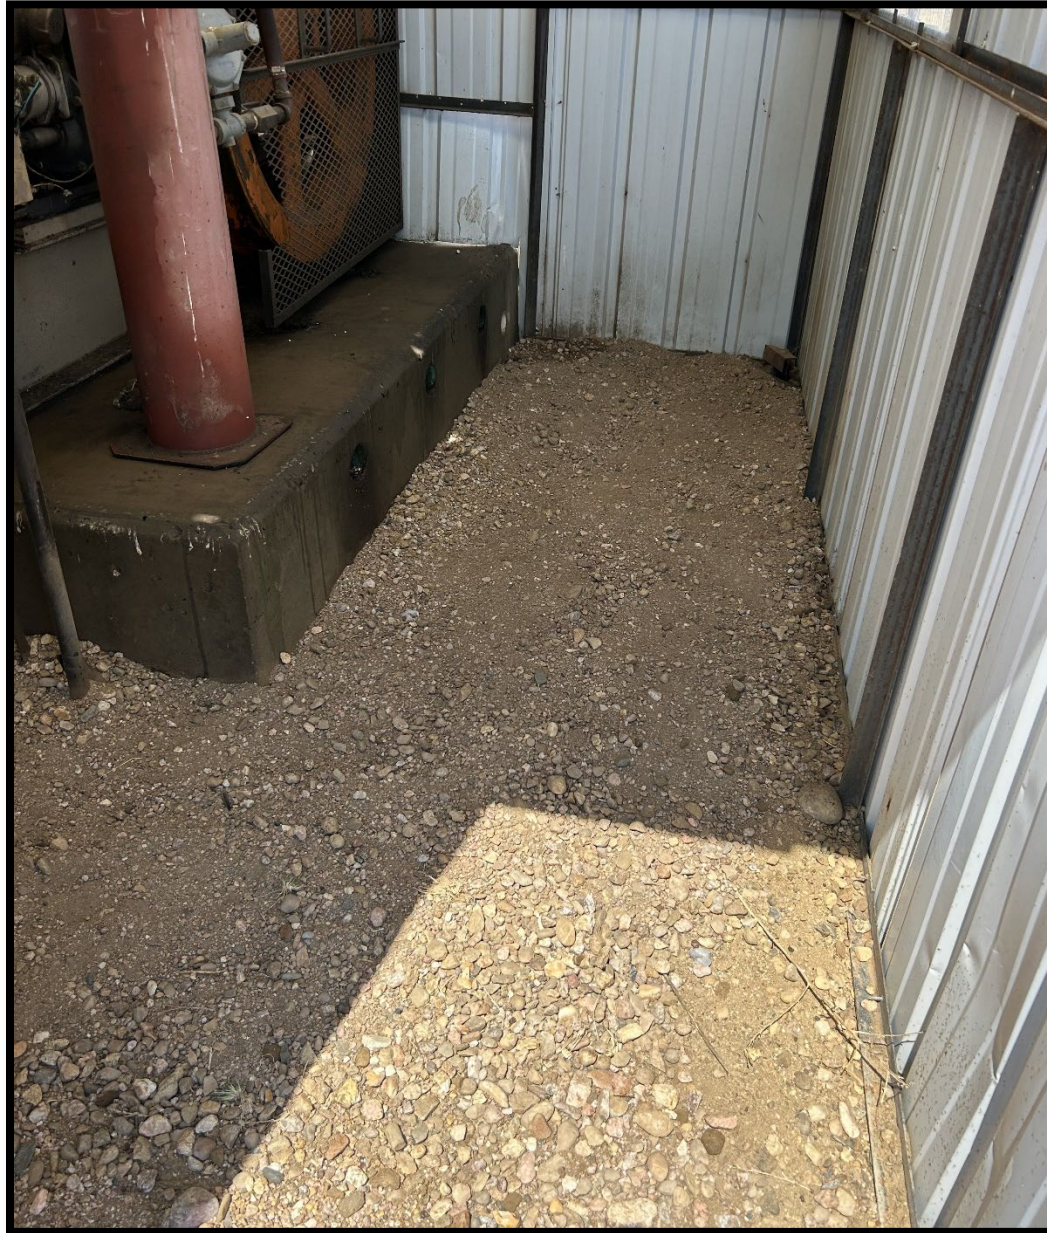
CA: Stained Soil at Exhaust and Engine. Properly treat or dispose of oily waste in accordance with 907.e.

CA Resolution: Operator has provided photo evidence showing that the stained soil at the wellhead has been addressed in compliance with the 900 and 600 series.
