Operator: 8 NORTH LLC

Location Name: LOYD FARMS-612N61W 32NENW

Loc ID: 302821

Inspection: 696300979

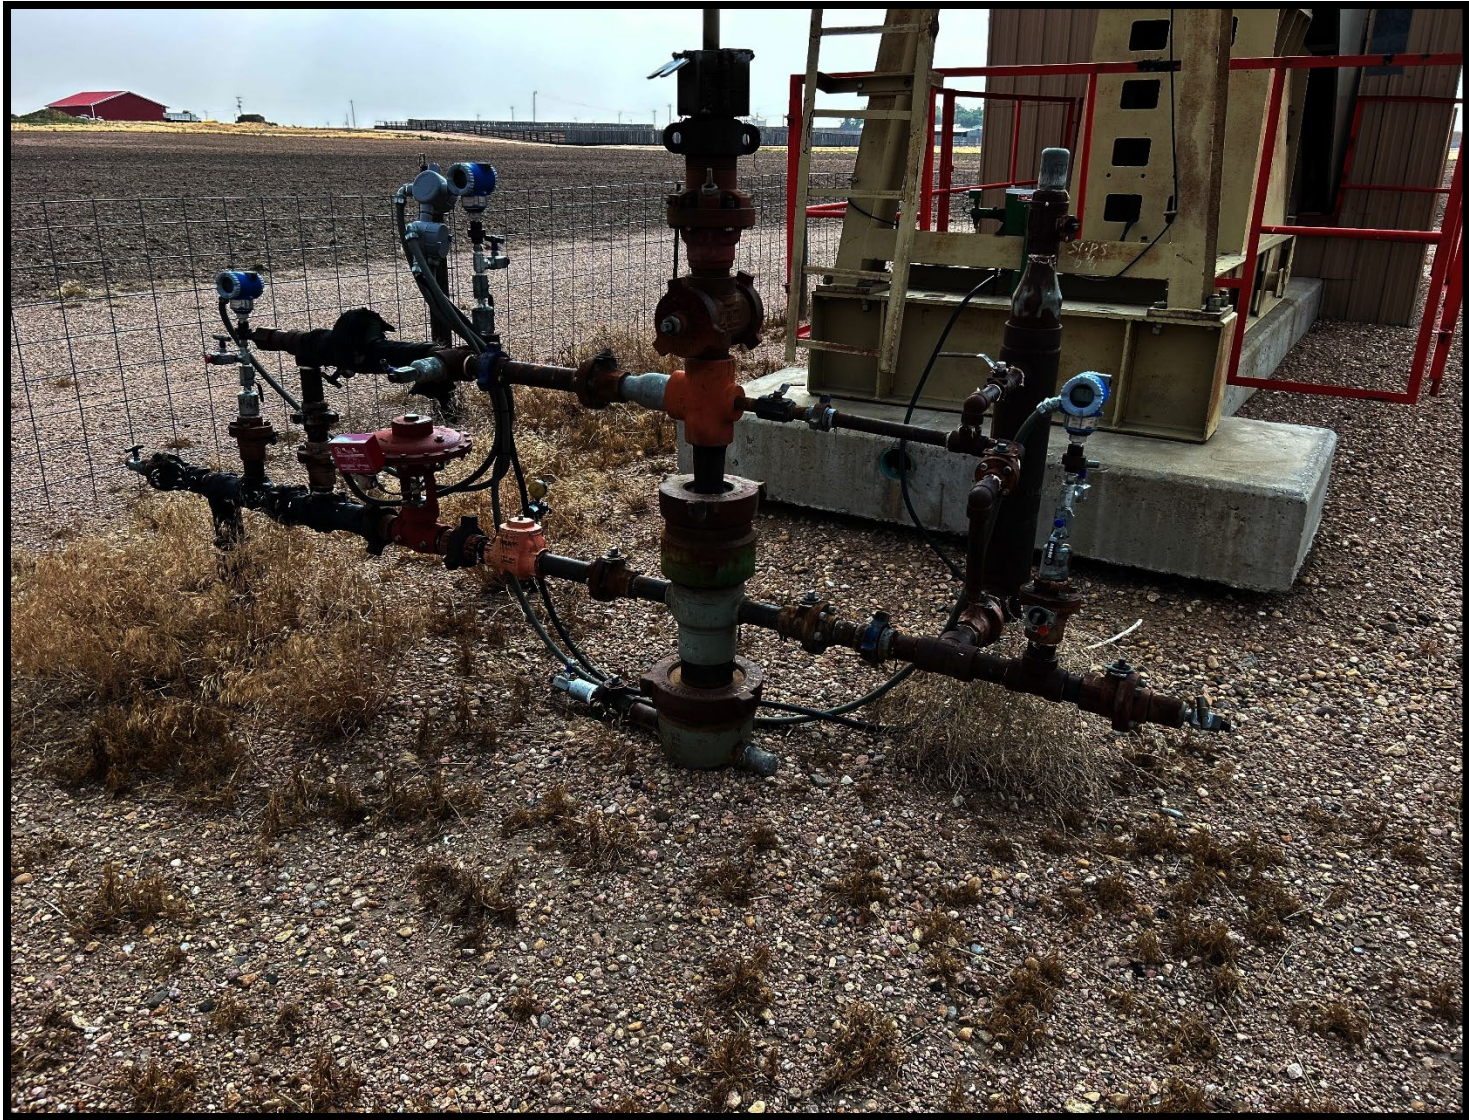
CA: Stained Soil at Exhaust and Wellhead, see photos 2 and 3. Mechanical condition Comply with Rule 605.d. Properly treat or dispose of oily waste in accordance with 907.e.

CA Resolution: Operator has provided photo evidence showing that the stained soil at the wellhead has been addressed in compliance with the 900 and 600 series.
