Operator: 8 North

Location Name: TROSTEL-611N61W 32SWNW

Loc ID: 410119

Inspection: 684904653

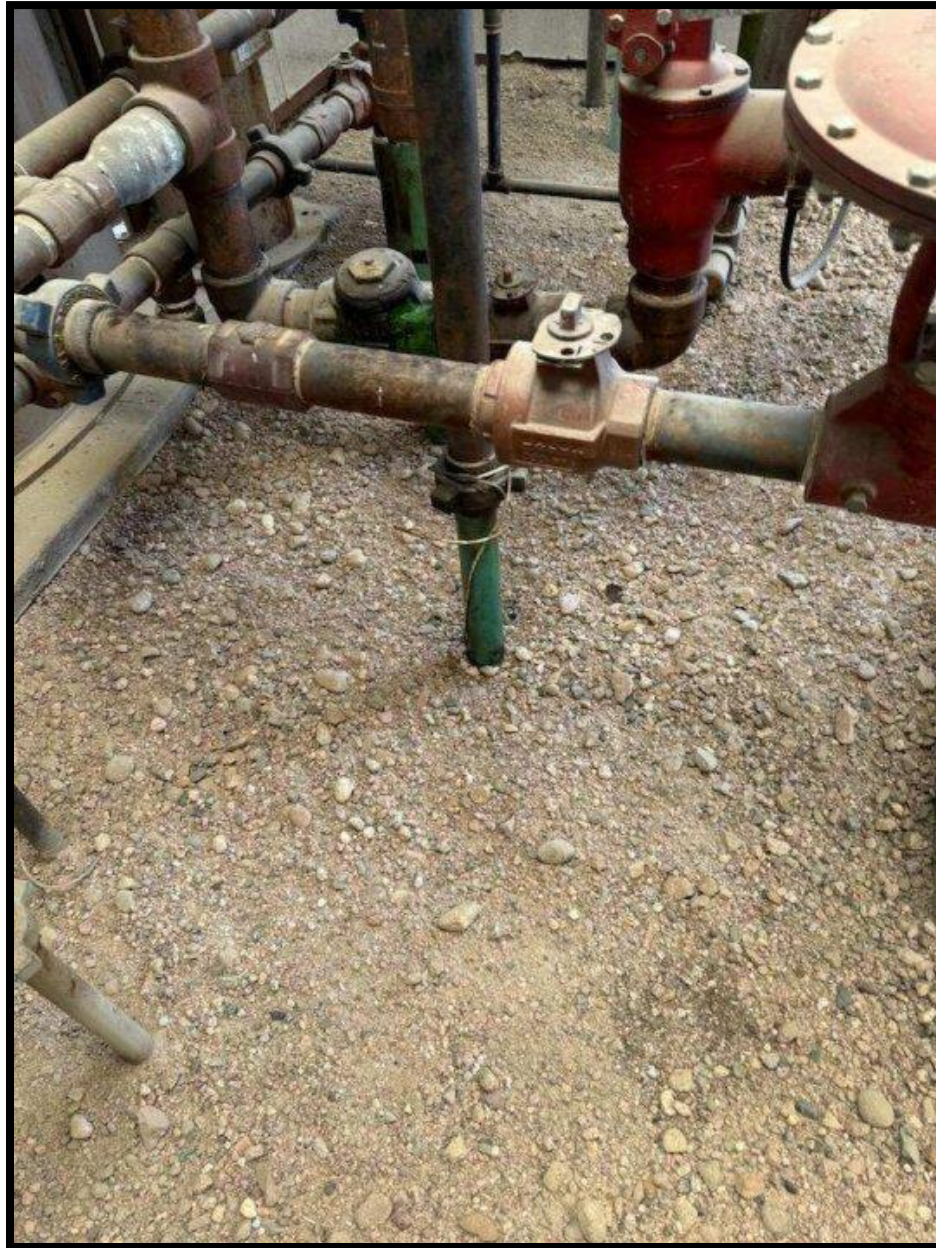
Exhibit A

CA Resolution: Operator has provided photo evidence that the stained soil in treater house has been removed or remediated to comply with the 600 series.

CA: Remove or remediate stained soil; Securely fasten all valves, pipes, and fittings to ensure good mechanical condition, inspect at regular intervals and maintain in good mechanical condition per Rule 605.d.
