WELL NAME: WOOKSTOCK 43-19, API #: 071-08677, INSP. # 695110146

**COLORADO**  
Energy & Carbon Management  
Commission  
Department of Natural Resources

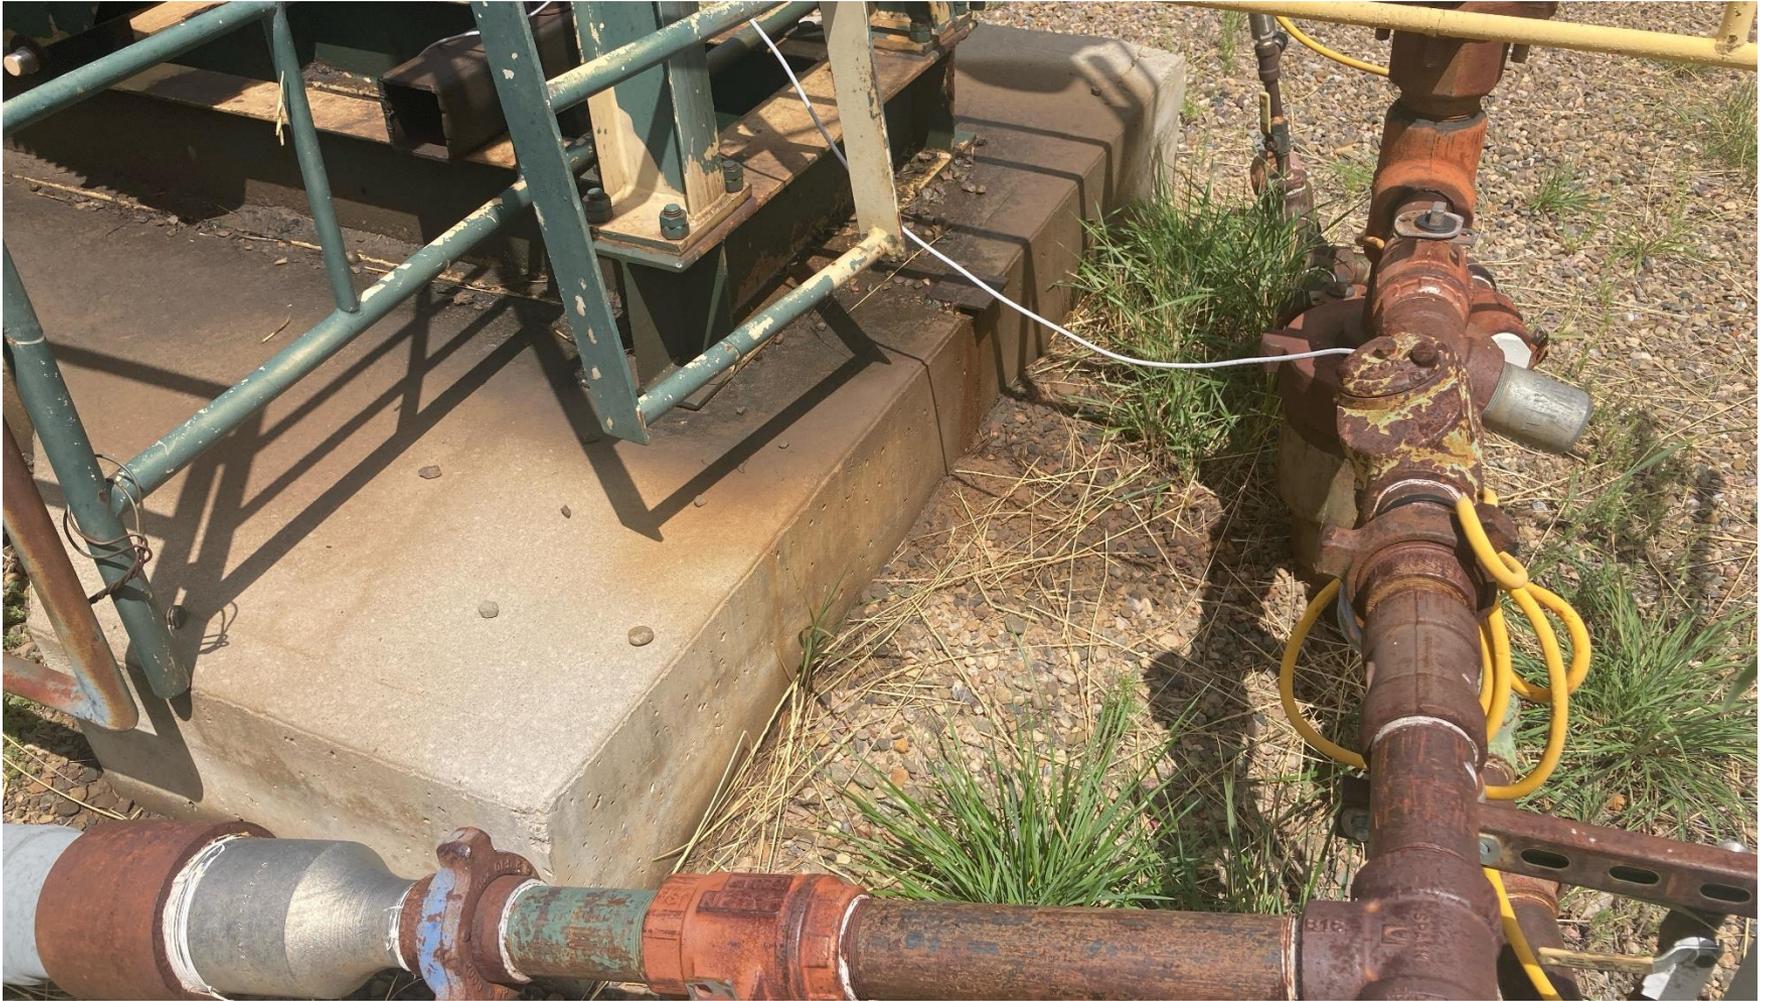
**PHOTO 4: AREA OF IMPACTED SOIL NEAR WELLHEAD APPEARS TO BE FROM LEAKING GEAR BOX ON PUMPJACK. Conduct maintenance on equipment, cleanup stained material and review self inspection processes.**

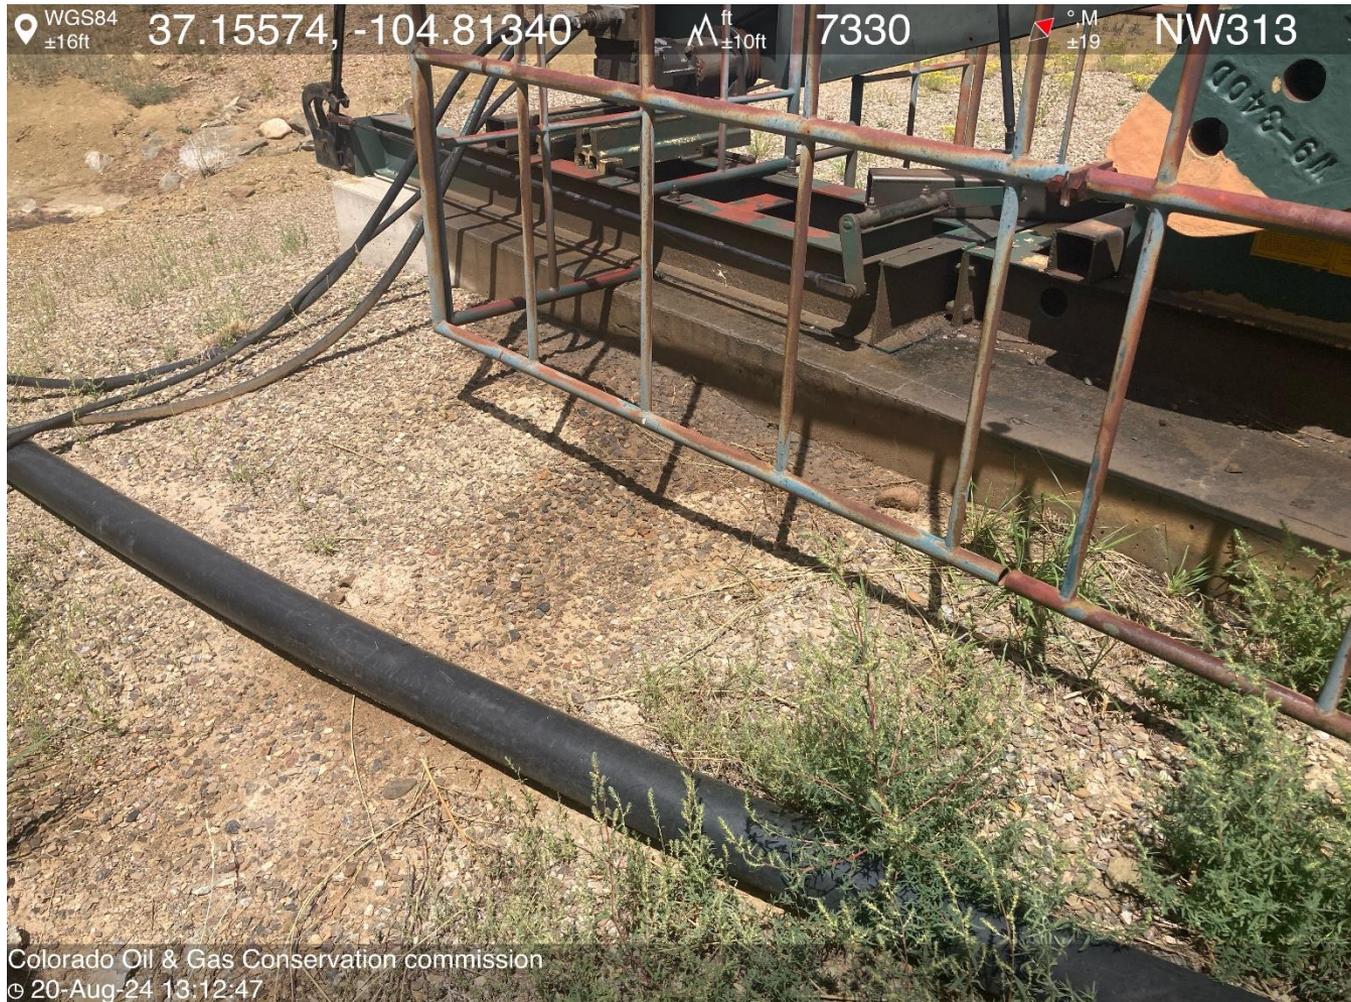
**PHOTO 5: AREA OF IMPACTED SOIL NEAR WELLHEAD APPEARS TO BE FROM LEAKING GEAR BOX ON PUMPJACK. Conduct maintenance on equipment, cleanup stained material and review self inspection processes.**
