Operator: 8 North

Location Name: FABRIZIUS-611N61W 27NWNE

Loc ID: 302924

Inspection: 696301294

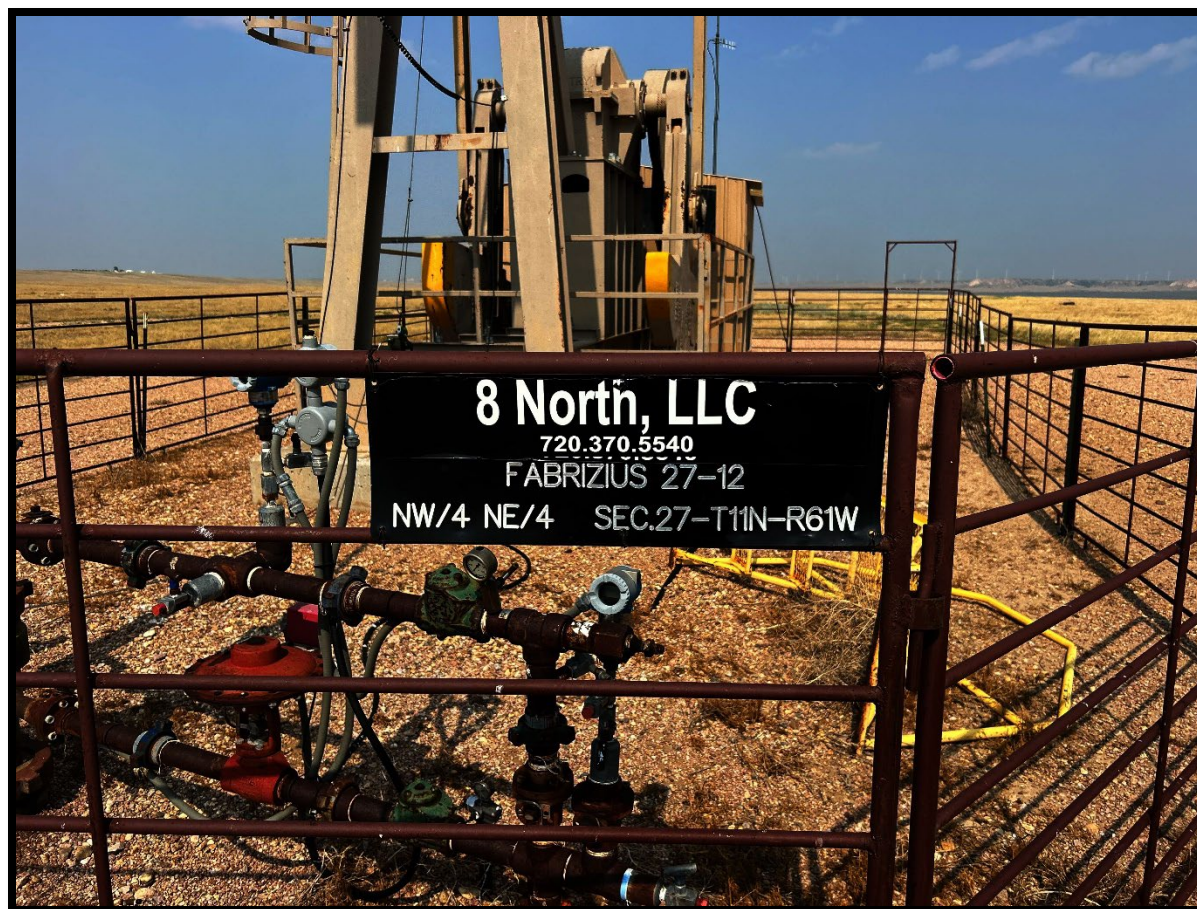
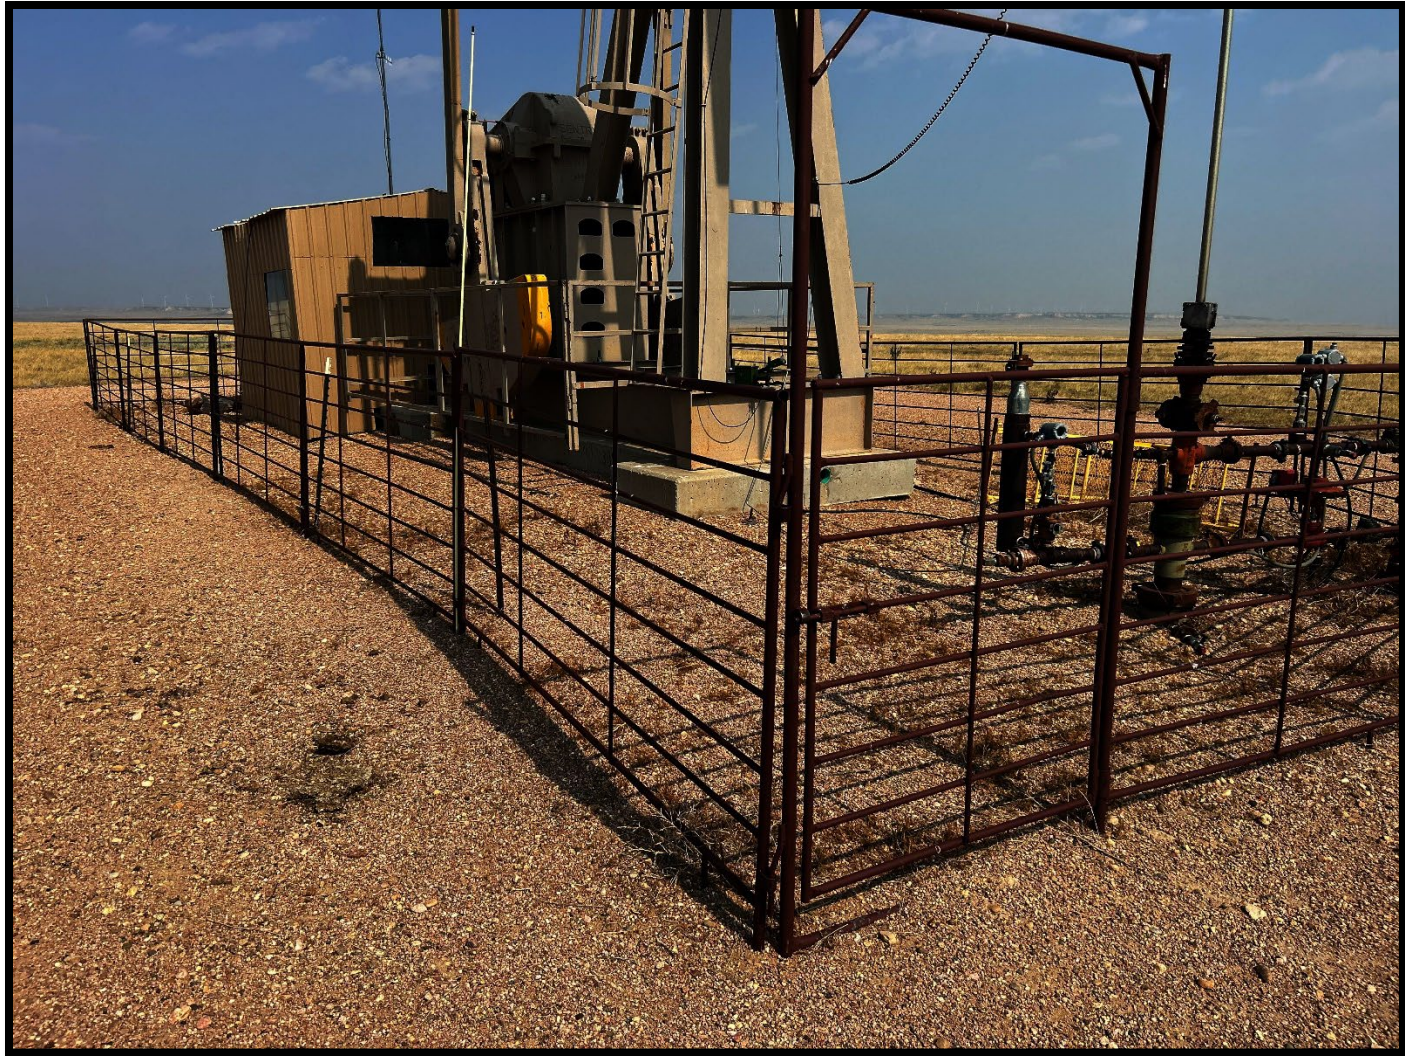
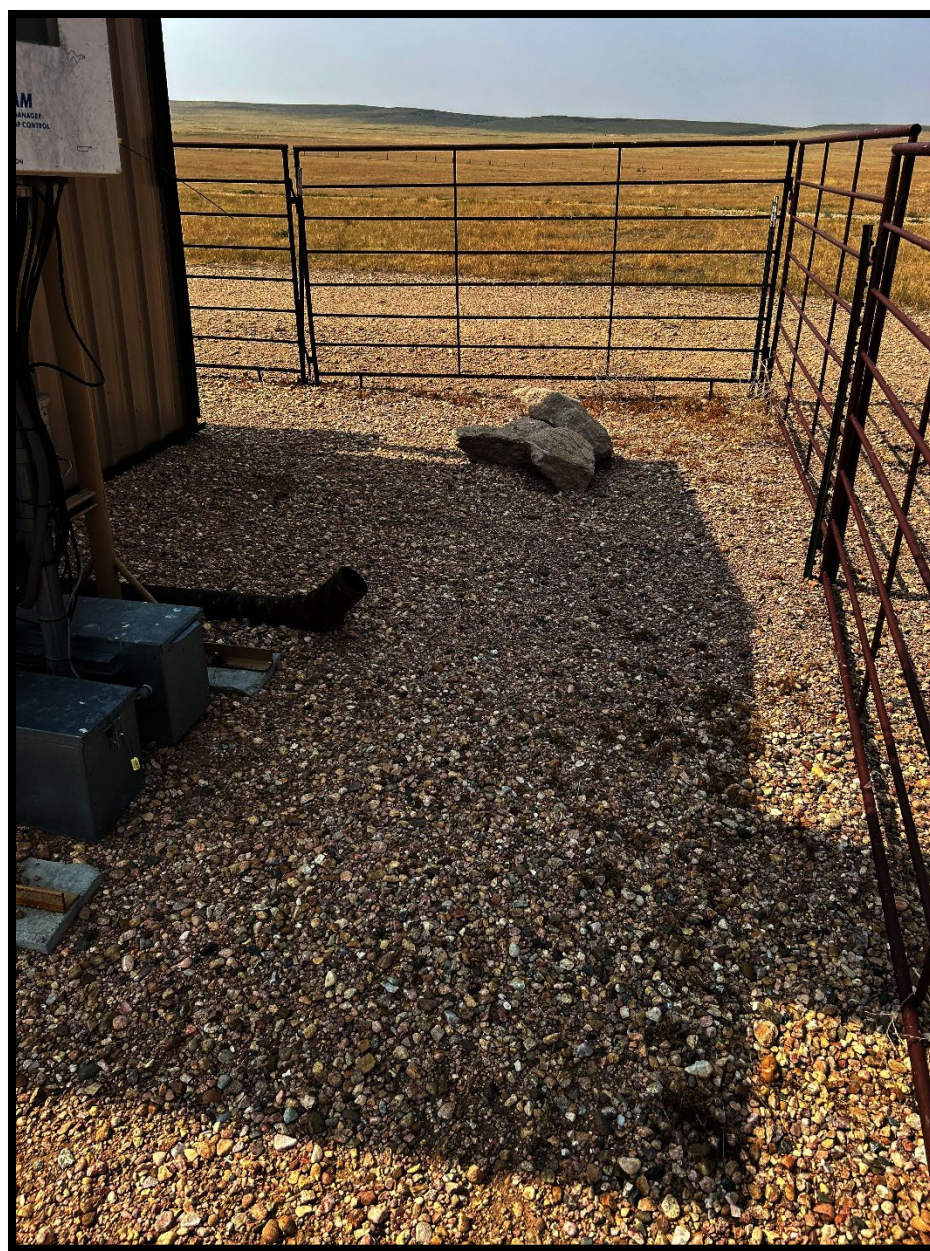
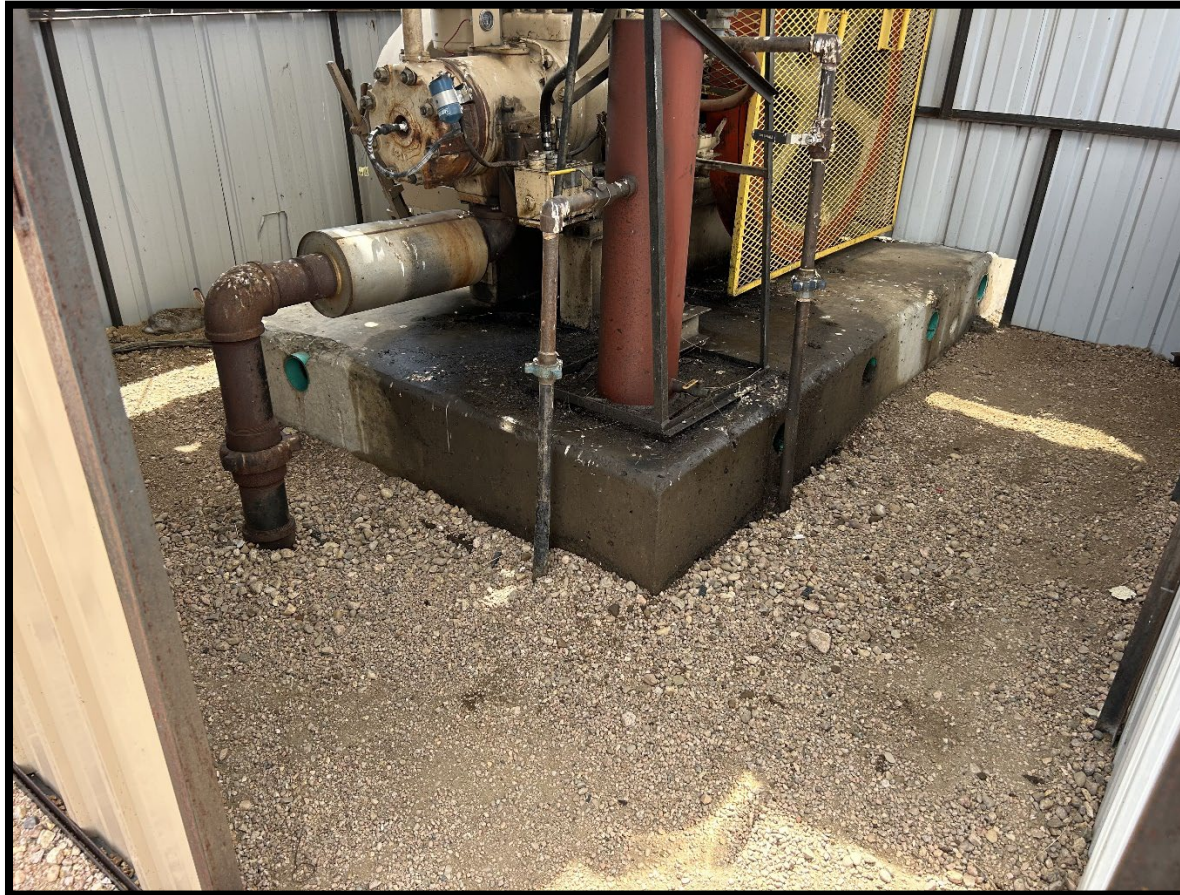
CA: Stained Soil at Engine and Exhaust, For localized stained soils or oily waste - Properly dispose of oily waste in accordance with 907.e

CA: UNUSED EQUIPMENT- Unused Stand, Comply Rule 603.f.

CA Resolution: Operator has provided photo evidence to show that the stained soil has been appropriately removed/cleared and mechanical issues leading to the leak have also been addressed.

CA Resolution: Unused equipment has been addressed to comply with the 600 series.
