**Operator: 8 North**

**Location Name: FABRIZIUS-611N61W 28NWNW**

**Loc ID: 306452**

**Inspection: 684905209**

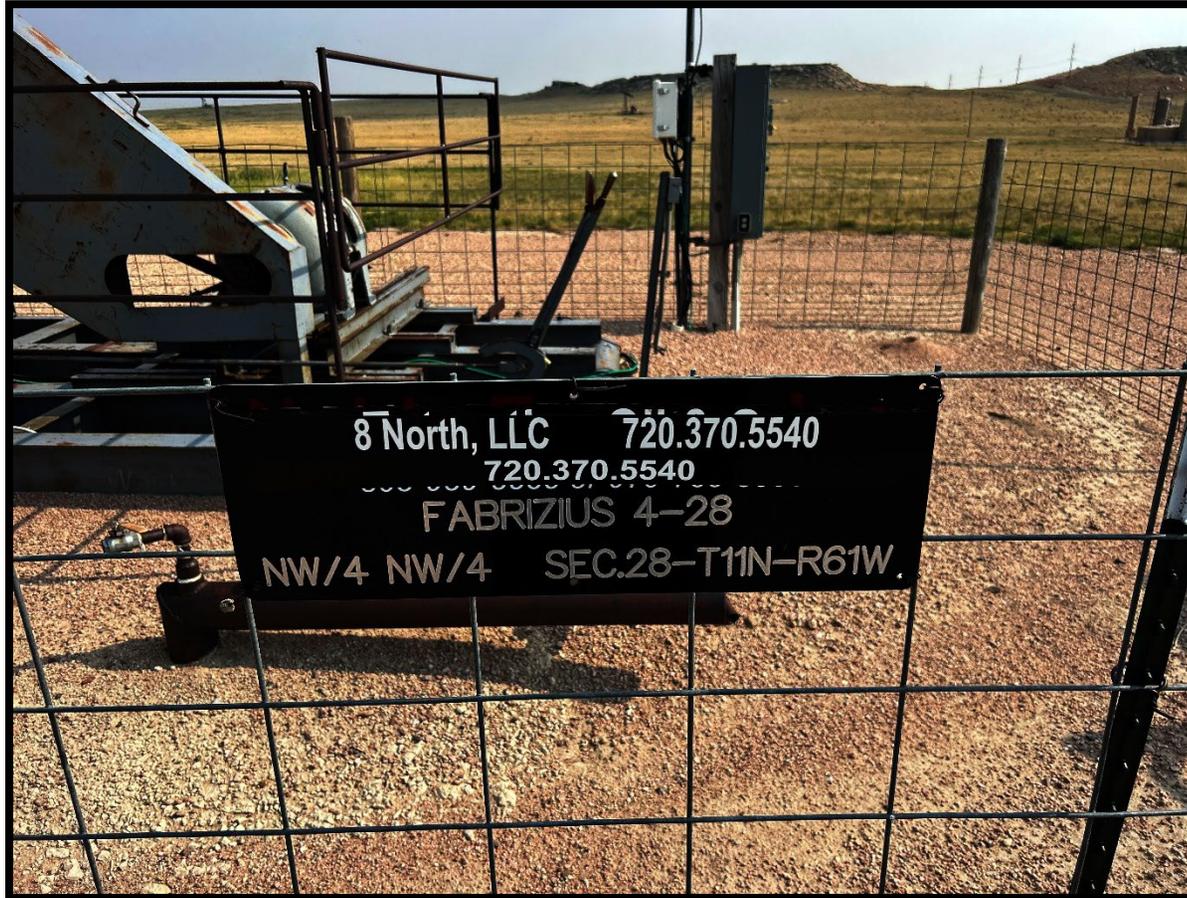
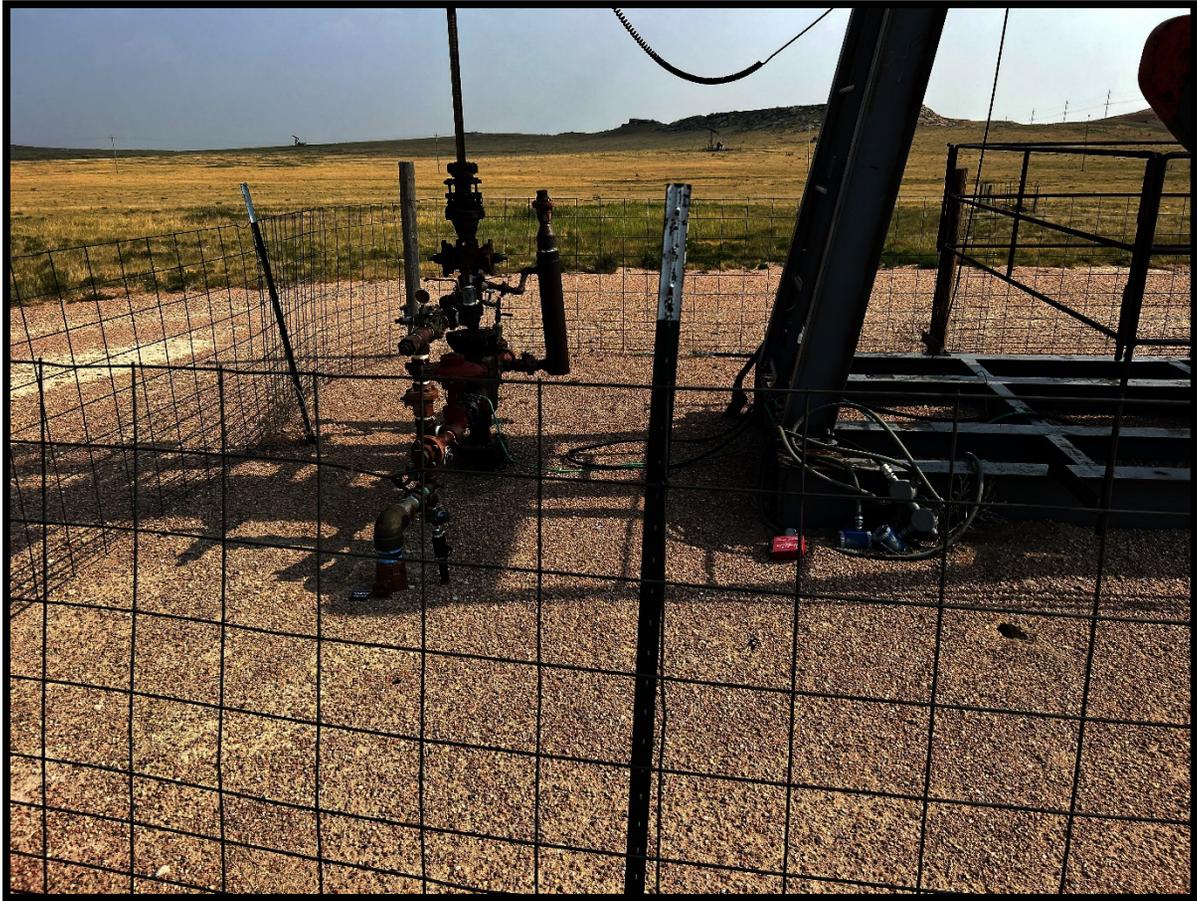
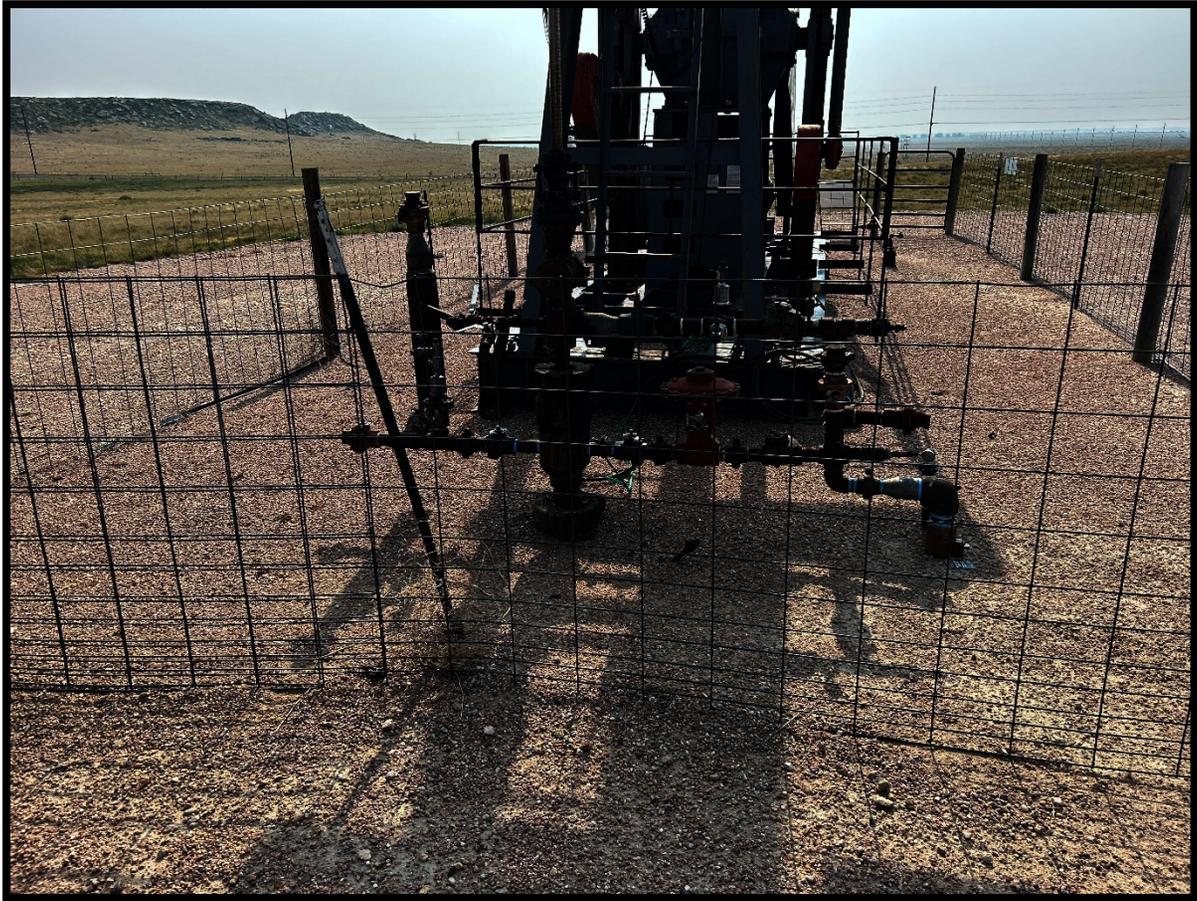
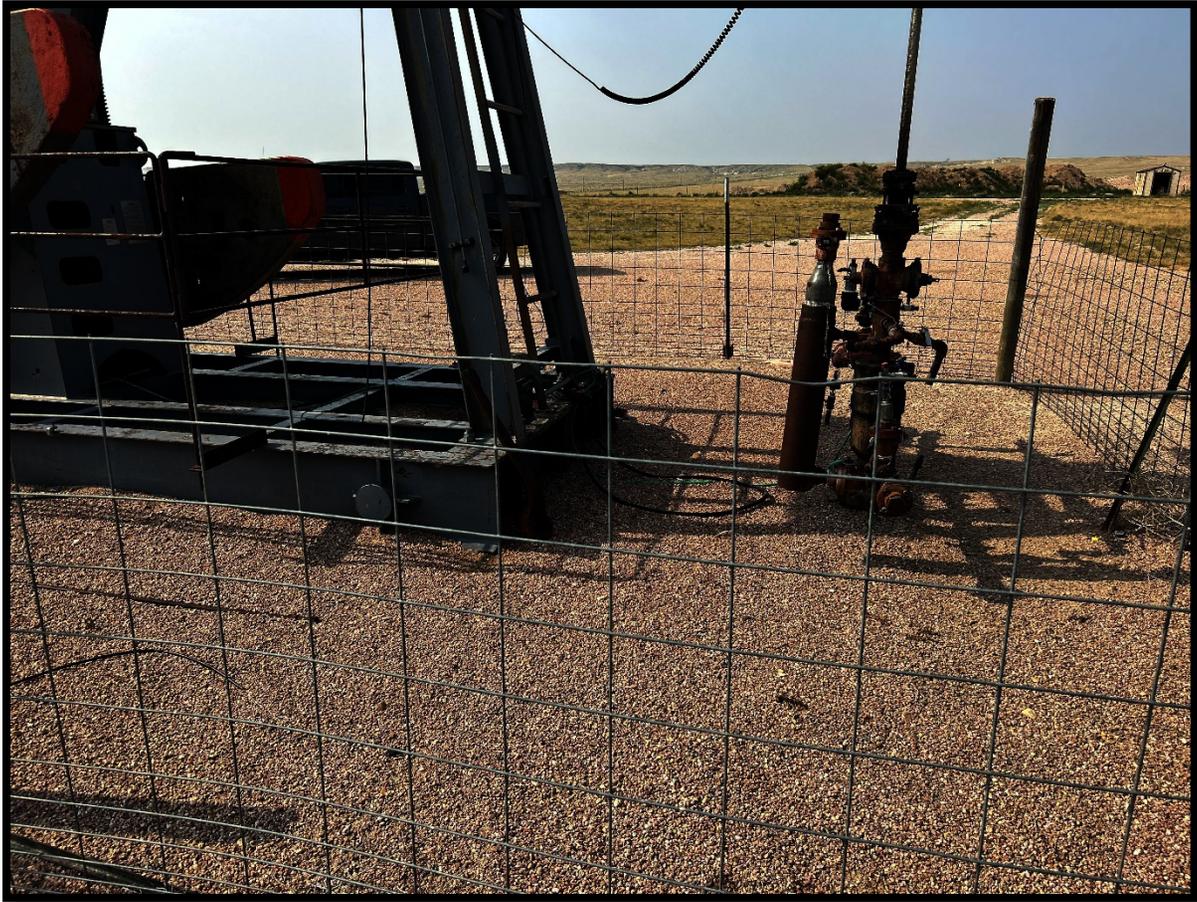
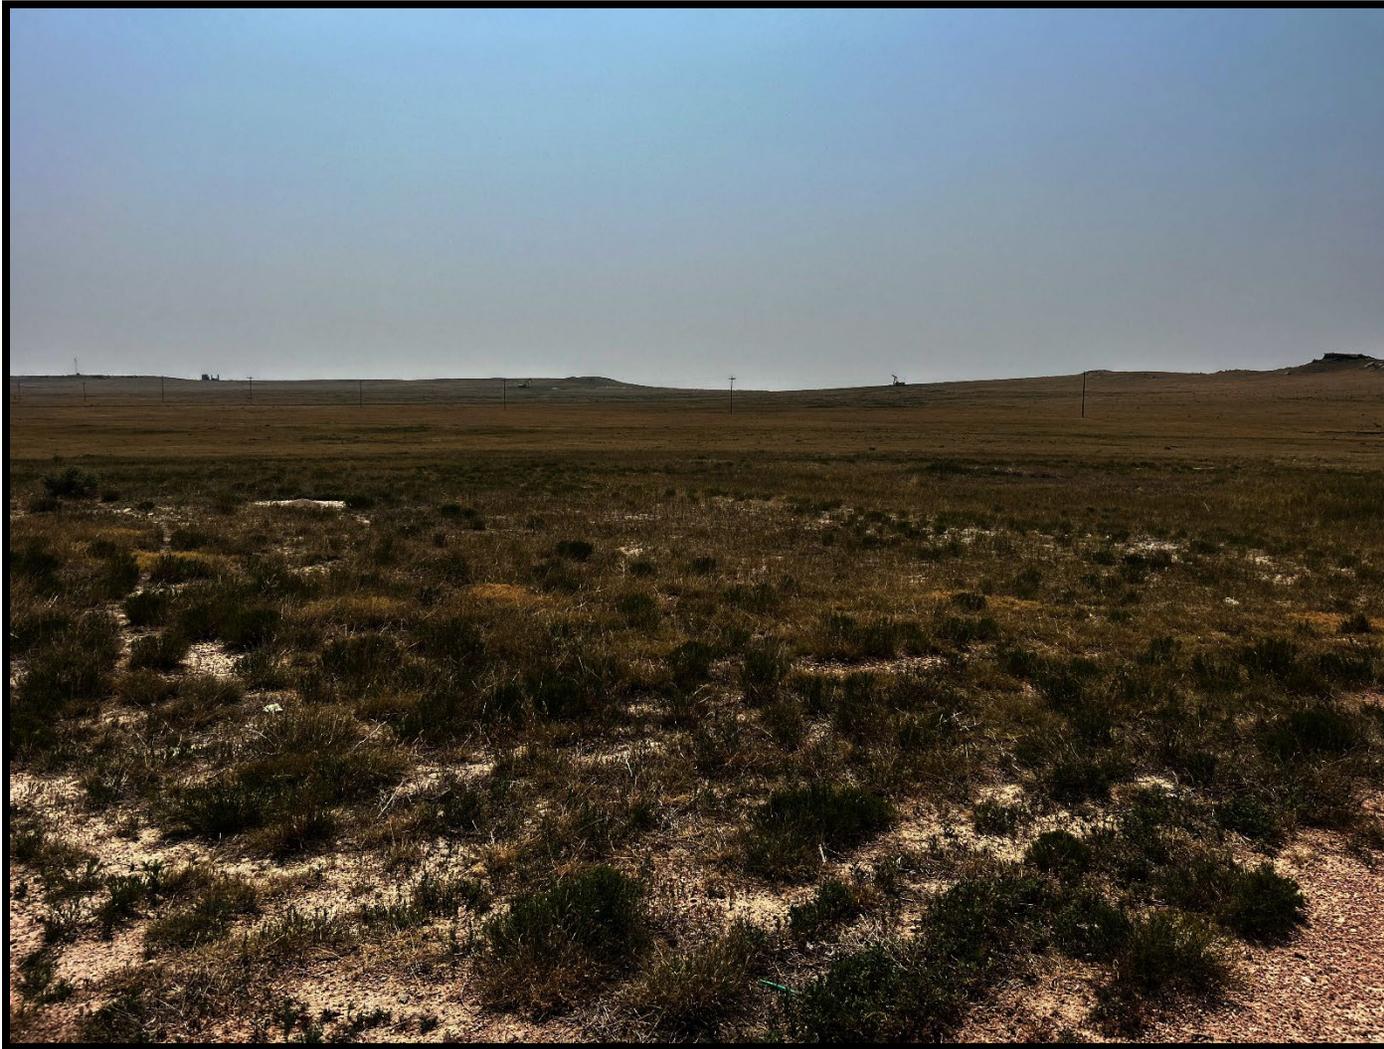
**CA:** Debris E of wellhead. Comply with rule 603.f.

**CA:** Stained soil at wellhead. Comply with Rule 603.f

**CA Resolution:** Operator has addressed debris on location to comply with the 600 series.

**CA Resolution:** Operator has provided photo evidence showing that the stained soil at the wellhead has been addressed in compliance with the 900 and 600 series.
