WELL NAME: BREWER FEDREAL 2-17, API #: 033-06108, INSP. # 695110172

COLORADO
Energy & Carbon Management
Commission
Department of Natural Resources

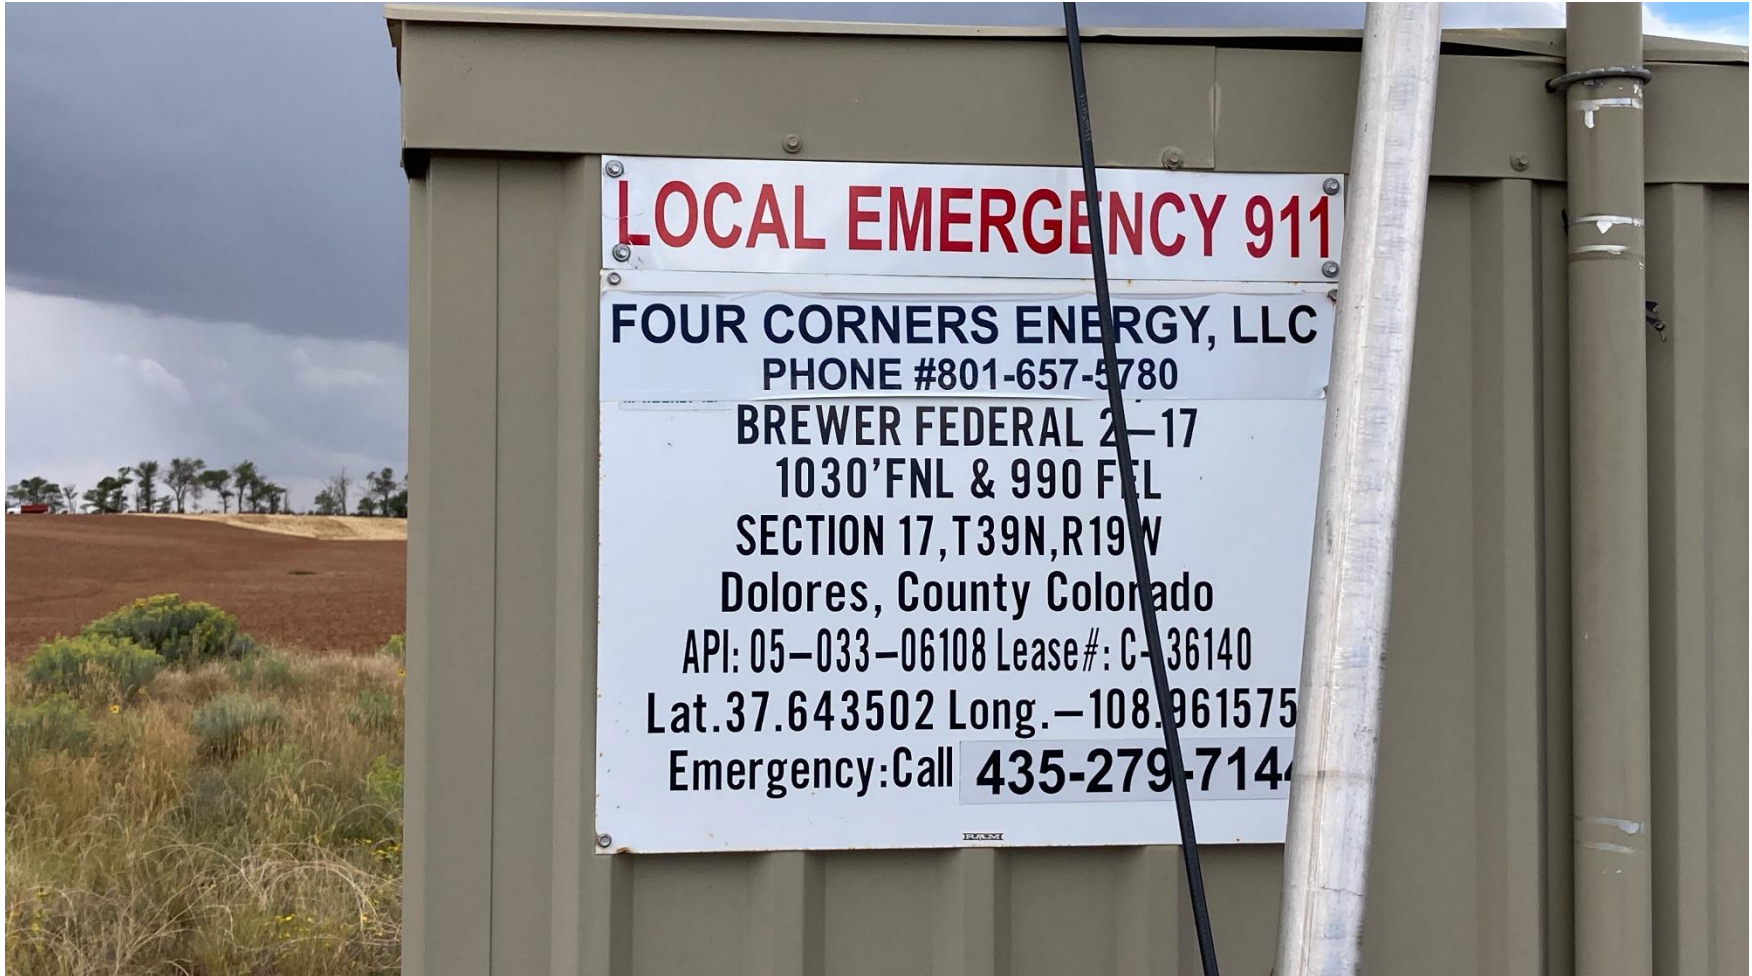
PHOTO 1: WELL SIGN/ COMPANY NAME POST ON LOCATION IS INACCURATE AND EMERGENCY CONTACT NUMBERS ARE INVALID. UPDATE EMERGENCY CONTACT PHONE NUMBER AS SOON AS POSSIBLE AND POST CURRENT OPERATOR NAME PER RULE 605.

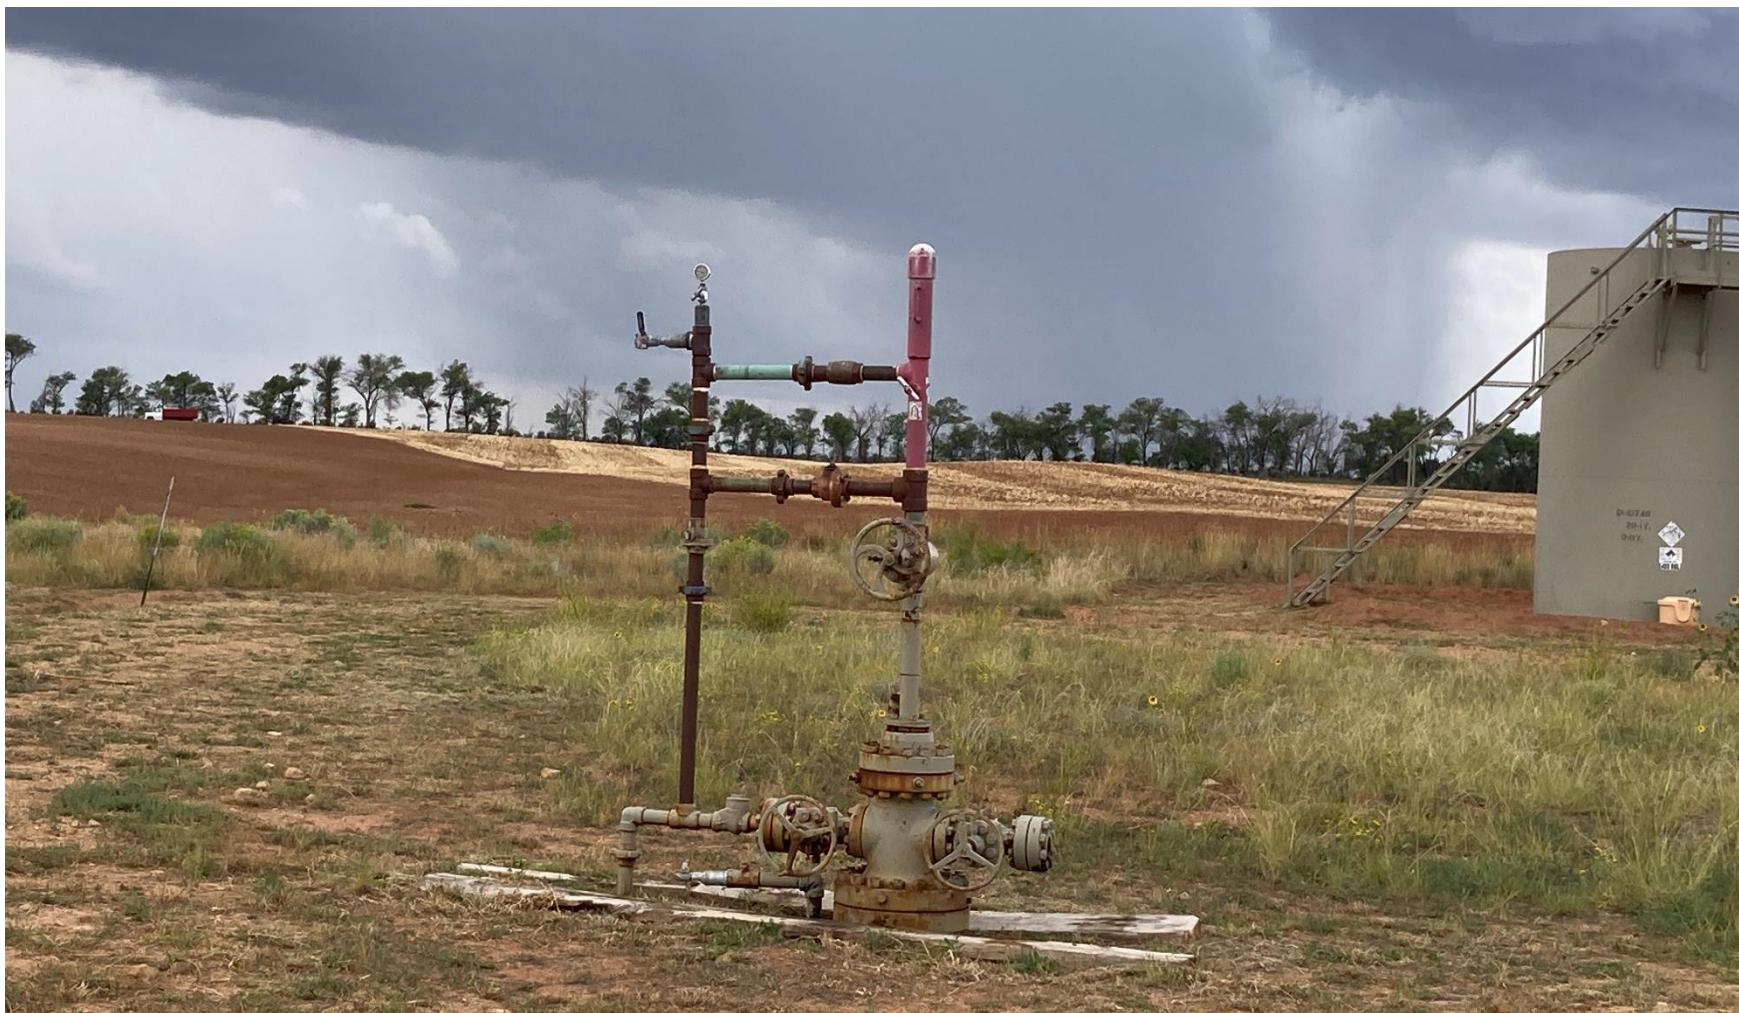
PHOTO 3: WELLHEAD AND EQUIPMENT

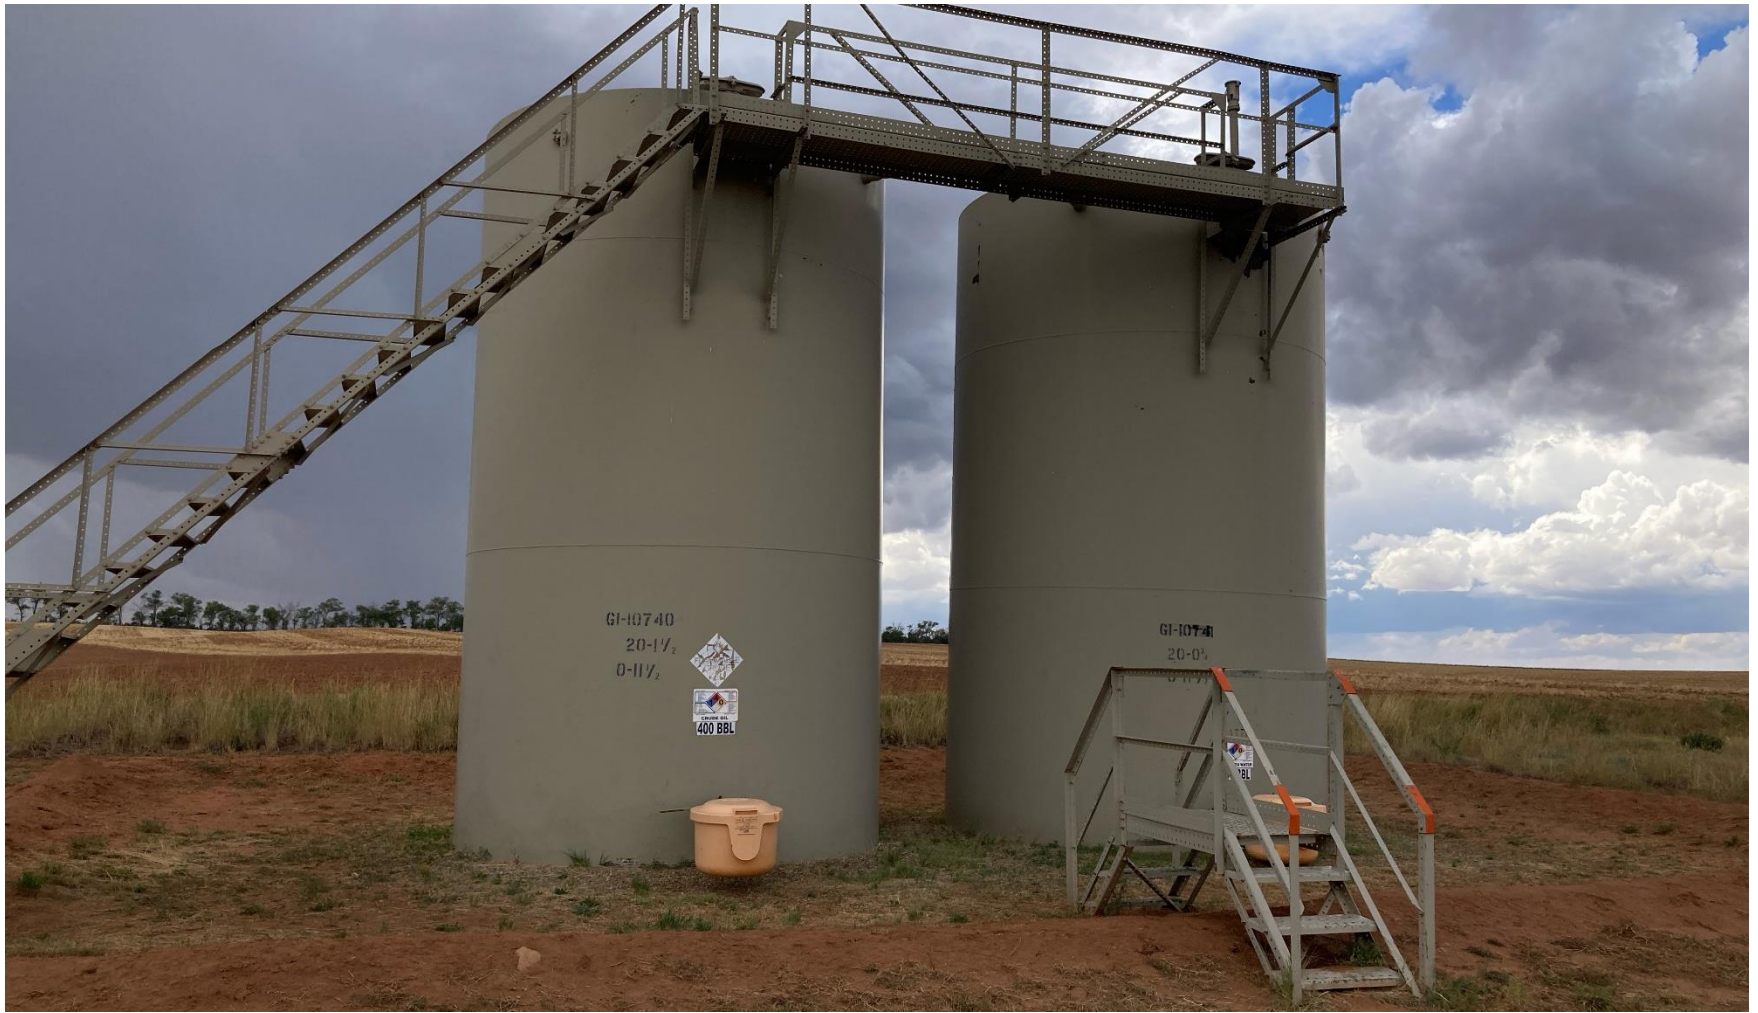
PHOTO 3: TANK BATTERY

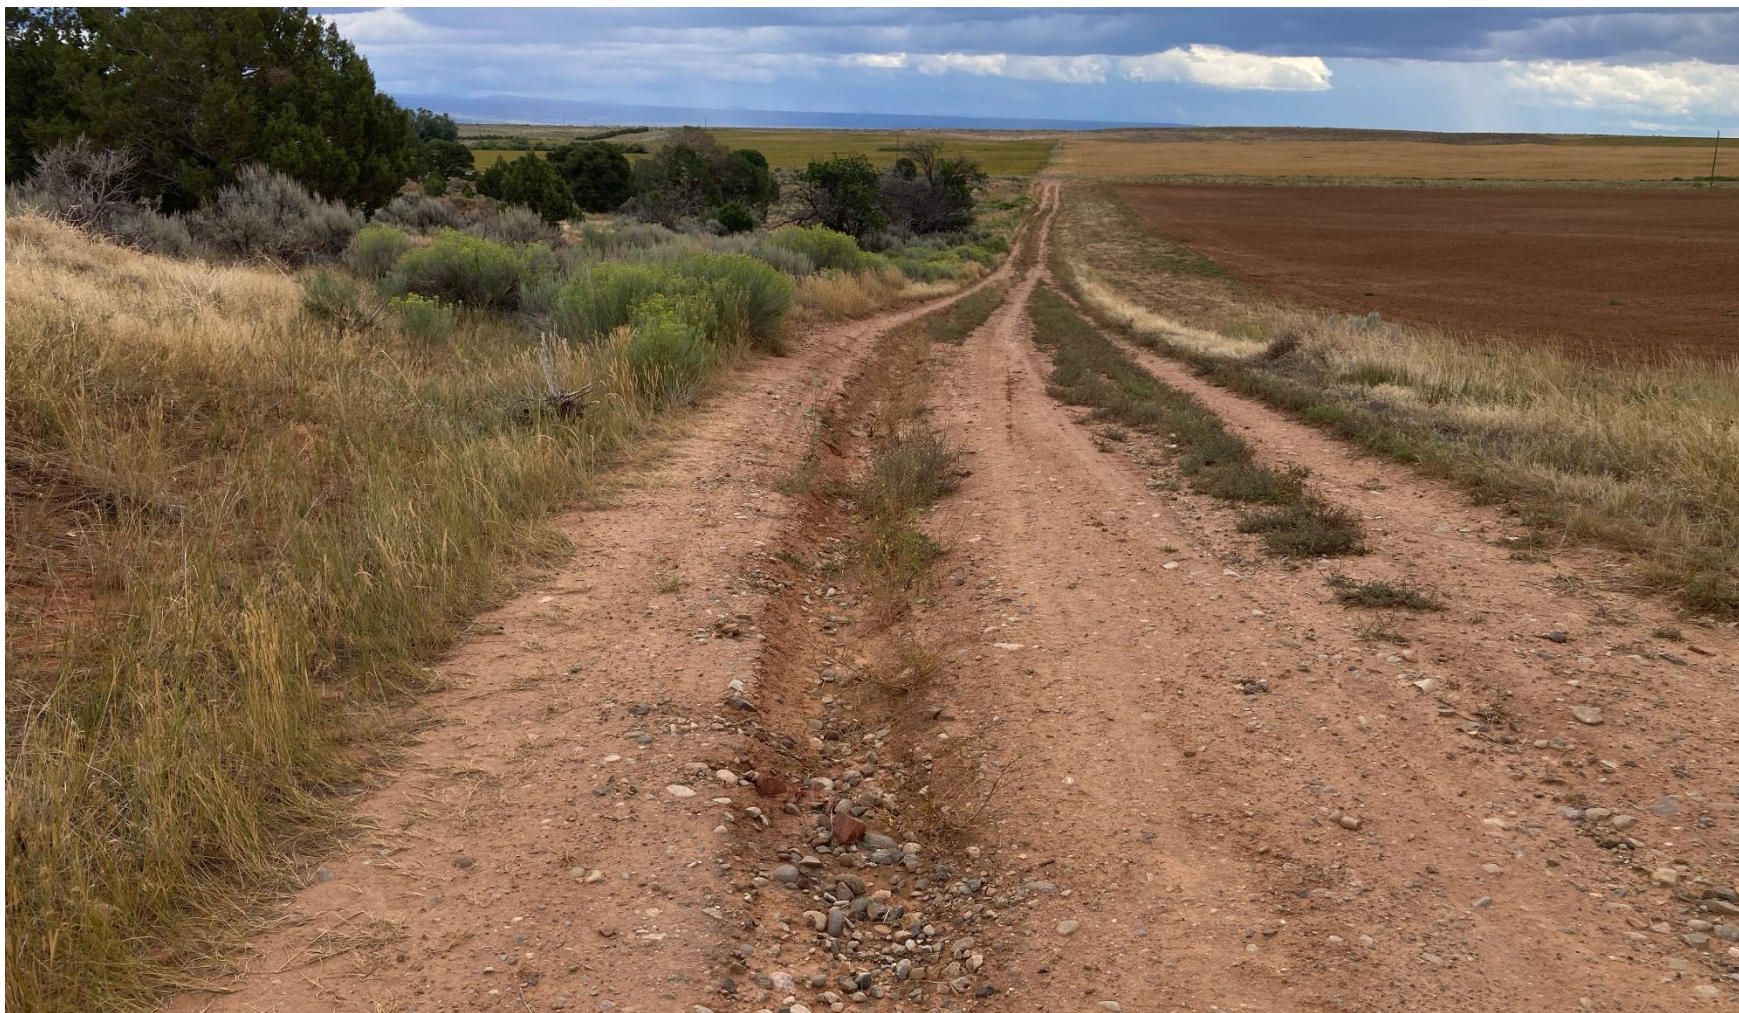
PHOTO 5: VEHICLE TRACKING AND STORM WATER HAVE ERODED ROW AND IS CAUSING VEHICLE TO SIDETRACK AND MAKE ROAD WIDER. REPAIR ROW AND INSTALL BMP'S TO PREVENT VEHICLE TRACKING AND STORMWATER EROSION PER RULE 1002.
