Inspection Photos

API: 017-06656

Operator: **CITATION OIL & GAS CORP**

Inspection Date: 8/28/2024

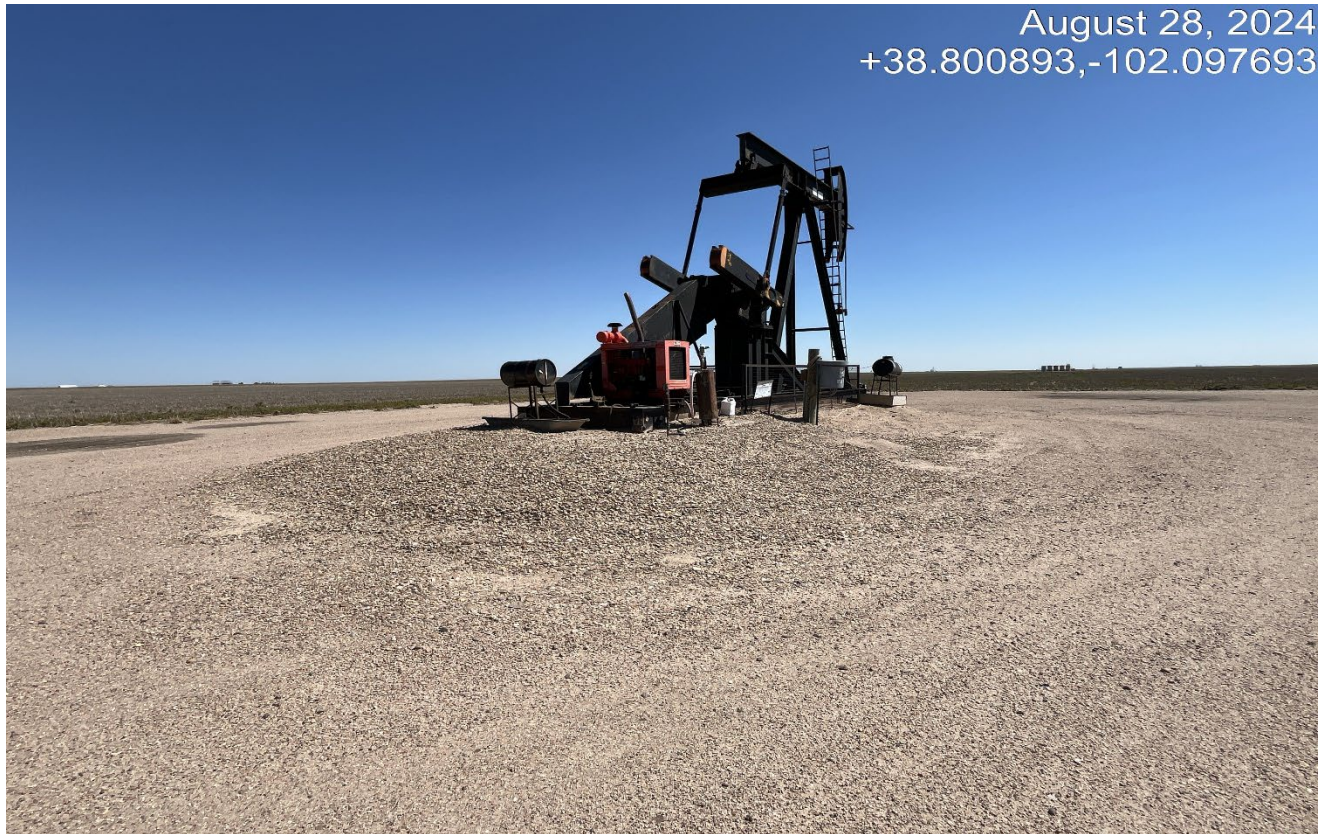
Photo 1. Facing northeast toward the wellsite.

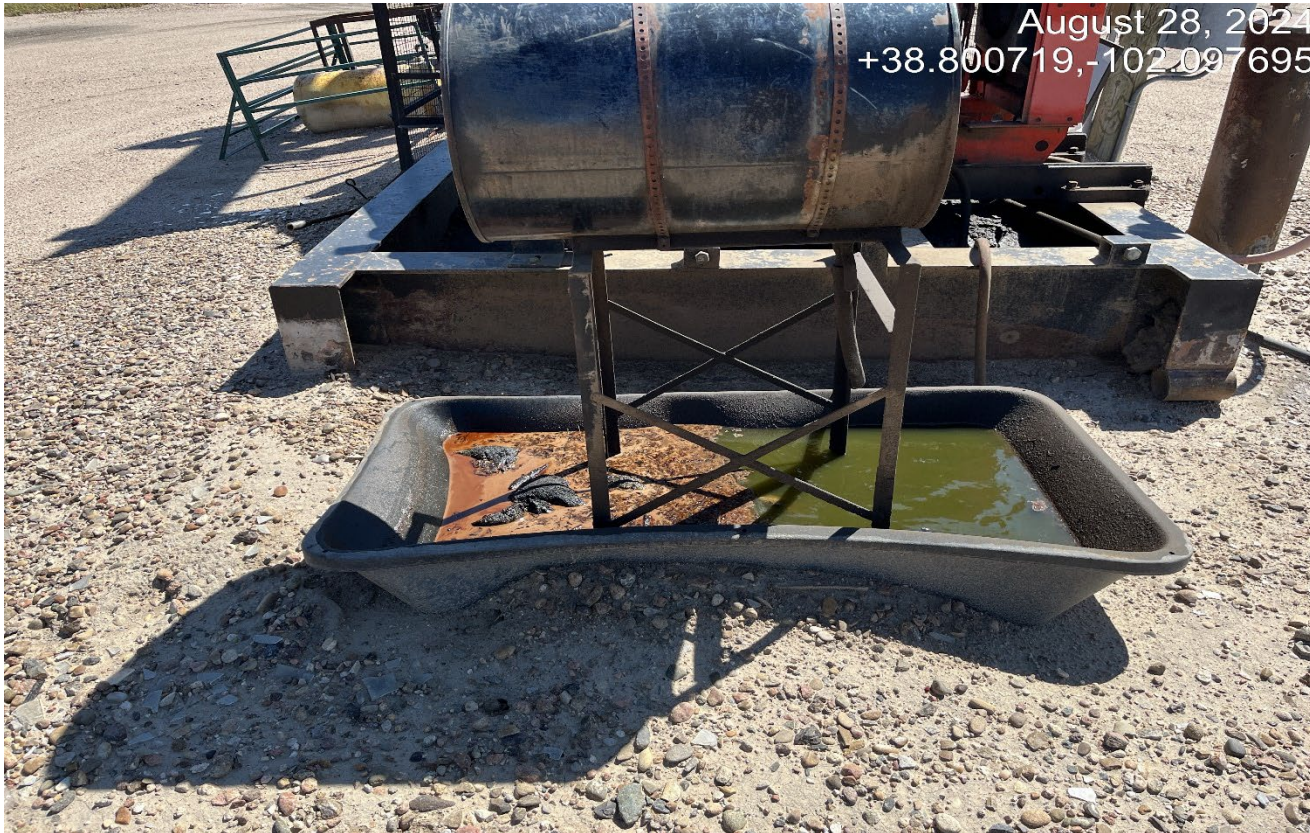
Photo 2. There is oily fluids in the secondary containment that needs to be disposed. Wildlife protections need to be installed.

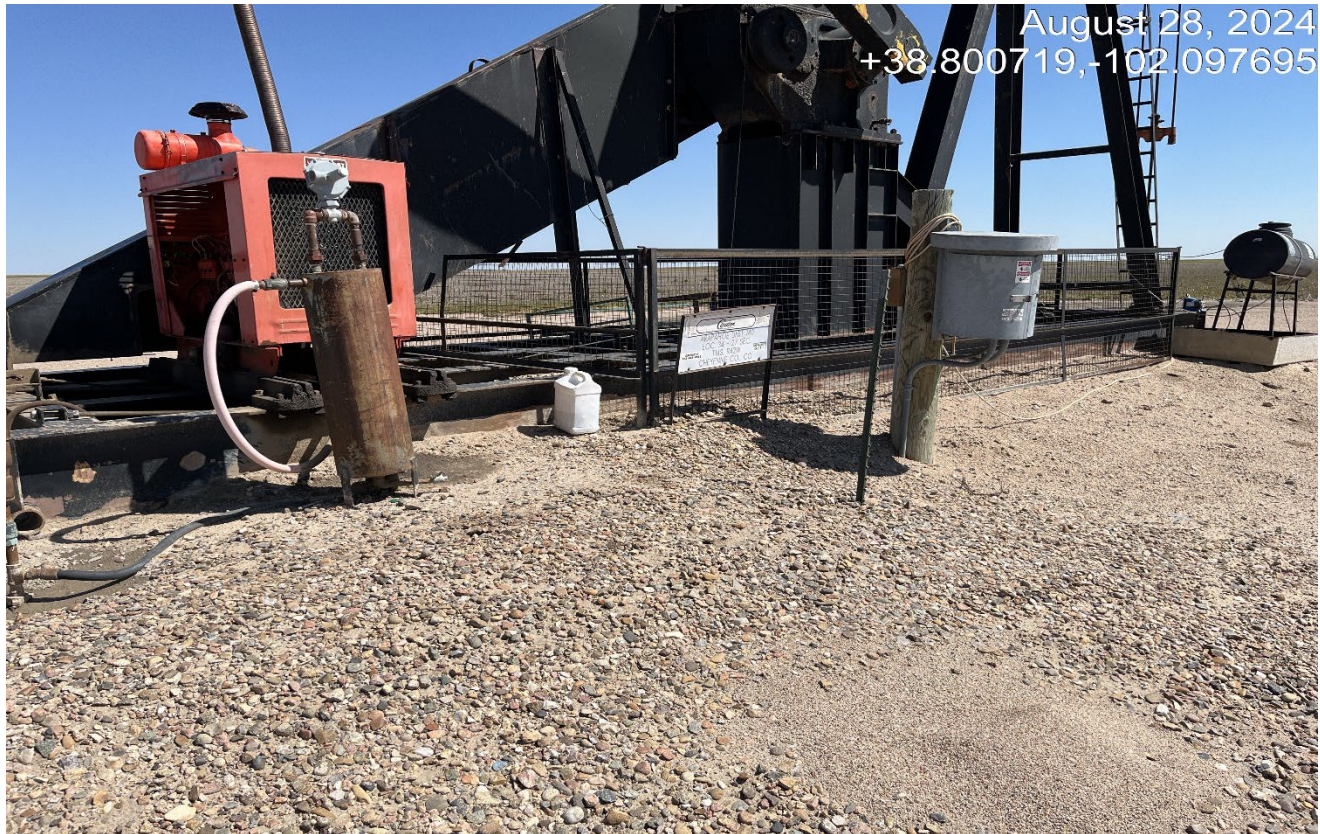
Photo 3. Facing toward the pumpjack.

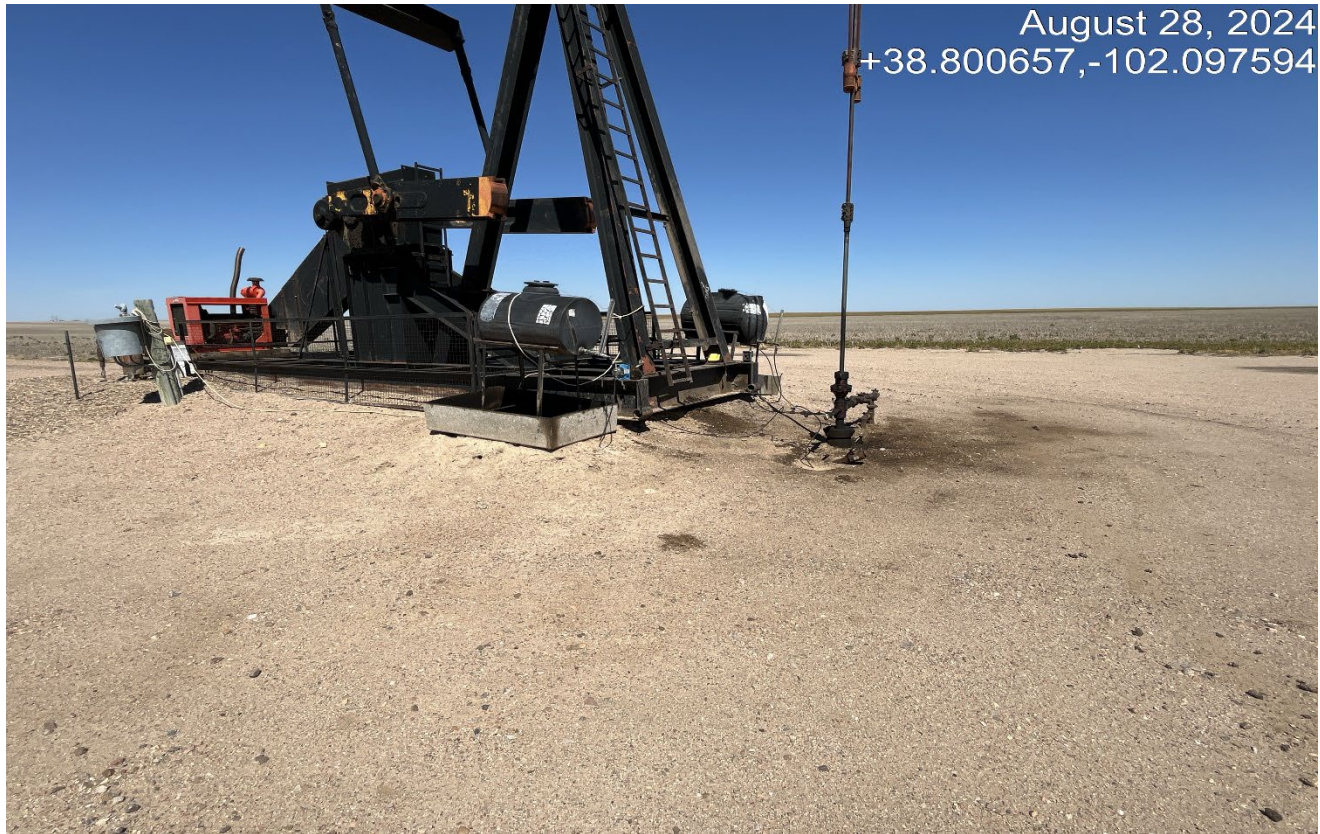
Photo 4. There is stained soils at the wellhead that need to be cleaned up.

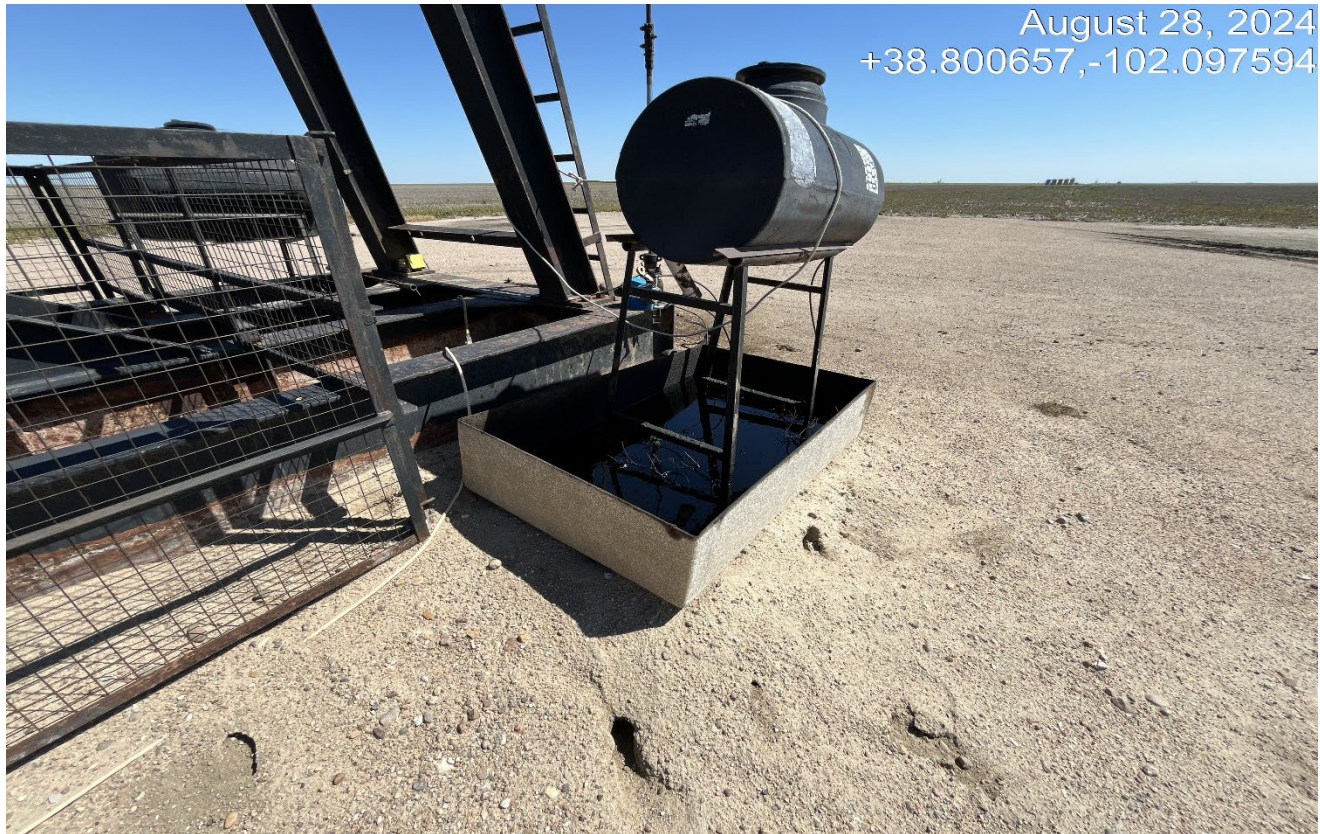
Photo 5. There is oily fluids in the secondary containment that needs to be disposed. Wildlife protections need to be installed.

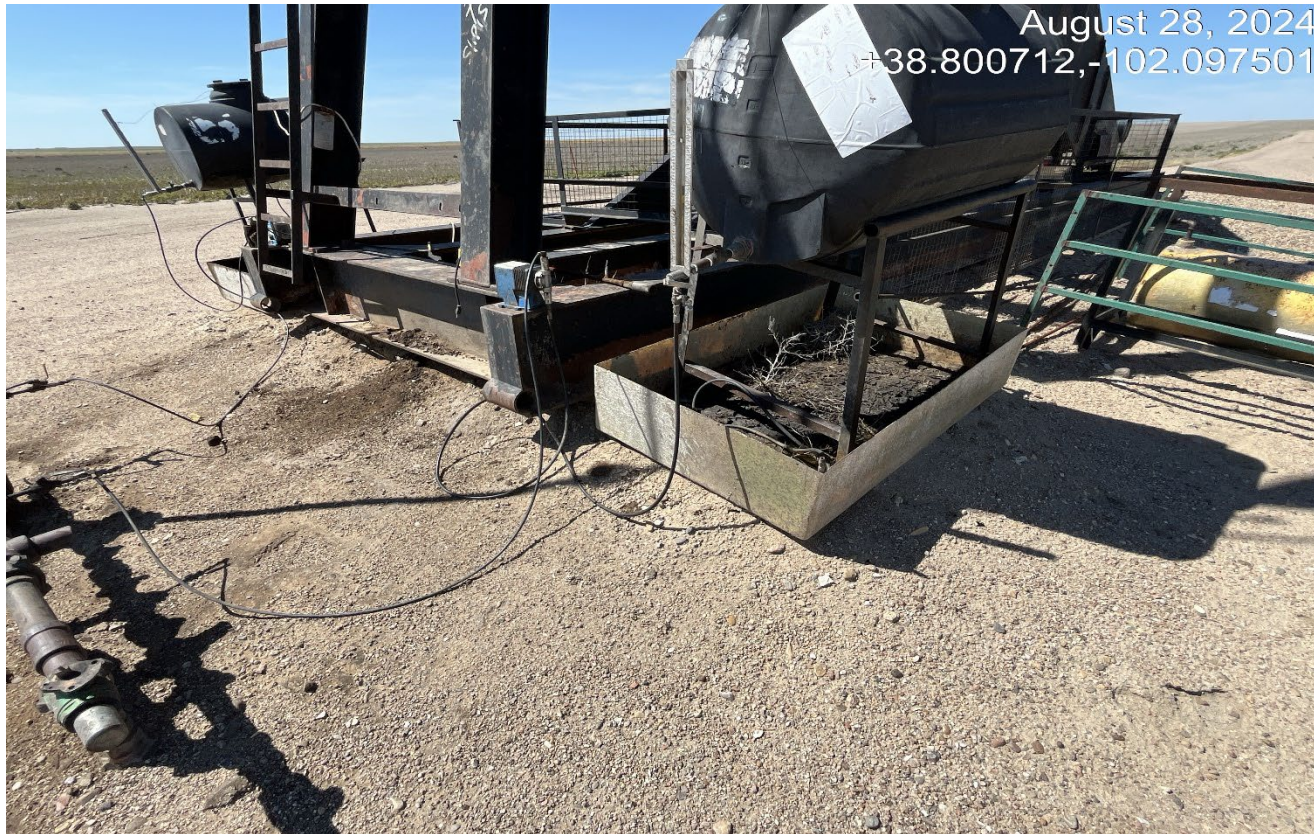
Photo 6. There is oily fluids in the secondary containment that needs to be disposed. Wildlife protections need to be installed. Tanks must be labeled.
