**Operator: 8 North**

**Location Name: BASHOR PC GQ 15-13**

**Loc ID: 417826**

**Inspection: 684904669**

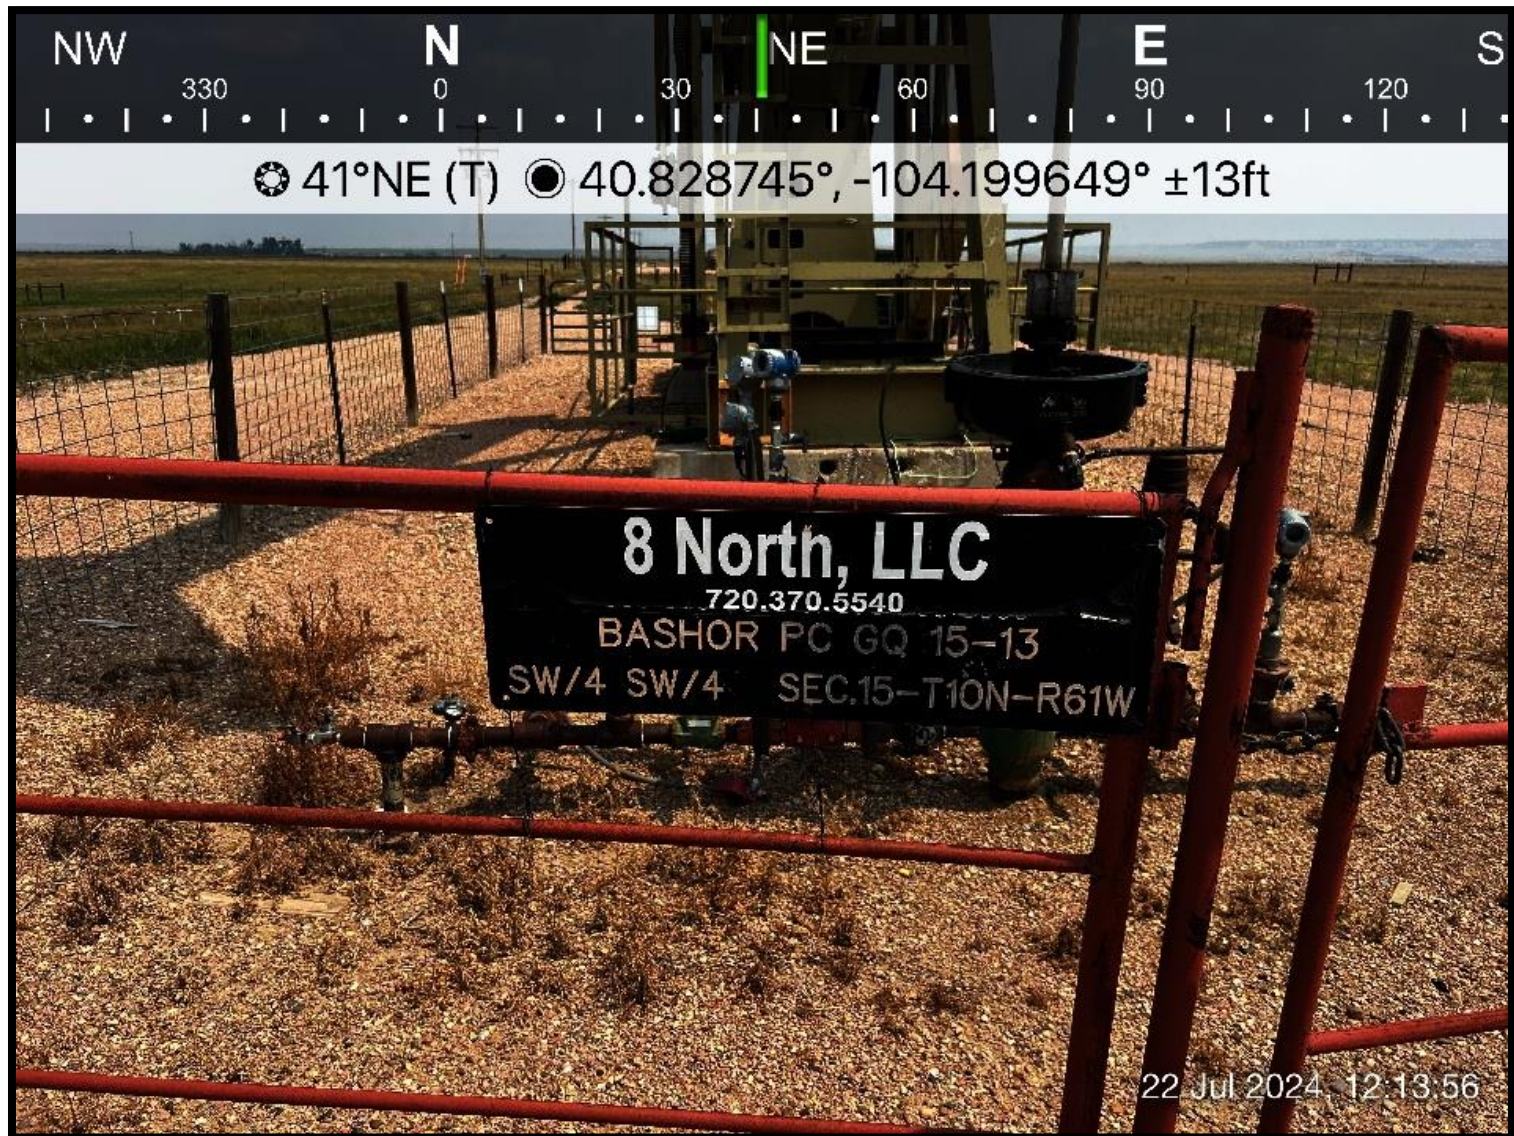
Exhibit A

**CA:** Stained soil at wellhead Corrective Action: Remove or remediate stained soil; Securely fasten all valves, pipes, and fittings to ensure good mechanical condition, inspect at regular intervals and maintain in good mechanical condition per Rule 605.d.

**CA Resolution:** Operator has provided photo evidence to show that the stained soil has been appropriately removed/cleared and mechanical issues leading to the leak have also been addressed.
