Fwd: Isle Dome Pit Issues Observed 7/26/2022

Subject: Isle Dome Pit Issues Observed 7/26/2022

07/26/2022 site visit the following where observed:

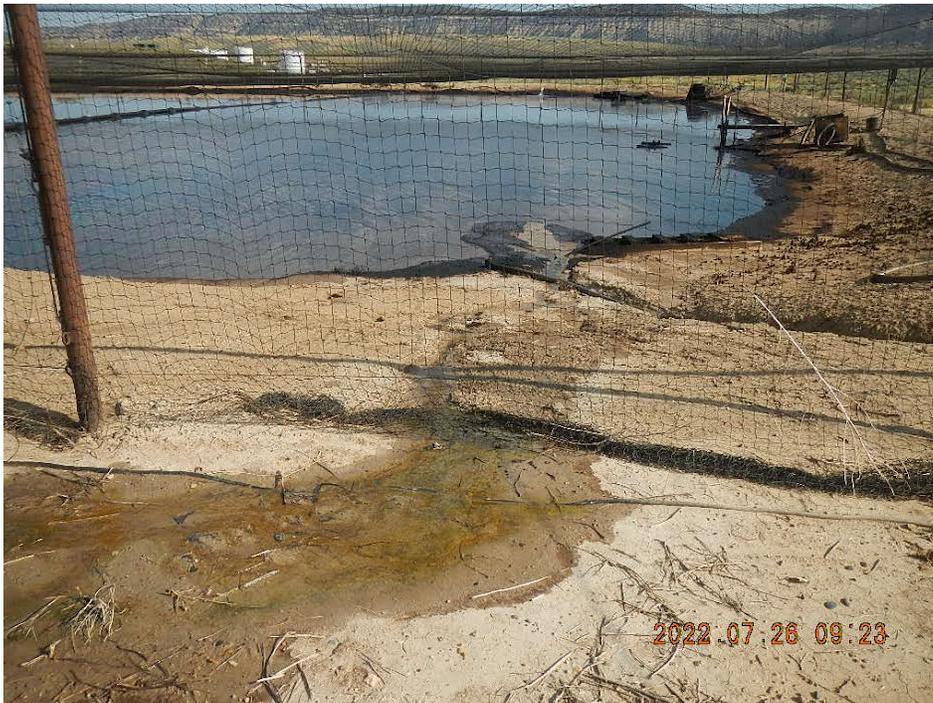
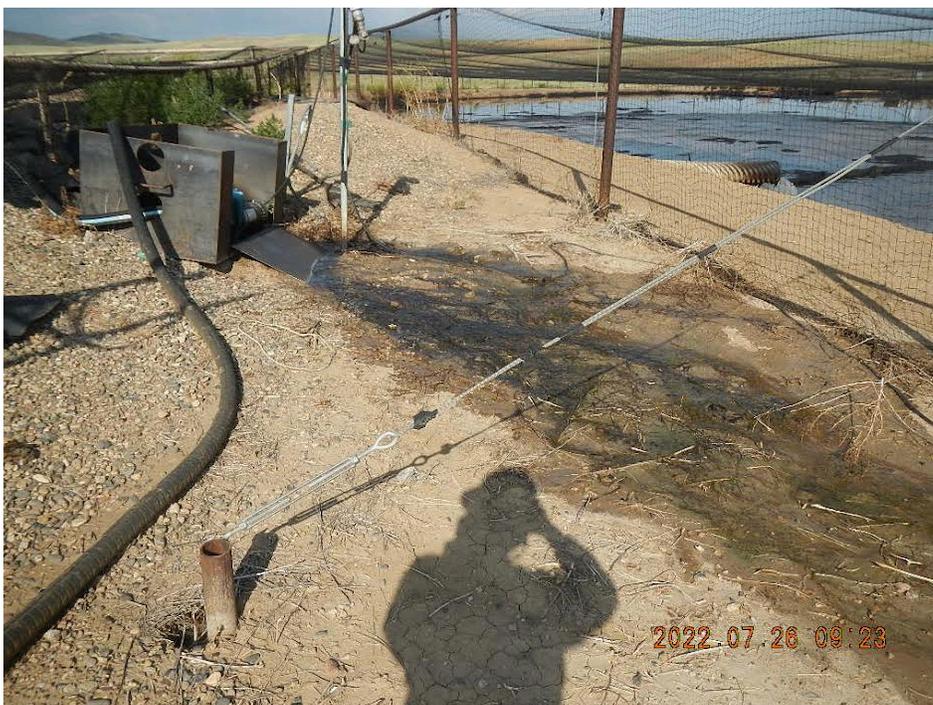
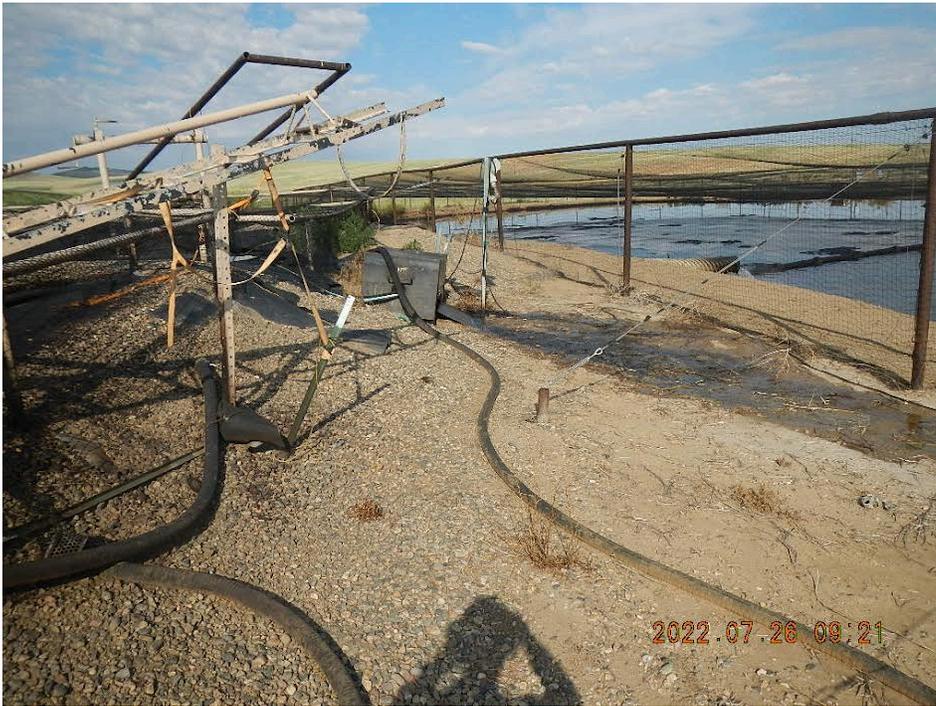
- Fluids were observed being discharged to the ground surface from a faulty transfer pump pumping from the second small pit to an unknown flowline;
- Liner compromised in the second small pit, floating on the oil surface with fluid lever upto and possible onto the earthen pit berm (less than 2' of freeboard). Red circle illustrates liner area of concern and arrows illustrate liner floating on the oil and liner void of earthen berm; and
- Numerous holes and gaps in the netting of all three (3) pits.

Please see photos, attached movie clip, and attached PDF. Although the Spill/Release was inside of the pit complex and fluids were flowing over the surface from the second pit to the large pit, this is a reportable spill as the transfer pump was not functioning properly releasing fluids to the ground surface. The operator is required to follow the COGCC Rule 912 Spill and Release Rules.
