**Site Location Map**  
**Kerr-McGee Oil and Gas Onshore LP**  
**Fehr 7 8 24 25 26 41-32 Facility**  
**SENE Sec. 32-T2N-R66W**  
**Weld County, Colorado**

**Kerr-McGee Oil and Gas Onshore LP**  
**Fehr 7 8 24 25 26 41-32 Production Facility**  
 SENE Sec. 32-T2N-R66W  
 Weld County, Colorado

**ATTACHMENT A**  
**FIELD NOTES AND PHOTOGRAPHIC LOG**

## Tank Battery Closure Checklist 2

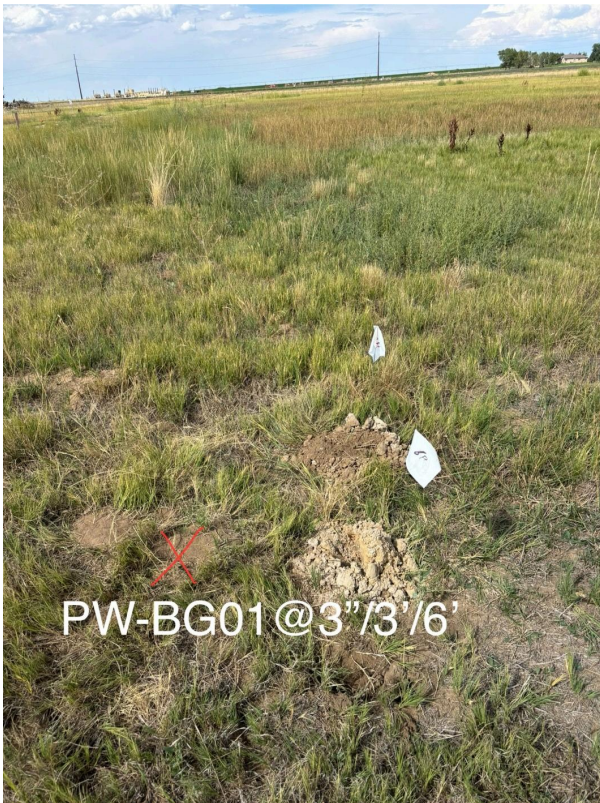
R1 - P1

| # | Sample Date | Sample Time | Soil Sample ID | PID Readings | Visual | Olfactory | Equipment Type |
|---|---|---|---|---|---|---|---|
| R1 | 09/11/2024 | 11:30 AM | PW-BG01 @ 3" | 0.5 | N.S | N.O | Background |

Facing north

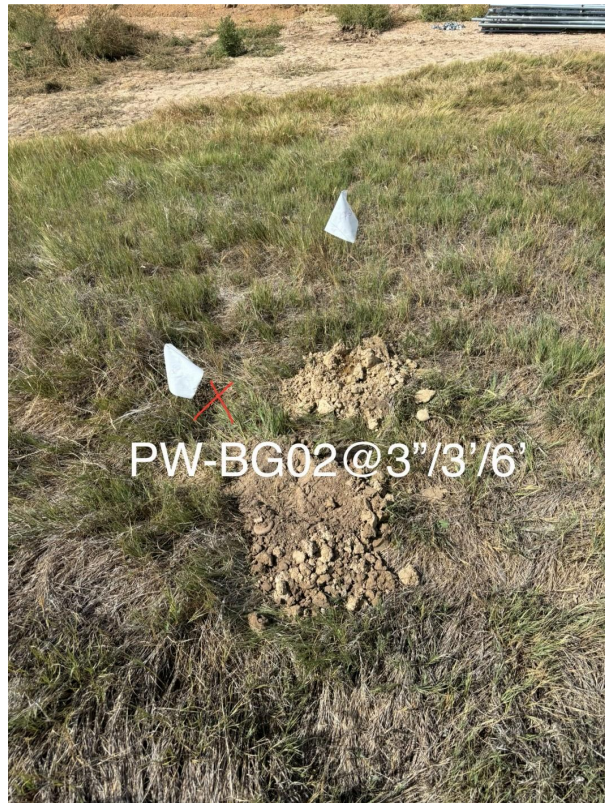
R4 - P1

| # | Sample Date | Sample Time | Soil Sample ID | PID Readings | Visual | Olfactory | Equipment Type |
|---|---|---|---|---|---|---|---|
| R4 | 09/11/2024 | 11:40 AM | PW-BG02 @ 3" | 0.9 | N.S | N.O | Background |

Facing north

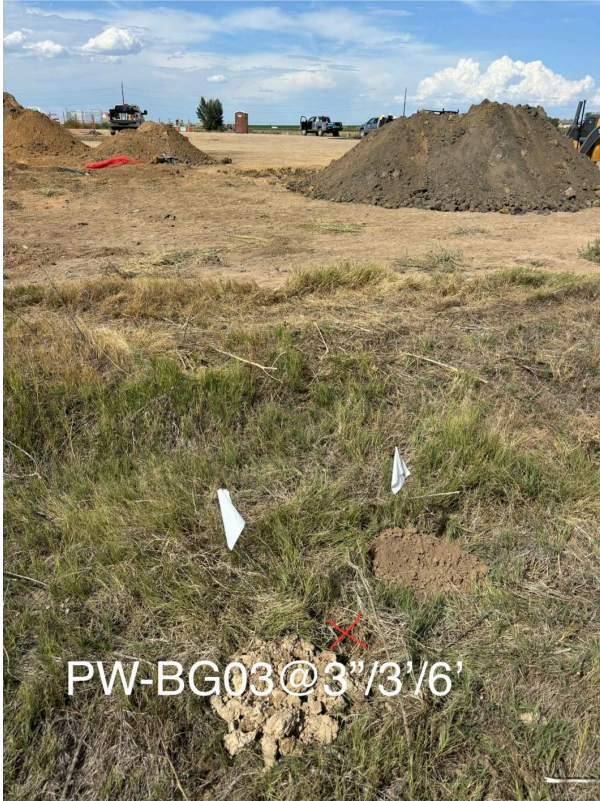
R7 - P1

| # | Sample Date | Sample Time | Soil Sample ID | PID Readings | Visual | Olfactory | Equipment Type |
|---|---|---|---|---|---|---|---|
| R7 | 09/11/2024 | 11:50 AM | PW-BG03 @ 3" | 1.3 | N.S | N.O | Background |

Facing north

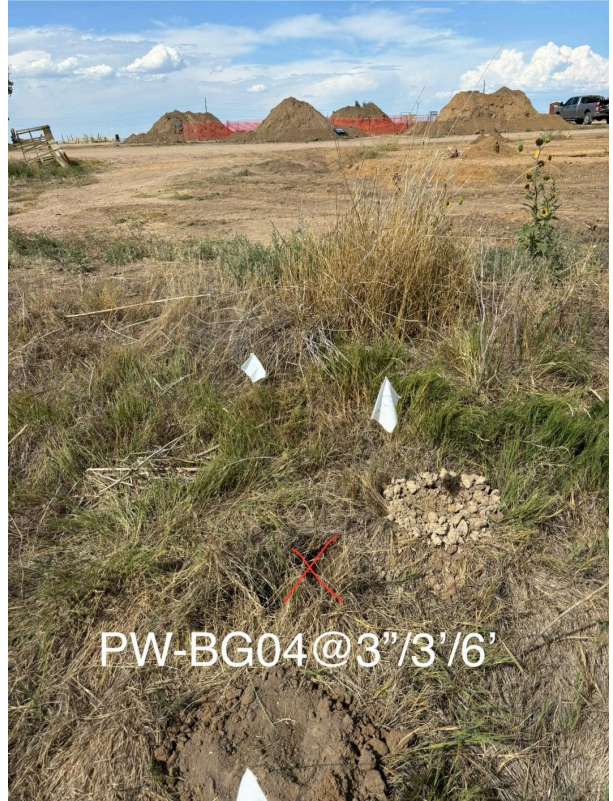
R10 - P1

| # | Sample Date | Sample Time | Soil Sample ID | PID Readings | Visual | Olfactory | Equipment Type |
|---|---|---|---|---|---|---|---|
| R10 | 09/11/2024 | 12:00 PM | PW-BG04 @ 3" | 0.3 | N.S | N.O | Background |

Facing north

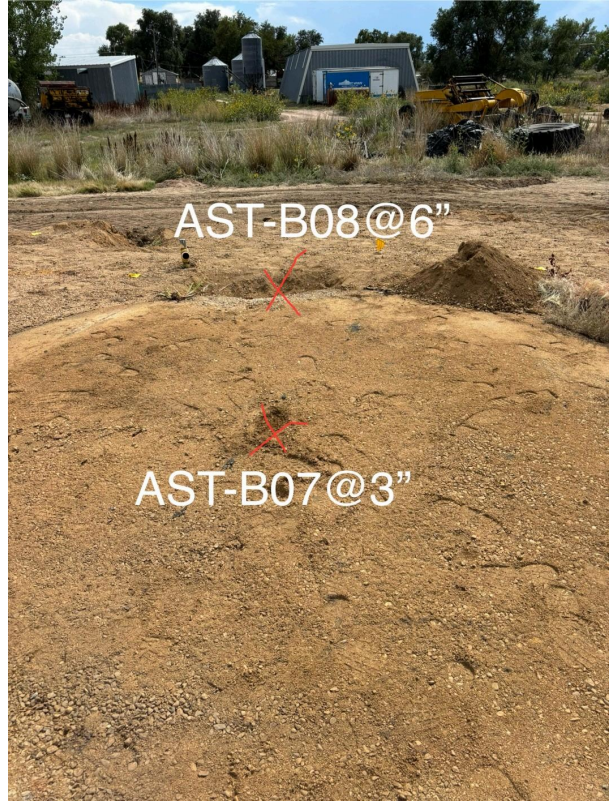
R19 - P1

| # | Sample Date | Sample Time | Soil Sample ID | PID Readings | Visual | Olfactory | Equipment Type |
|---|---|---|---|---|---|---|---|
| R19 | 09/11/2024 | 02:30 PM | AST-B07 @ 3" | 1.6 | N.S | N.O | Aboveground Storage Tank |

Facing south

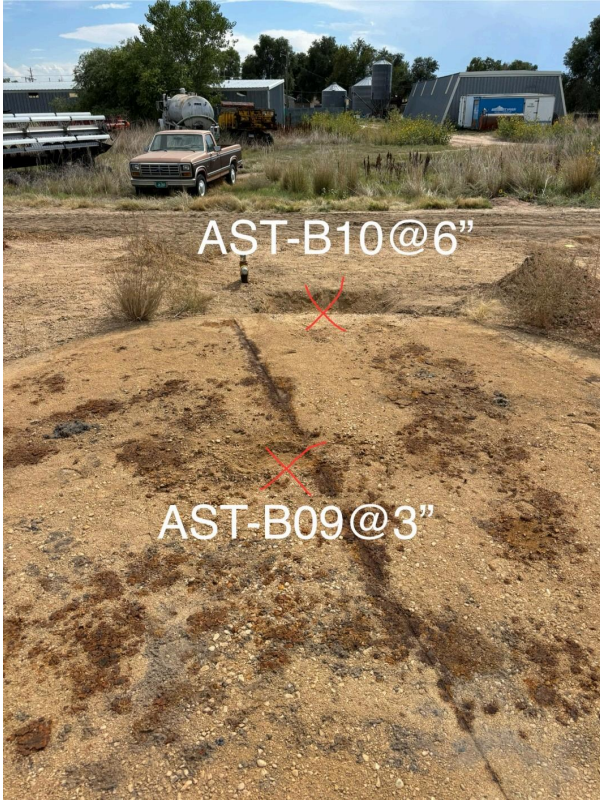
R21 - P1

| # | Sample Date | Sample Time | Soil Sample ID | PID Readings | Visual | Olfactory | Equipment Type |
|---|---|---|---|---|---|---|---|
| R21 | 09/11/2024 | 02:40 PM | AST-B09 @ 3" | 2.1 | N.S | N.O | Aboveground Storage Tank |

Facing south

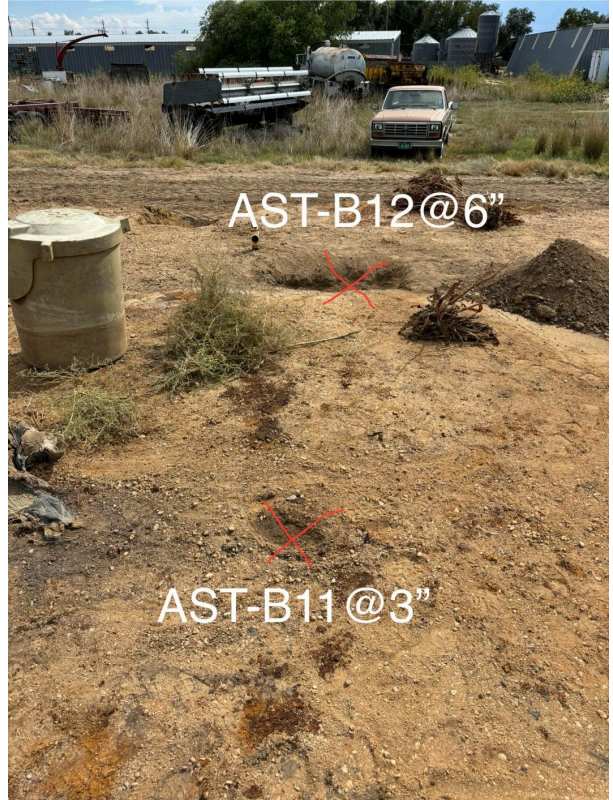
R23 - P1

| # | Sample Date | Sample Time | Soil Sample ID | PID Readings | Visual | Olfactory | Equipment Type |
|---|---|---|---|---|---|---|---|
| R23 | 09/11/2024 | 02:50 PM | AST-B11 @ 3" | 0.1 | N.S | N.O | Aboveground Storage Tank |

Facing south

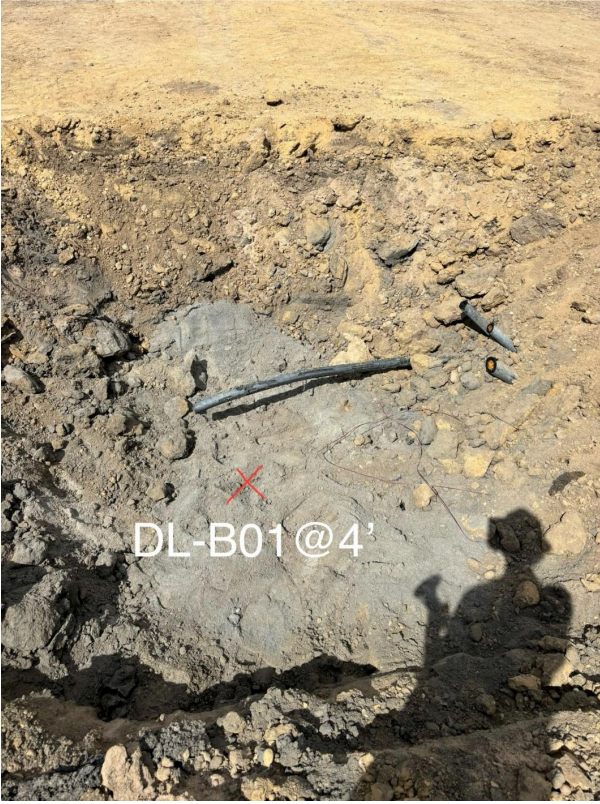
R25 - P1

| # | Sample Date | Sample Time | Soil Sample ID | PID Readings | Visual | Olfactory | Equipment Type |
|---|---|---|---|---|---|---|---|
| R25 | 09/11/2024 | 02:54 PM | DL-B01 @ 4' | 1.6 | N.S | N.O | Dump Line |

Facing north

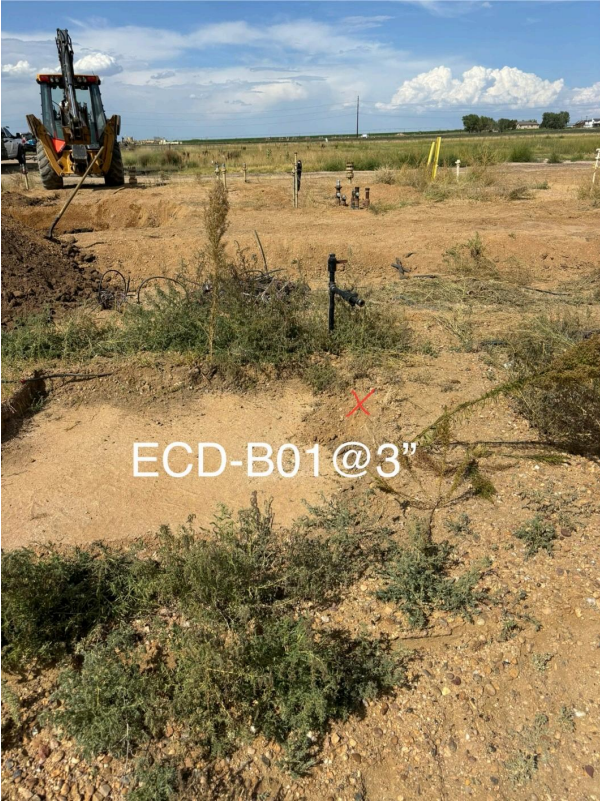
R28 - P1

| # | Sample Date | Sample Time | Soil Sample ID | PID Readings | Visual | Olfactory | Equipment Type |
|---|---|---|---|---|---|---|---|
| R28 | 09/11/2024 | 03:00 PM | ECD-B01 @ 3" | 1.7 | N.S | N.O | Emissions Control Device |

Facing north

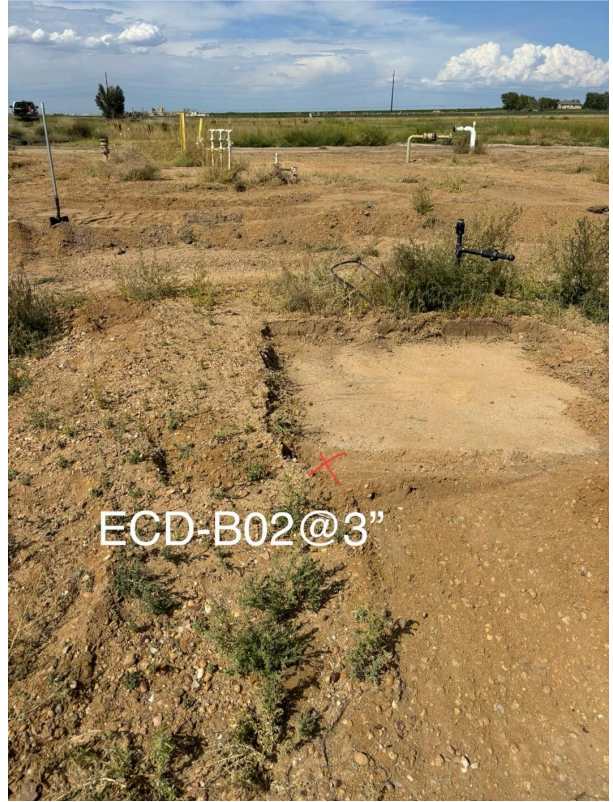
R29 - P1

| # | Sample Date | Sample Time | Soil Sample ID | PID Readings | Visual | Olfactory | Equipment Type |
|---|---|---|---|---|---|---|---|
| R29 | 09/11/2024 | 03:02 PM | ECD-B02 @ 3" | 1.2 | N.S | N.O | Emissions Control Device |

Facing north

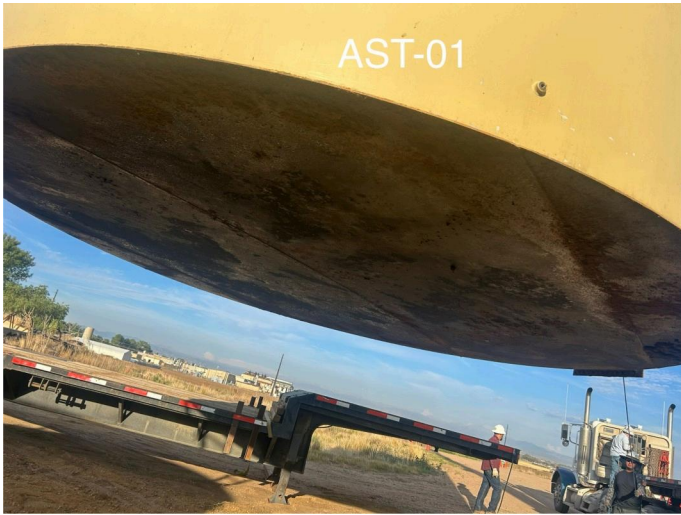
R30 - P1

| # | Sample Date | Sample Time | Soil Sample ID | PID Readings | Visual | Olfactory | Equipment Type |
|---|---|---|---|---|---|---|---|
| R30 | 09/11/2024 | 08:15 AM | Bottom of AST-01 | | | | Aboveground Storage Tank |

Facing West

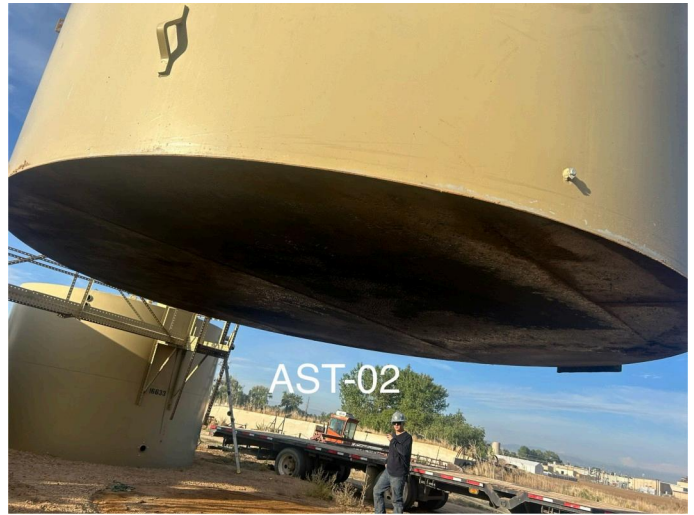
R31 - P1

| # | Sample Date | Sample Time | Soil Sample ID | PID Readings | Visual | Olfactory | Equipment Type |
|---|---|---|---|---|---|---|---|
| R31 | 09/11/2024 | 08:17 AM | Bottom of AST-02 | | | | Aboveground Storage Tank |

Facing West

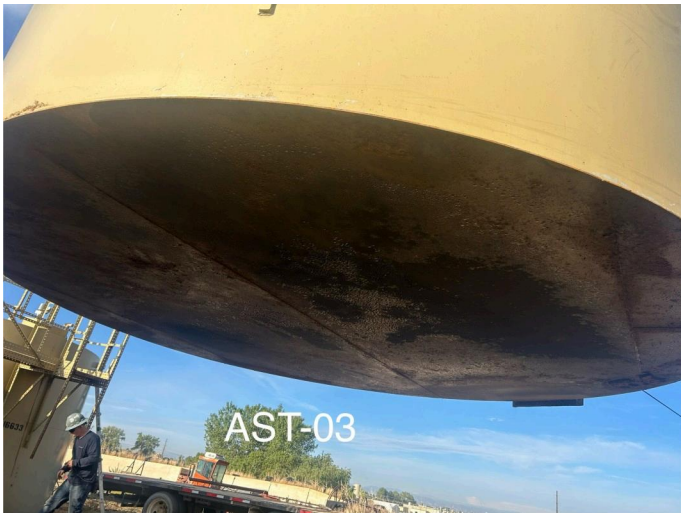
R32 - P1

| # | Sample Date | Sample Time | Soil Sample ID | PID Readings | Visual | Olfactory | Equipment Type |
|---|---|---|---|---|---|---|---|
| R32 | 09/11/2024 | 08:19 AM | Bottom of AST-03 | | | | Aboveground Storage Tank |

Facing West

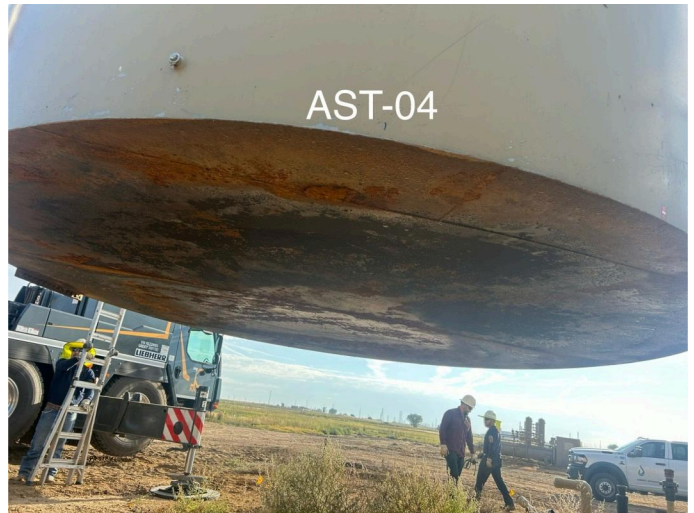
R33 - P1

| # | Sample Date | Sample Time | Soil Sample ID | PID Readings | Visual | Olfactory | Equipment Type |
|---|---|---|---|---|---|---|---|
| R33 | 09/11/2024 | 08:21 AM | Bottom of AST-04 | | | | Aboveground Storage Tank |

Facing East

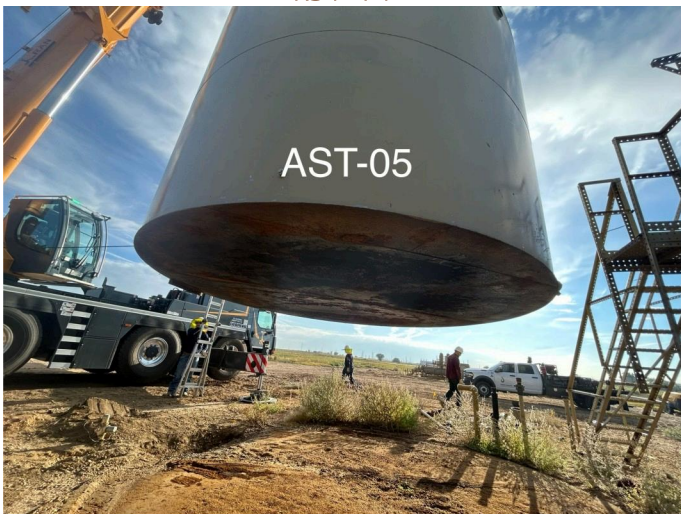
R34 - P1

| # | Sample Date | Sample Time | Soil Sample ID | PID Readings | Visual | Olfactory | Equipment Type |
|---|---|---|---|---|---|---|---|
| R34 | 09/11/2024 | 08:23 AM | Bottom of AST-05 | | | | Aboveground Storage Tank |

Facing East

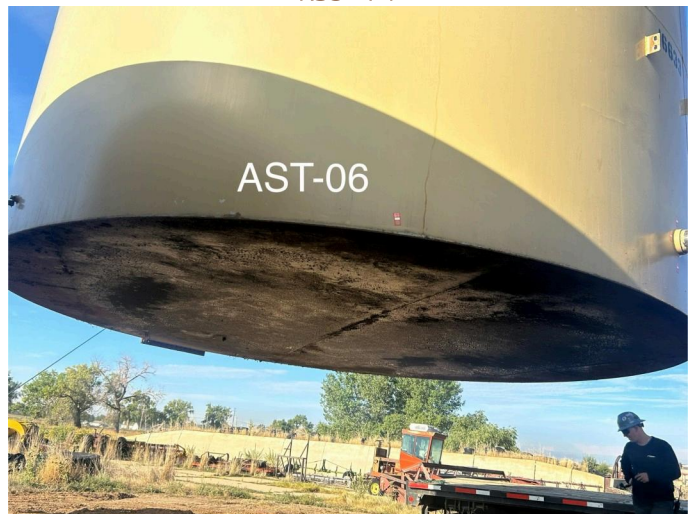
R35 - P1

| # | Sample Date | Sample Time | Soil Sample ID | PID Readings | Visual | Olfactory | Equipment Type |
|---|---|---|---|---|---|---|---|
| R35 | 09/11/2024 | 08:25 AM | Bottom of AST-06 | | | | Aboveground Storage Tank |

Facing West
