WELL NAME: JOHNSON 14-3, API #: 071-07721, INSP. # 716300164

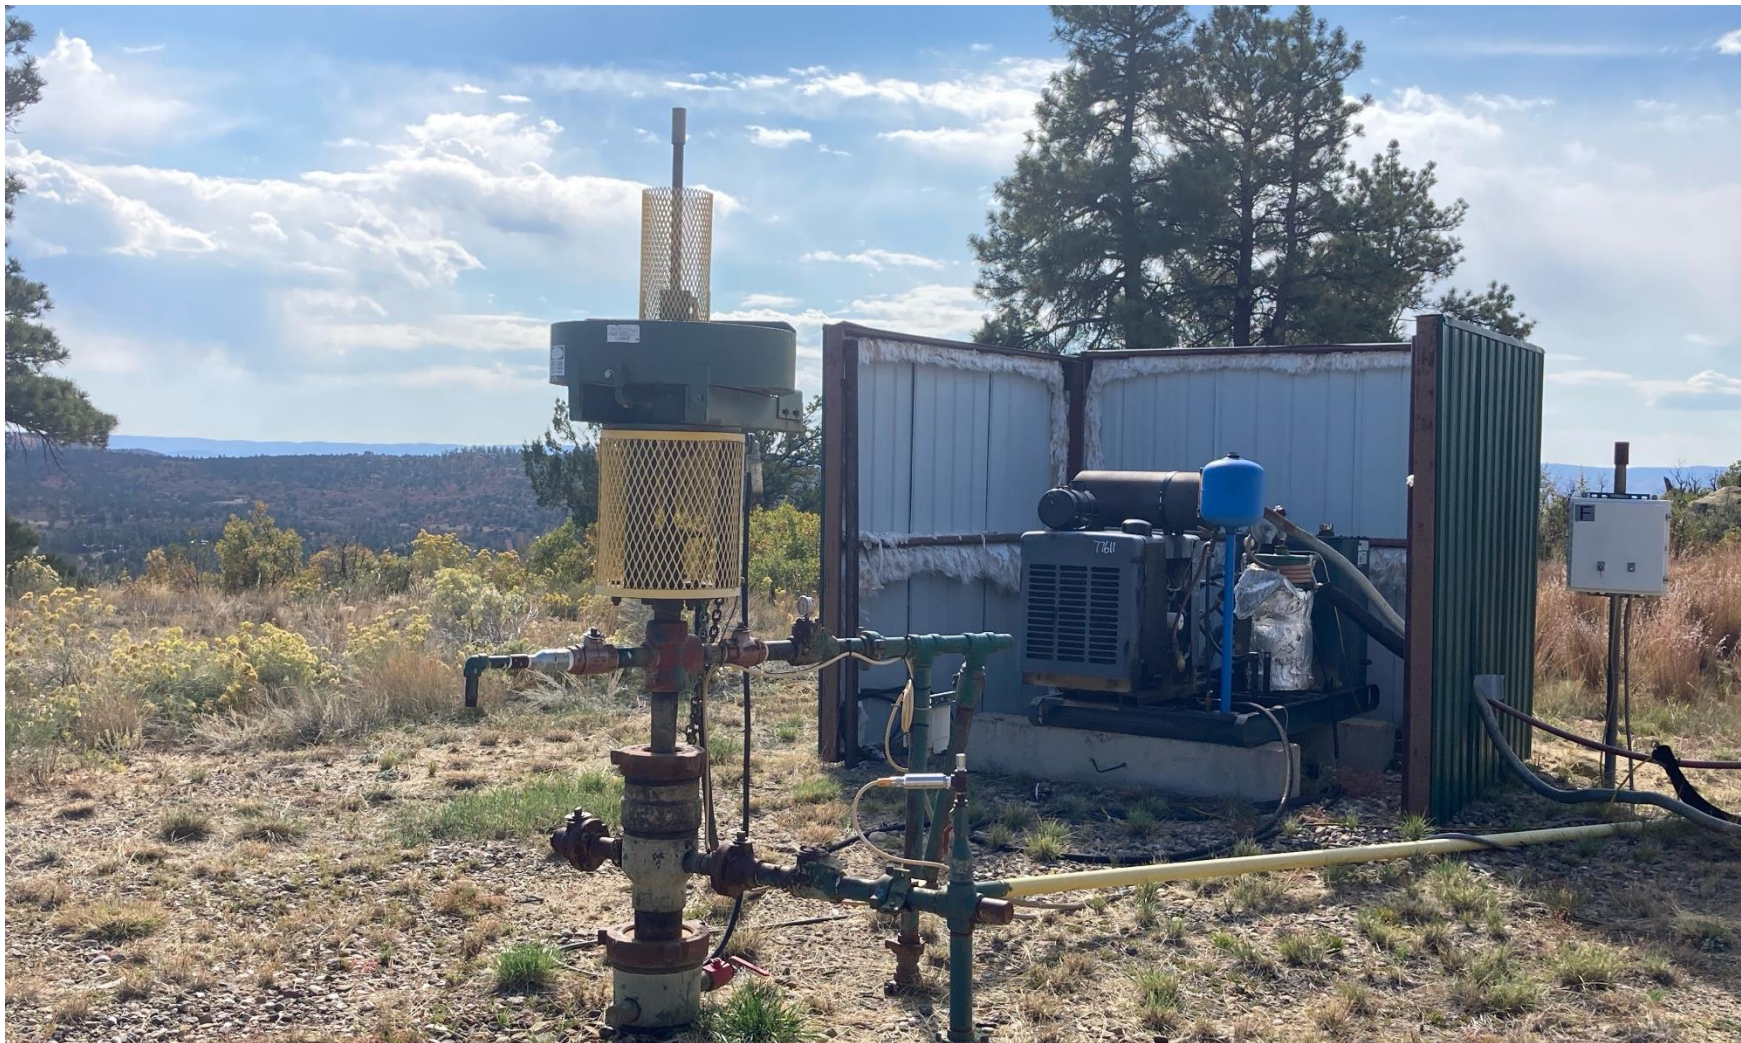
**PHOTO 3: WELLHEAD AND EQUIPMENT.**

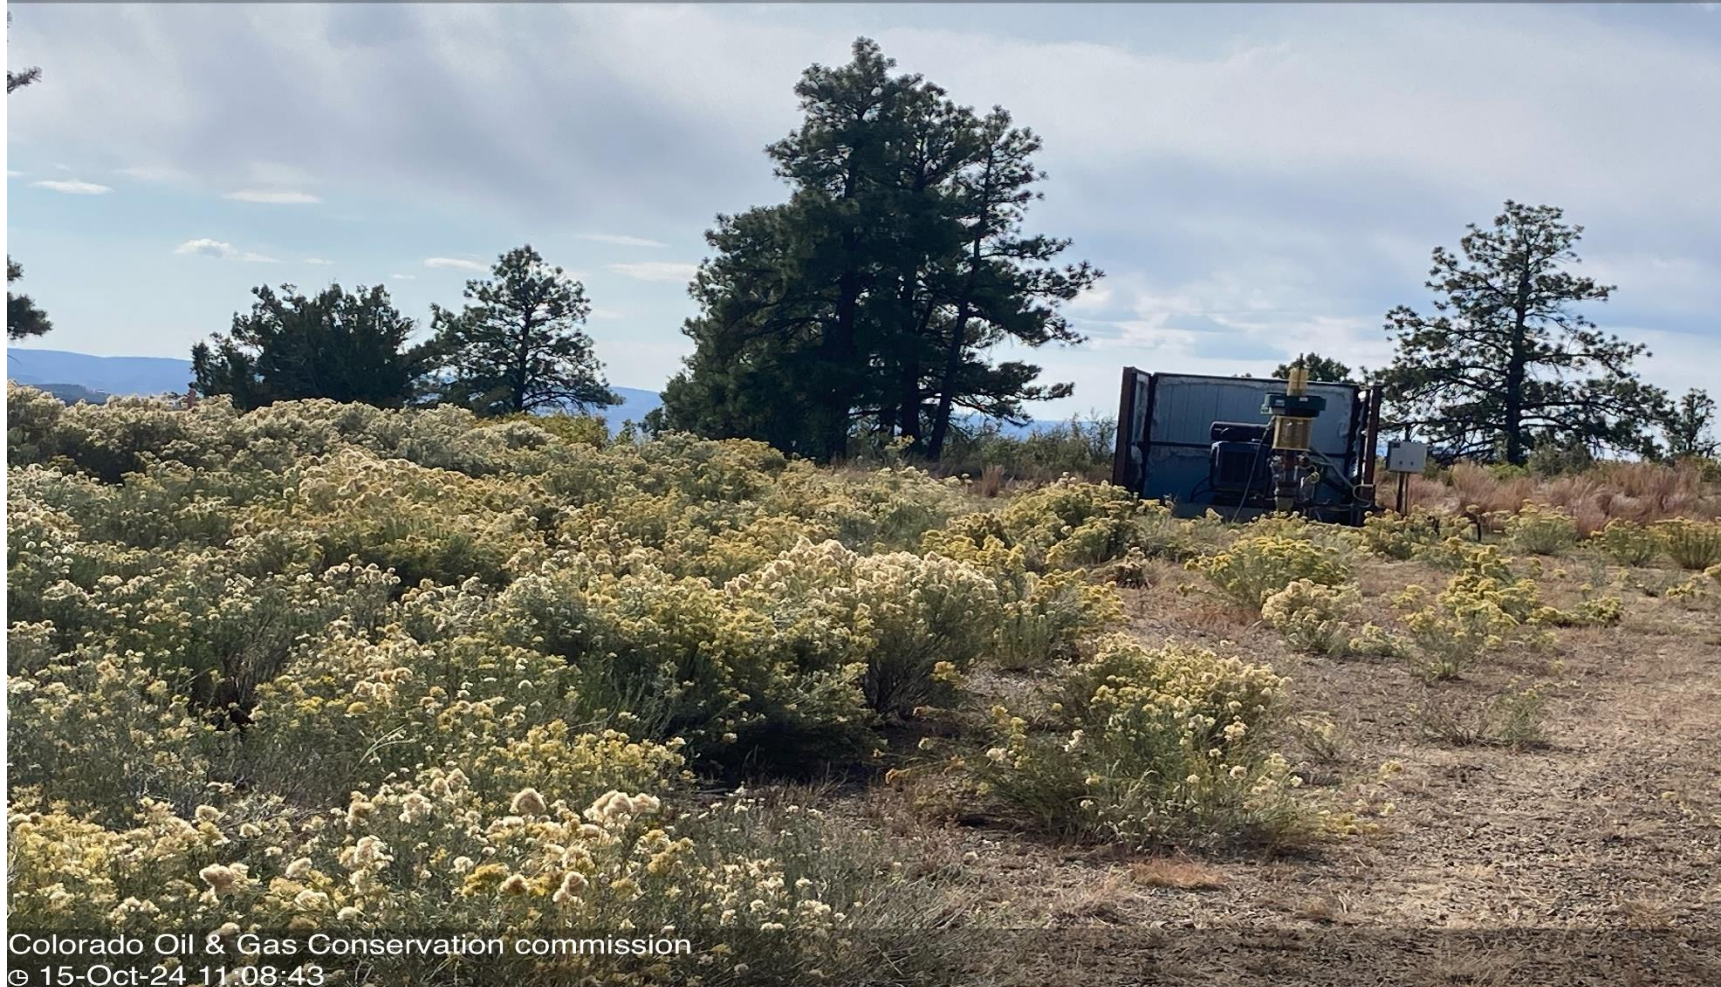
**PHOTO 4: WEEDS ON LOCATION HAVE NOT BEEN MAINTAINED. MAINTAIN WEEDS PER RULE 606. CA DATE 11/15/2024.**

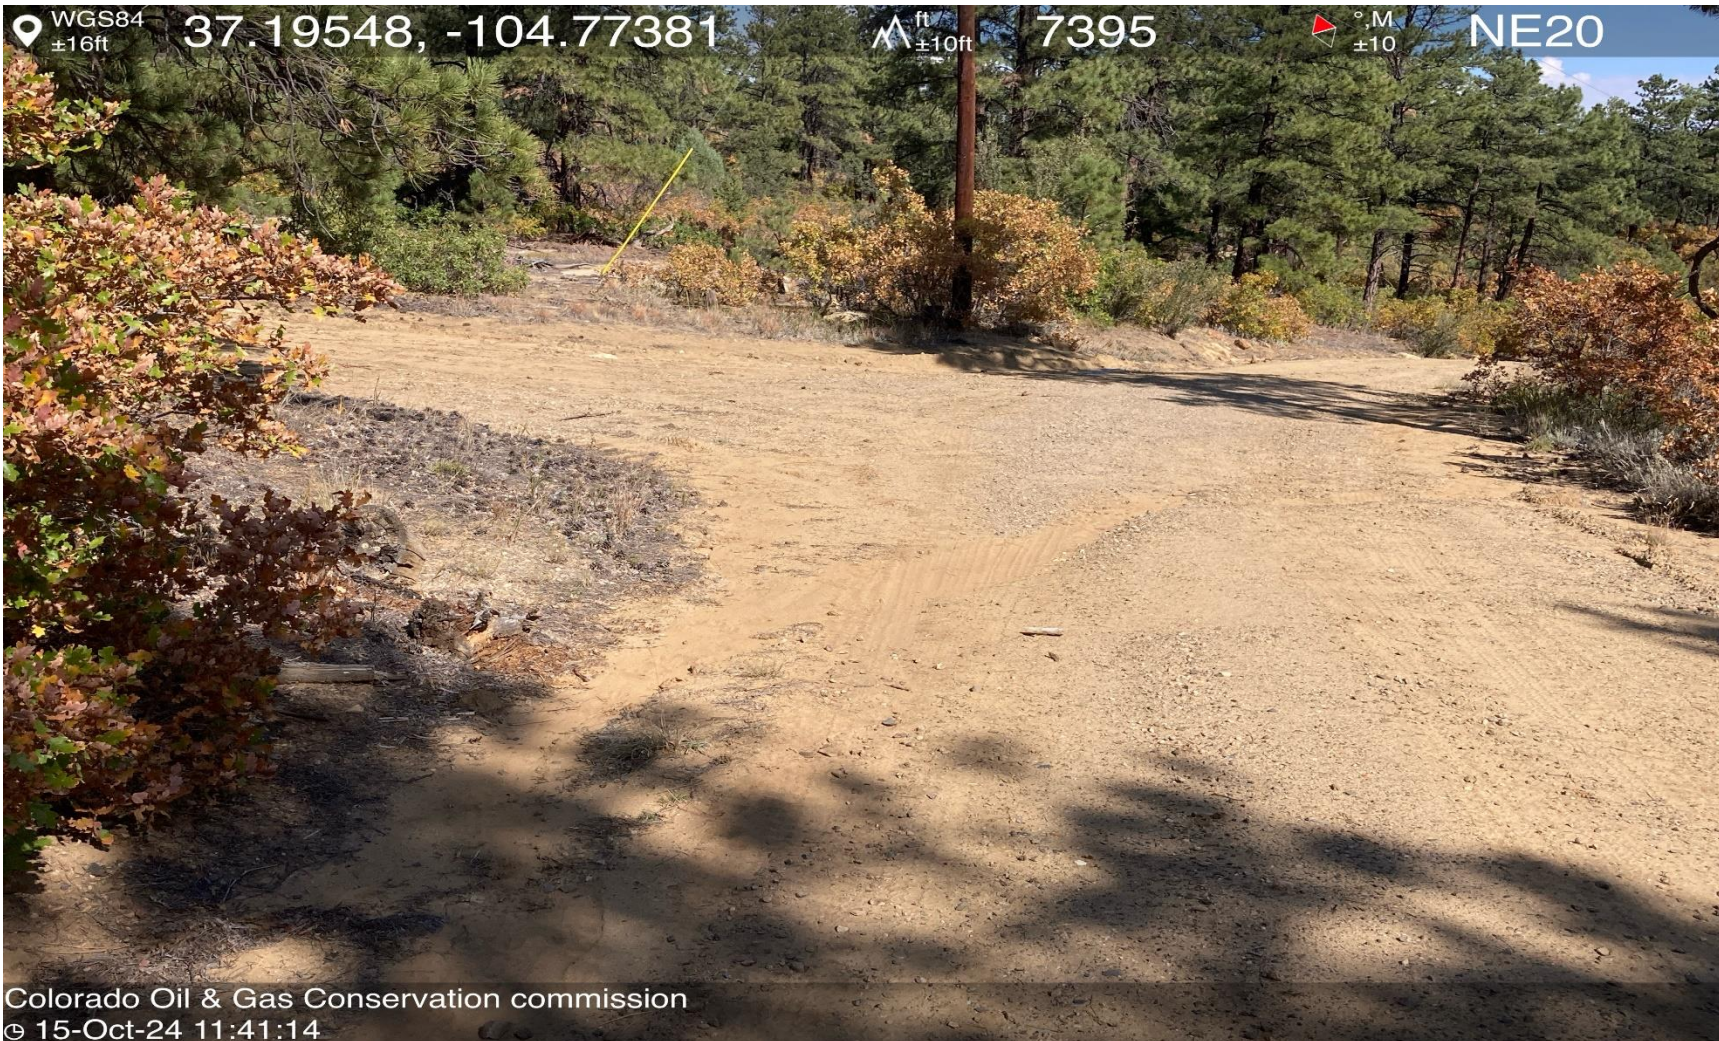
**PHOTO 5: CULVERT IS COMPLETELY COVERED WITH SEDIMENT AND IS CAUSING STORMWATER TO CROSS ROAD AND ERODE ROW. CLEAN AND MAINTAIN ALL CULVERTS PER RULE 1002. CA DATE 11/15/2024.**

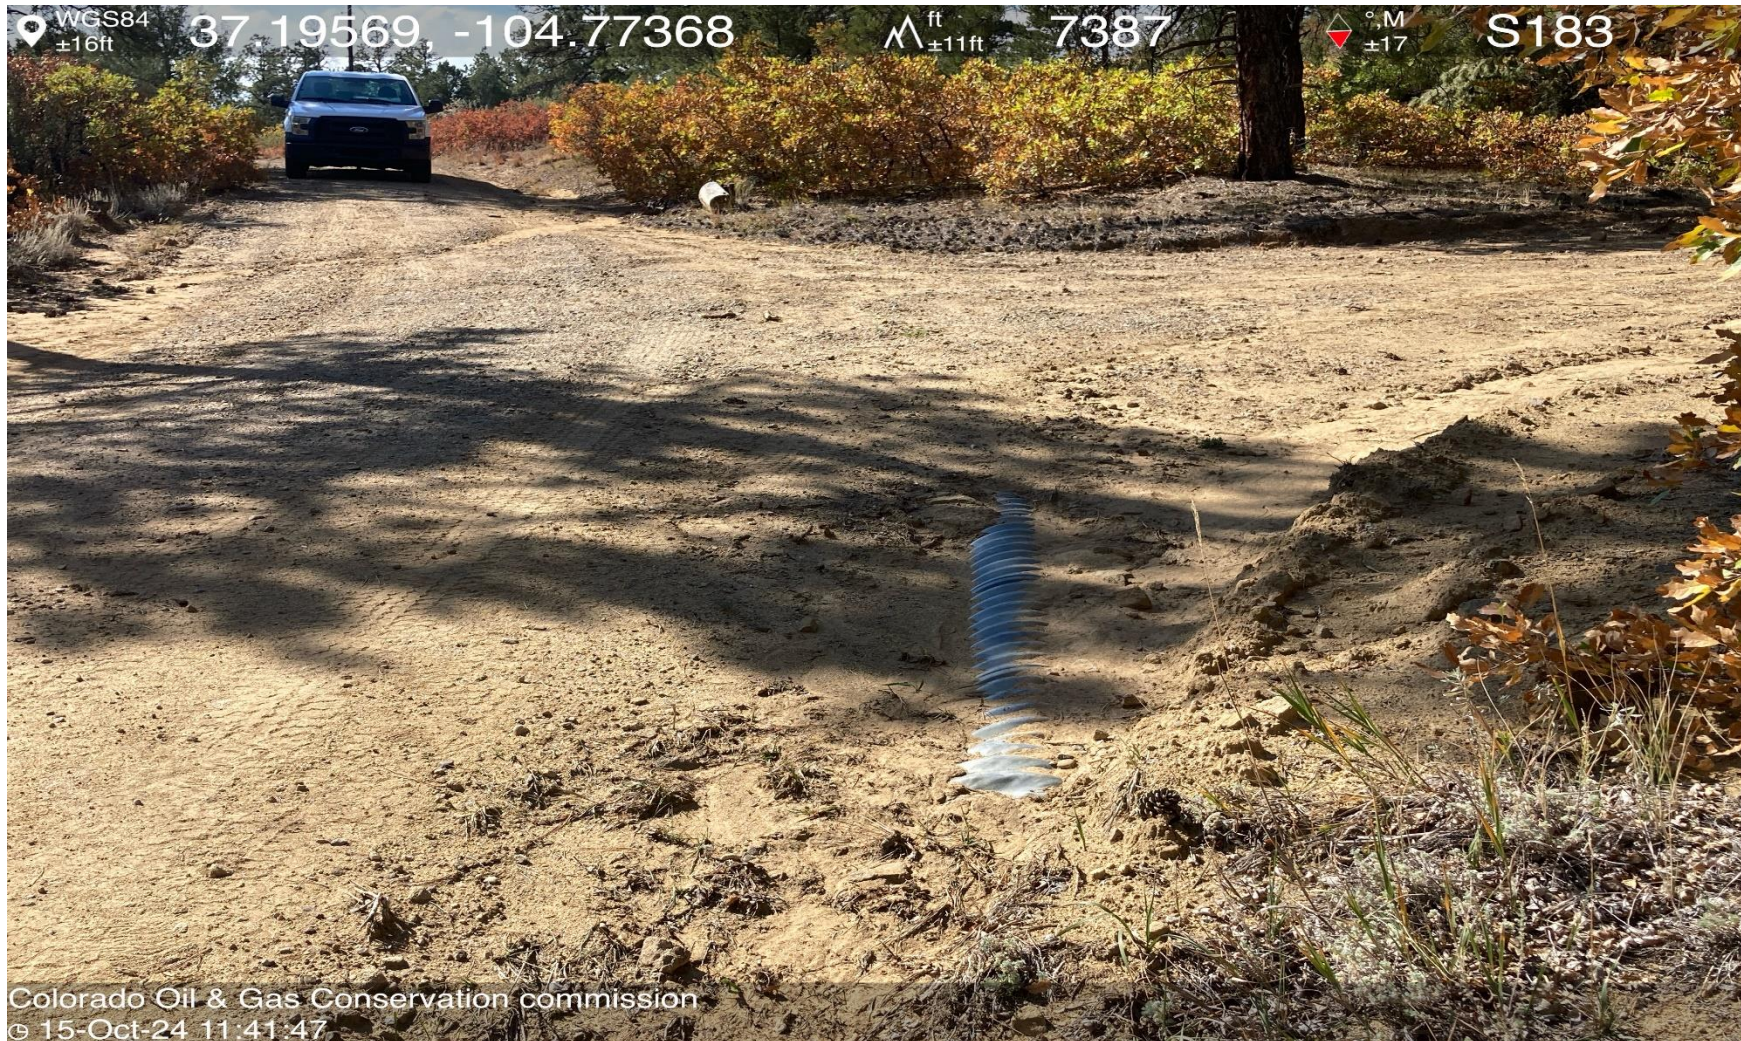
**PHOTO 6: IMAGE OF CULVERT FROM THE OTHER SIDE OF INTERSECTION. CLEAN AND MAINTAIN ALL CULVERTS PER RULE 1002. CA DATE 11/15/2024.**

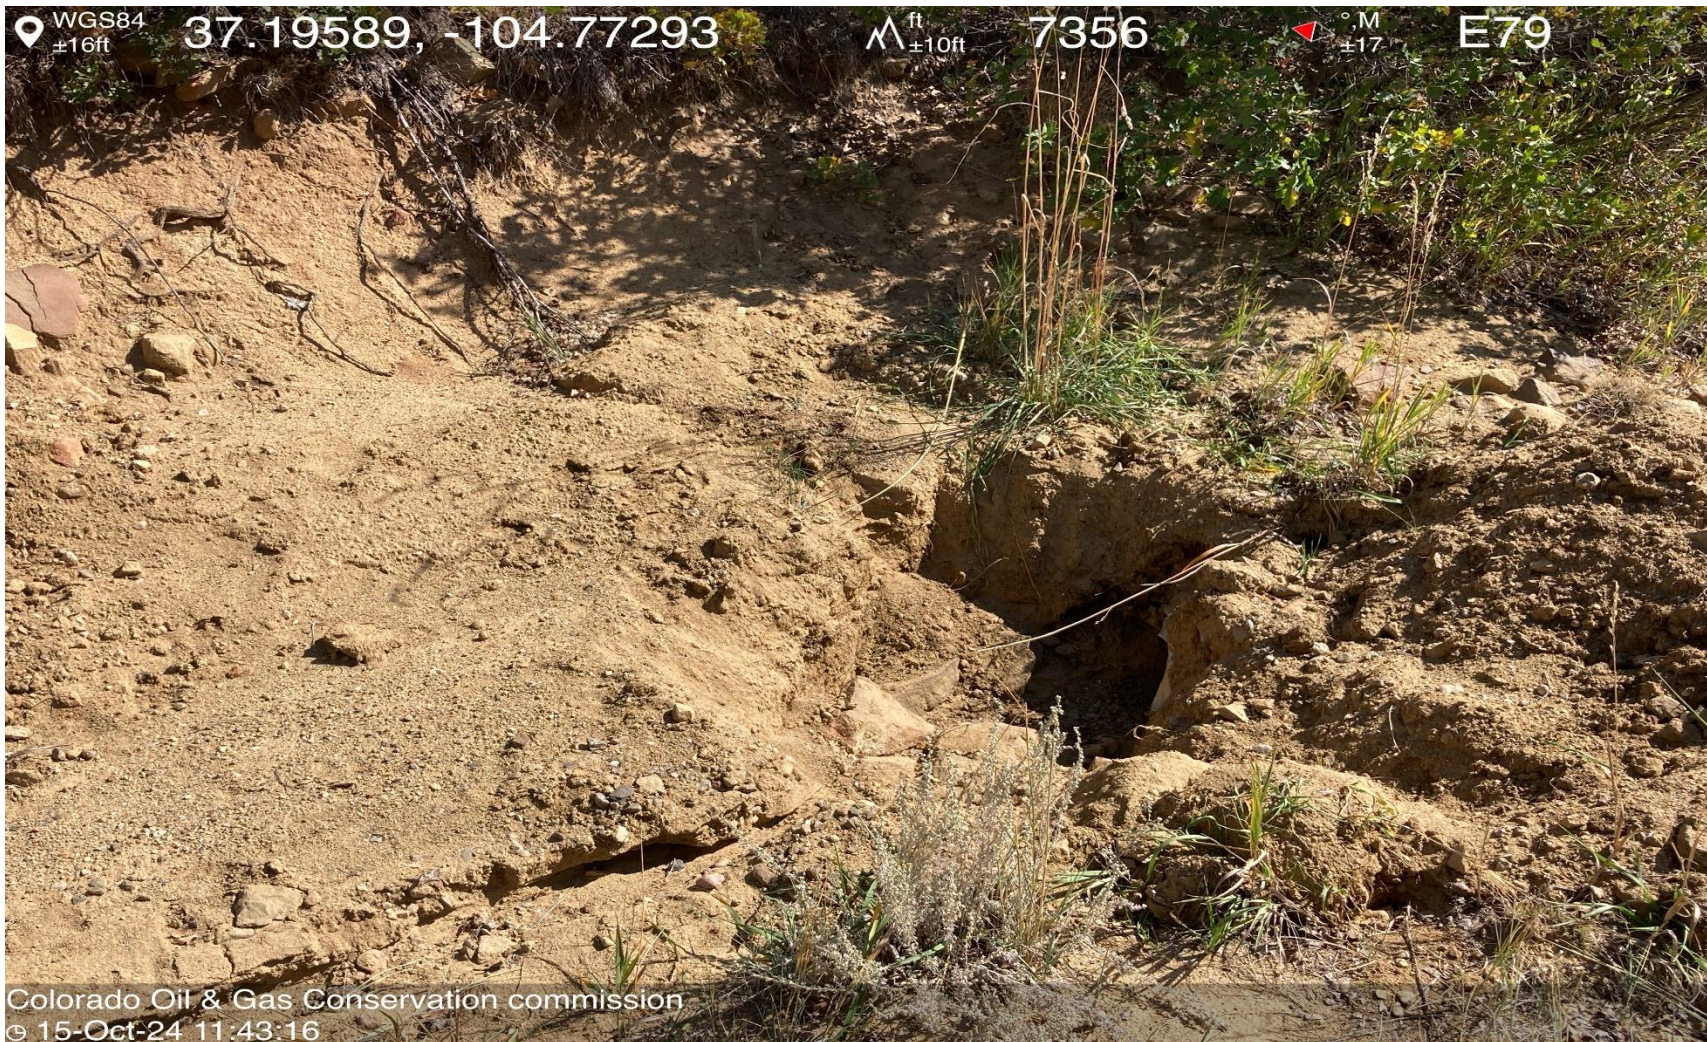
**PHOTO 7: NEXT CULVERT DOWN THE HILL WAS NOT CLEANED ADDIQUATELY. CLEAN AND MAINTAIN ALL CULVERTS PER RULE 1002. CA DATE 11/15/2024.**
