1876 RESOURCES HAILEY 342

OPERATOR: 1876 RESOURCES FORMER CUB CREEK

LOCATION: HAILEY 342 318870 + DRAINAGE

SPILL ID: 485972

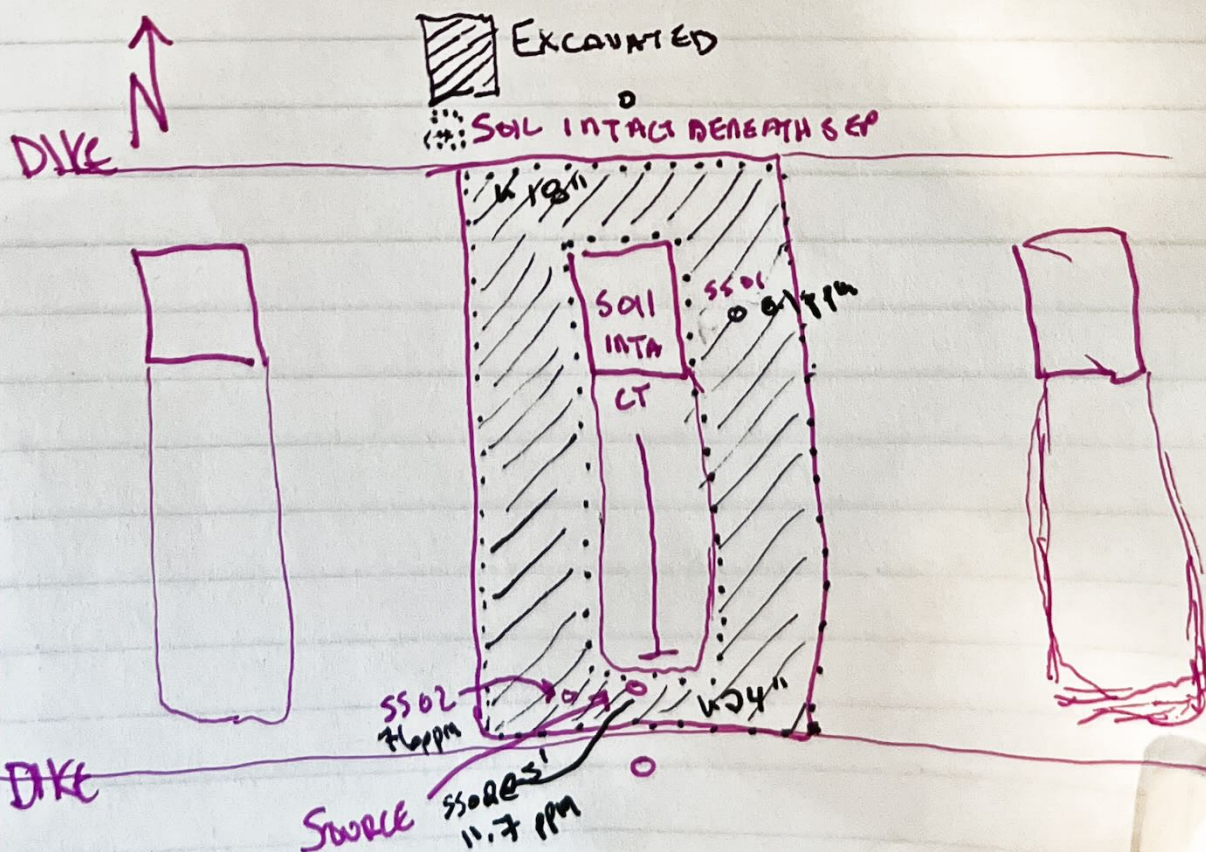
STAINED SOIL VISIBLE BENEATH SEP. SKID

DISCUSSED NEED FOR SCREENING +
SAMPLING ALONG SIDEWALLS

DISCUSSED PAD SAMPLES OUTSIDE OF
CONTAINMENT IF CLEAR (NO DETECTABLE
ORGANICS) COULD BE USED AS BG. TO
CLEAR METALS + SS.

PLAN TO HAND DIG @ SS02 @ 5' TO DEFINE THE
EXTENT + GET LOWER PID.

NEED TO OVER EXCAVATE SS02 @ 2'
