# Interim Reclamation and Stormwater Inspection

Location ID: 464916

Location Name: Dottie Doris/11,12-34

Inspection Document #: 718600090

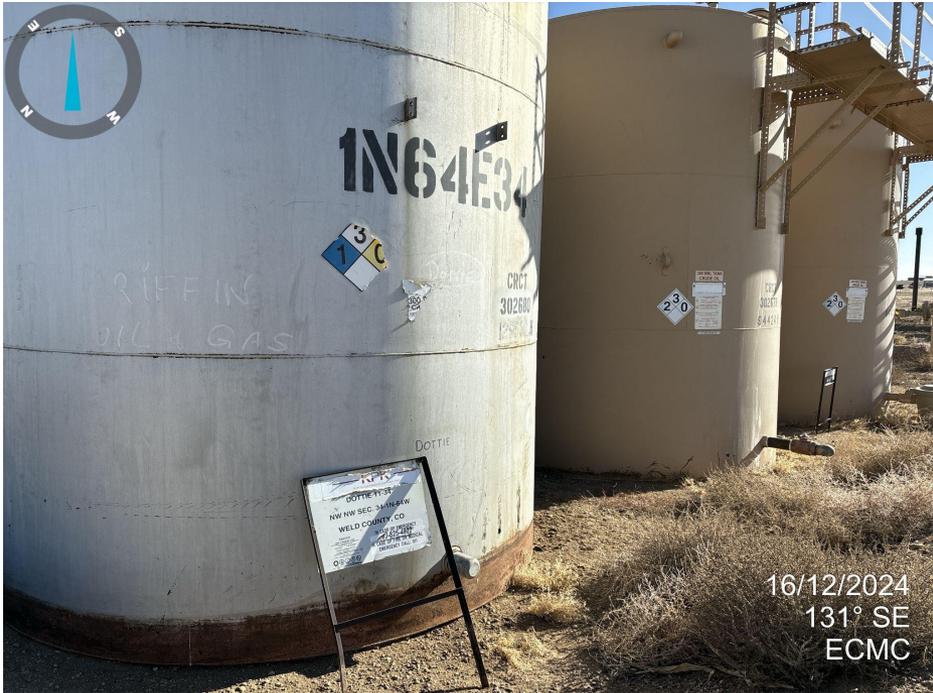
**Photo 1.** Photo taken from the north side of tank battery. Sign reads DOTTIE 11-33.

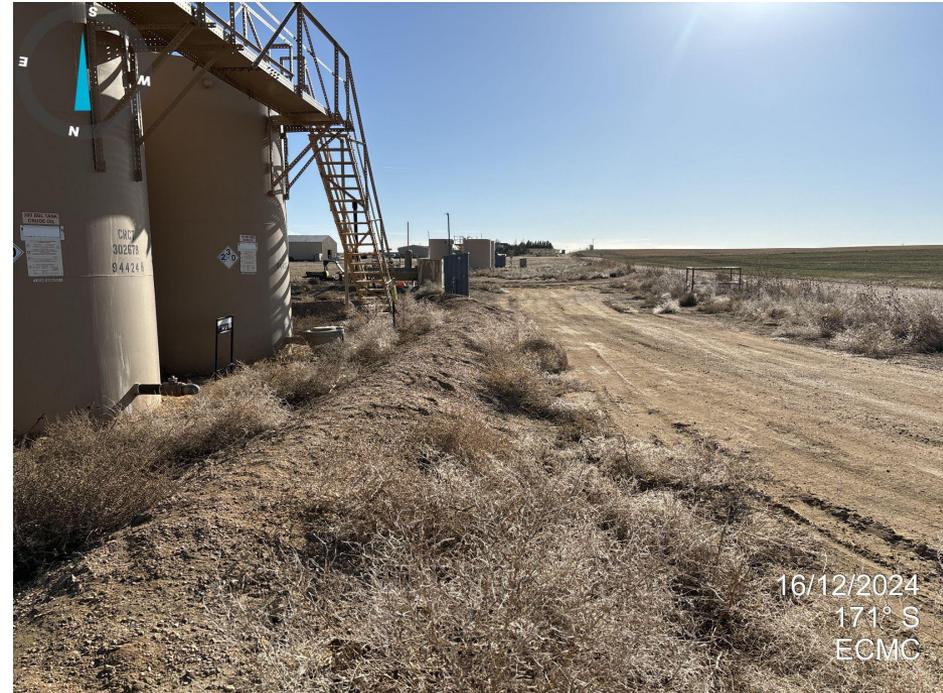
**Photo 2.** Looking south across tank battery. Undesirable annual vegetation is present throughout the location including Kochia and Russian thistle. This tank battery area is shared with Doris 12-34 (Loc 318979)

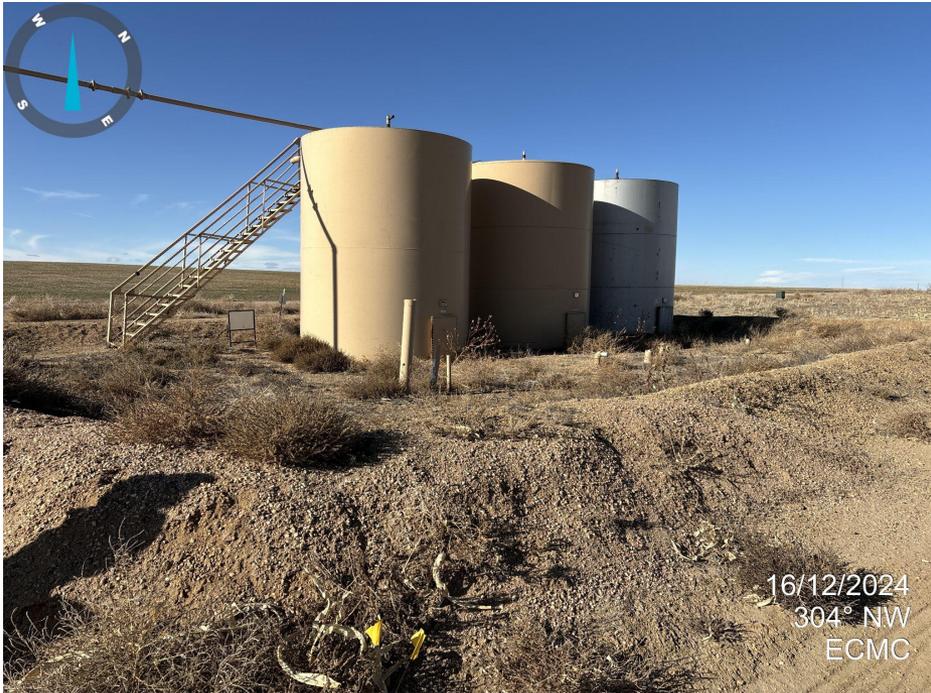
**Photo 3.** Picture taken east of tank battery looking west. Uncapped pipes and trash are present on location.

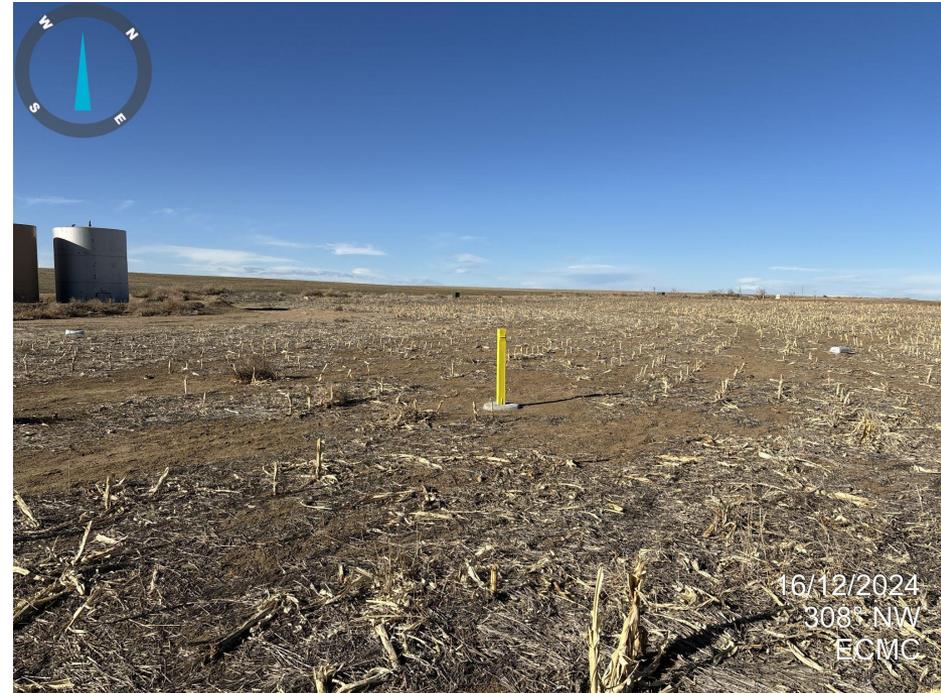
**Photo 4.** Photo taken from east of tank battery looking northwest. Groundwater monitoring wells are present in this area.
