Storm Water Management and Erosion control
Location Name: TEP ROCKY MOUNTAIN LLC WARE SR 23-12 Pad
Location ID: 449385

Location Overview: Location is within Black Bear Habitat area & in close proximity to High Priority/NSO Habitat areas. Location is within Rule 411a Surface Water Internal & Intermediate Buffers.
Location is approximately 343 yards from Beaver Creek.
Section/Township/Range: 12 7S94W

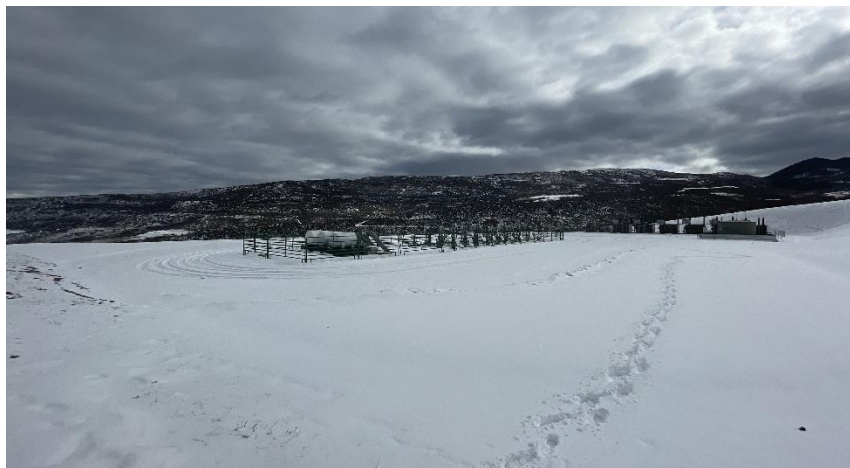
North West corner of location.

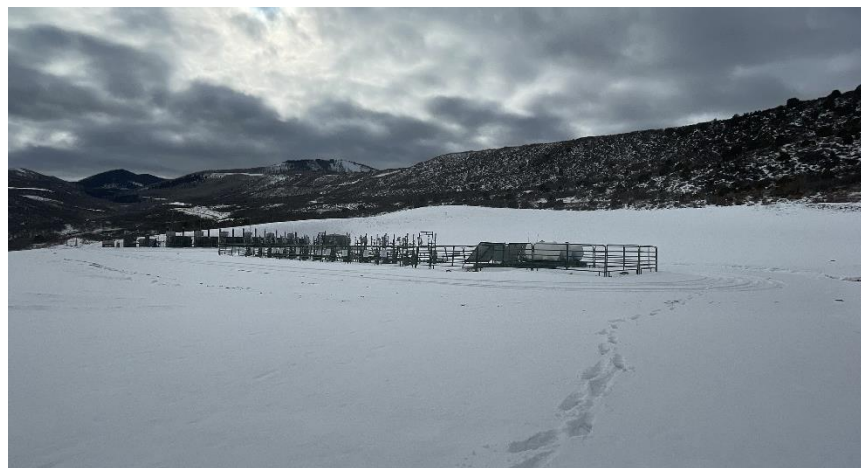
North East corner of location.

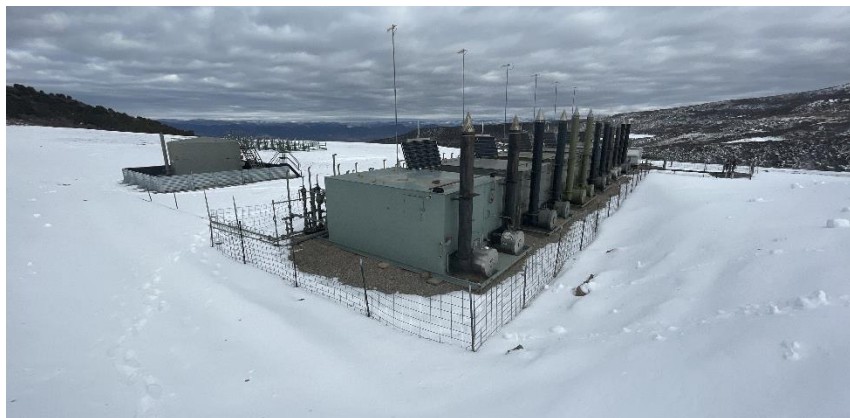
South West corner of location.

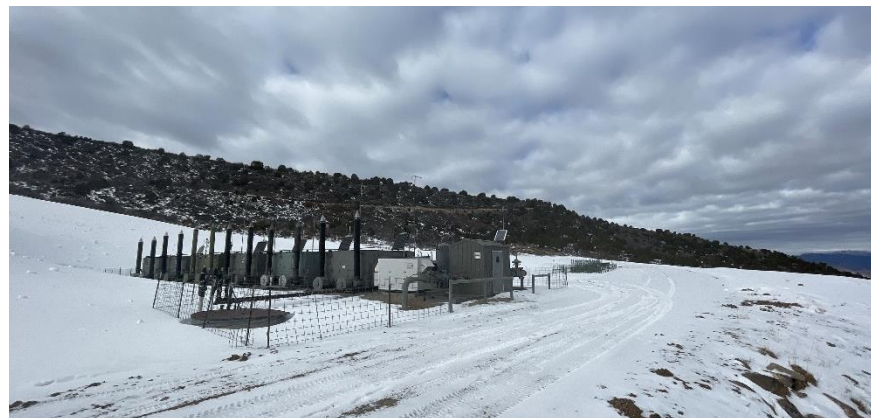
South East corner of location.

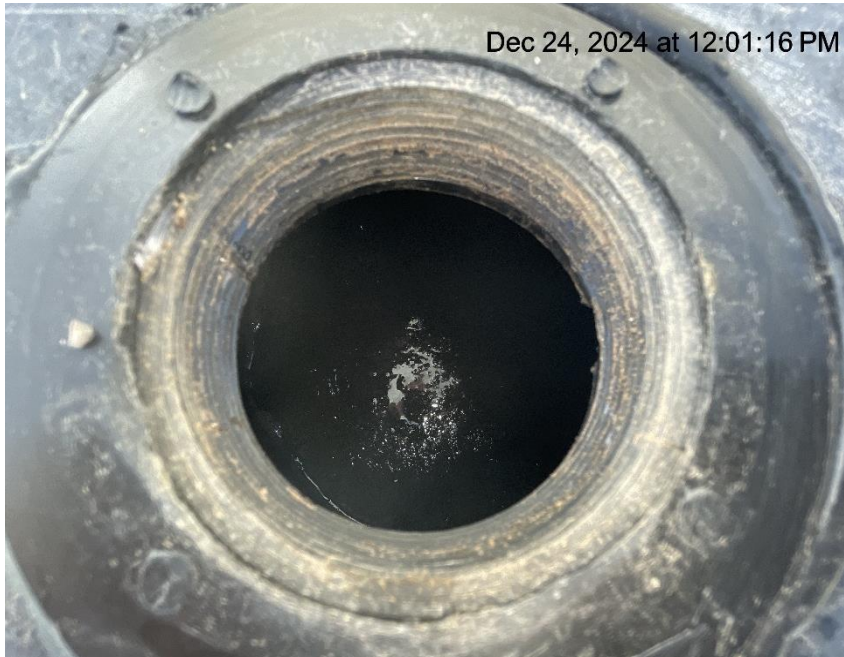
Photo # 5281 From inspection 708905317 conducted on 12/24/2024 Failure to maintain chemical BMP – Chemical tank containment approximately 2/3 to 3/4 full of fluid/BMP insufficient to contain possible spill

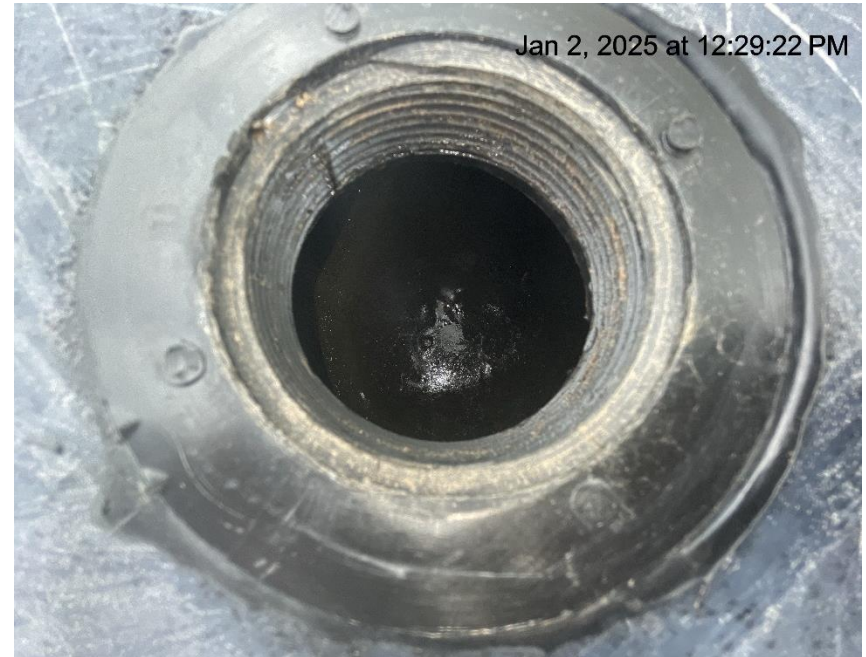
Photo # 6501 Failure to maintain chemical BMP – Chemical tank containment approximately 2/3 to 3/4 full of fluid/BMP insufficient to contain possible spill

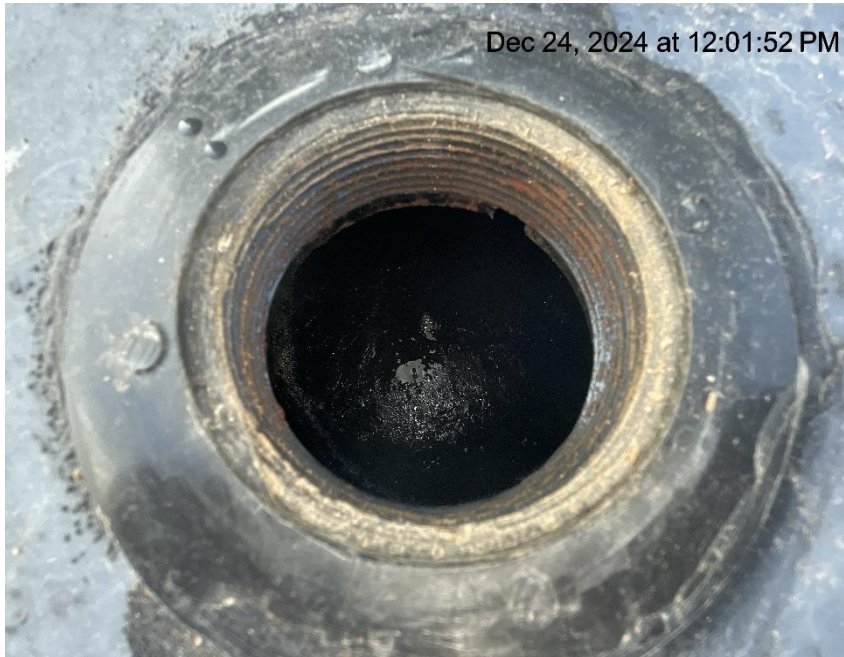
Photo # 5282 From inspection 708905317 conducted on 12/24/2024 Failure to maintain chemical BMP – Chemical tank containment approximately 2/3 to 3/4 full of fluid/BMP insufficient to contain possible spill

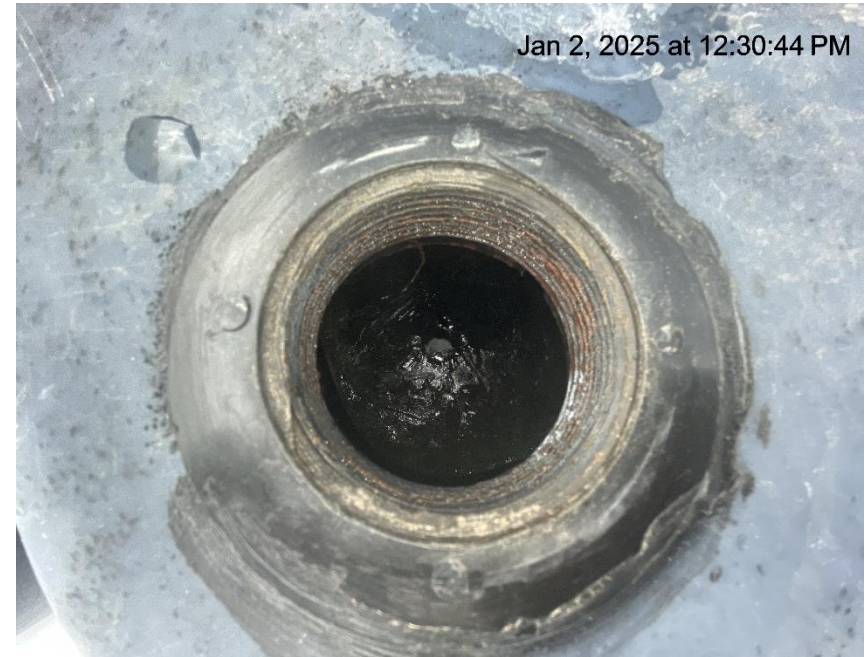
Photo # 6502 Failure to maintain chemical BMP – Chemical tank containment approximately 2/3 to 3/4 full of fluid/BMP insufficient to contain possible spill

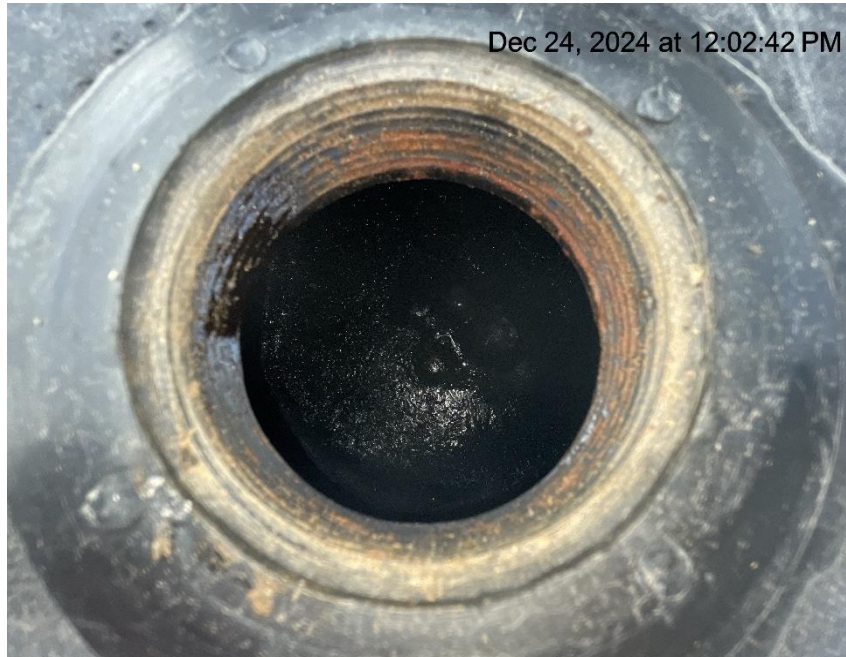
Photo # 5283 From inspection 708905317 conducted on 12/24/2024 Failure to maintain chemical BMP – Chemical tank containment approximately 2/3 to 3/4 full of fluid/BMP insufficient to contain possible spill

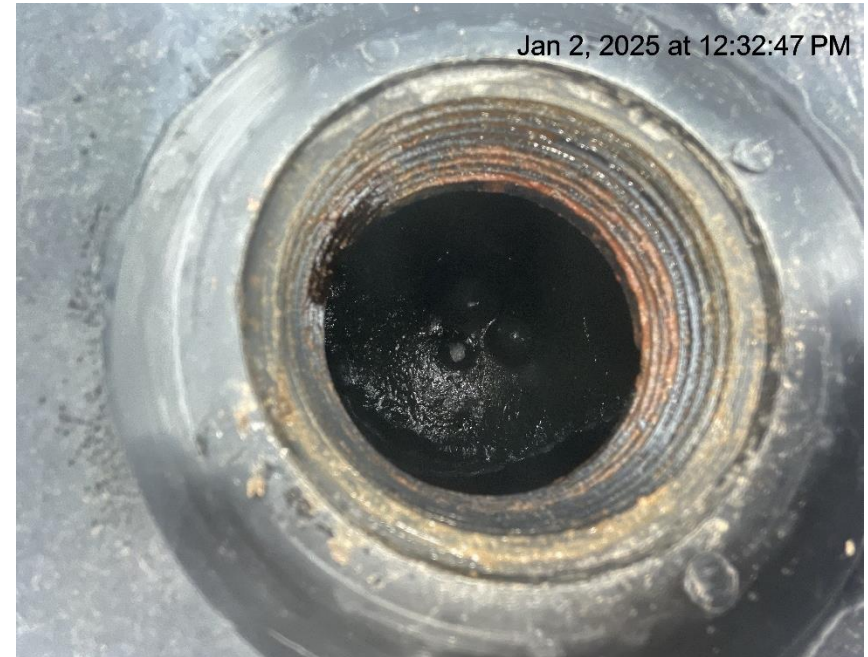
Photo # 6503 Failure to maintain chemical BMP – Chemical tank containment approximately 2/3 to 3/4 full of fluid/BMP insufficient to contain possible spill
