Final Reclamation and Stormwater Inspection

Location ID: 376661

Well Name: COLORADO HORTH #1

Inspection Document #: 718600127

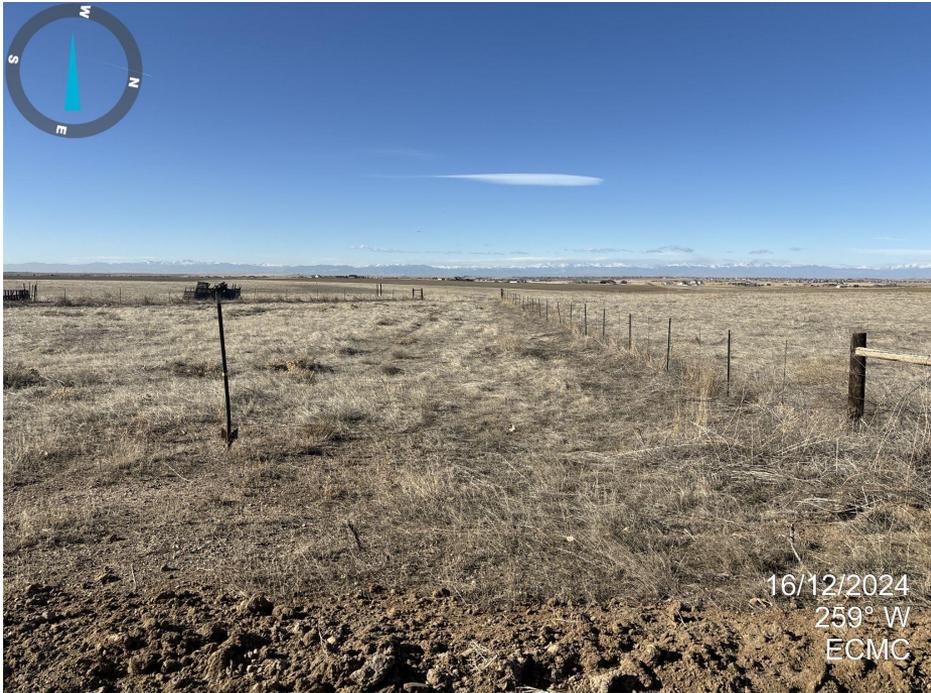
Photo 1. Photo taken looking west along access road. Road has not been recontoured. Gravel remains on access road and location. Undesirable annual plant species are present (Kochia, Cheatgrass).

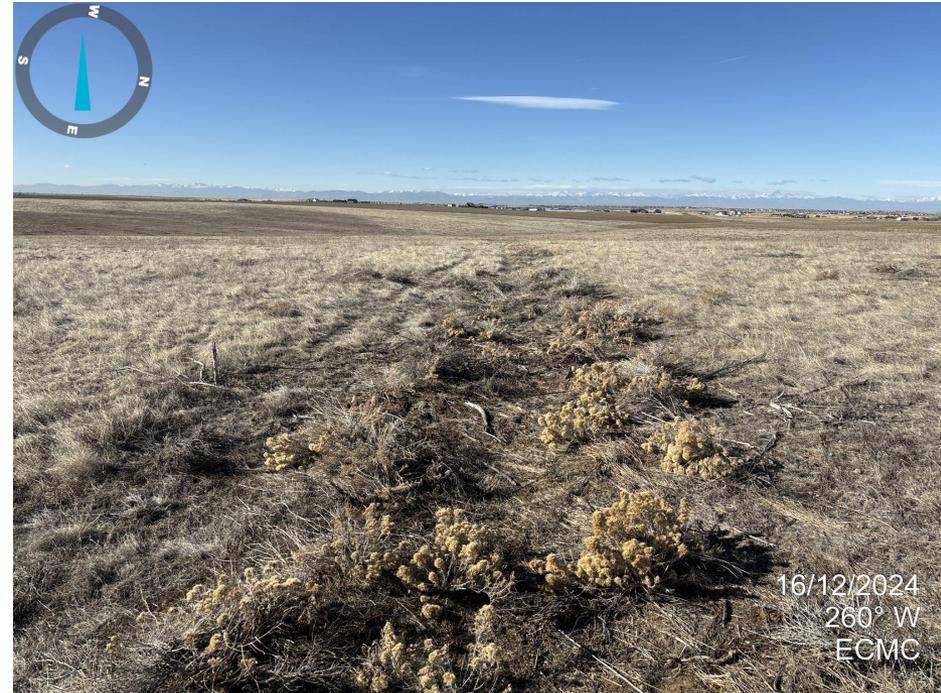
Photo 2. Midpoint of access road looking west. See Photo 1 comments.

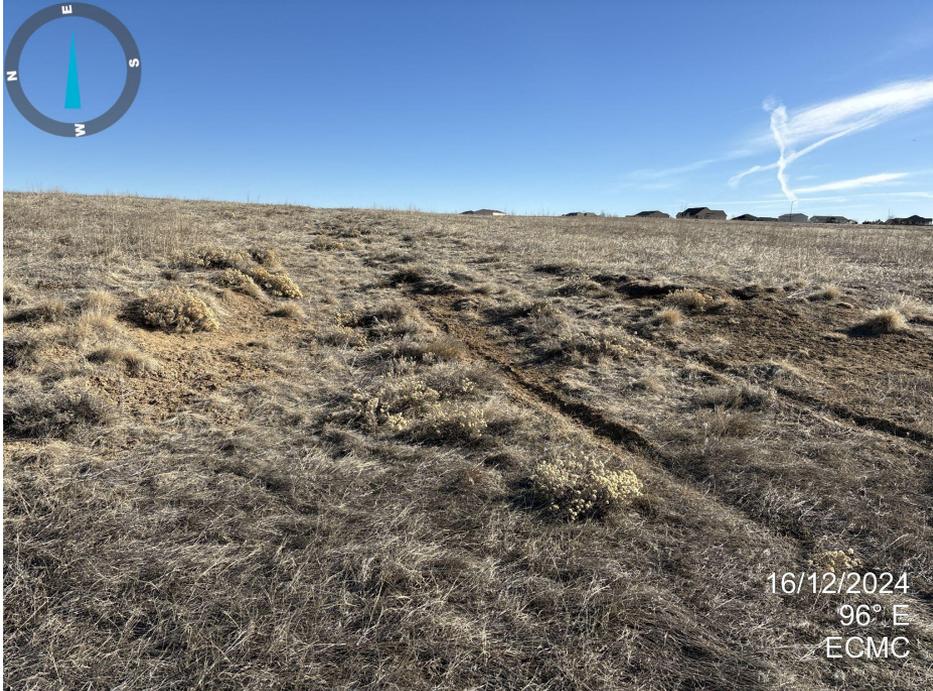
Photo 3. Looking east from well location. Well pad and access road have not been recontoured. Noxious weeds (Cheatgrass, Mullein) are present on location as well as Kochia and Russian thistle.

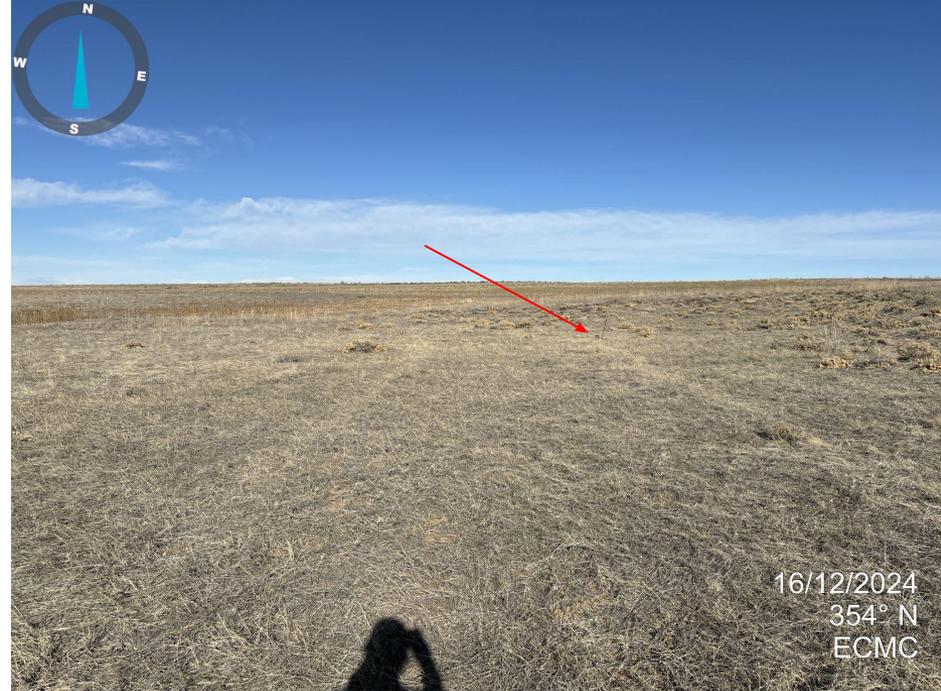
Photo 4. Photo taken from well location looking north. Perimeter guyline anchors remain in place (red arrow). See Photo 3 comments.

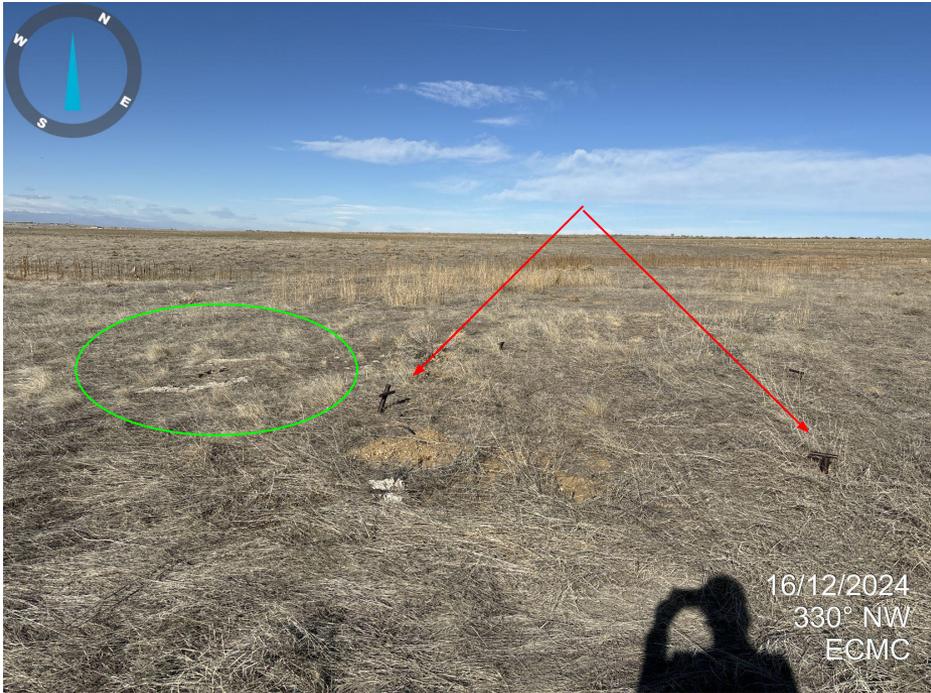
Photo 5. Looking northwest from center of location . Closely spaced anchors (red arrows) and cement (green circle) remain in place.

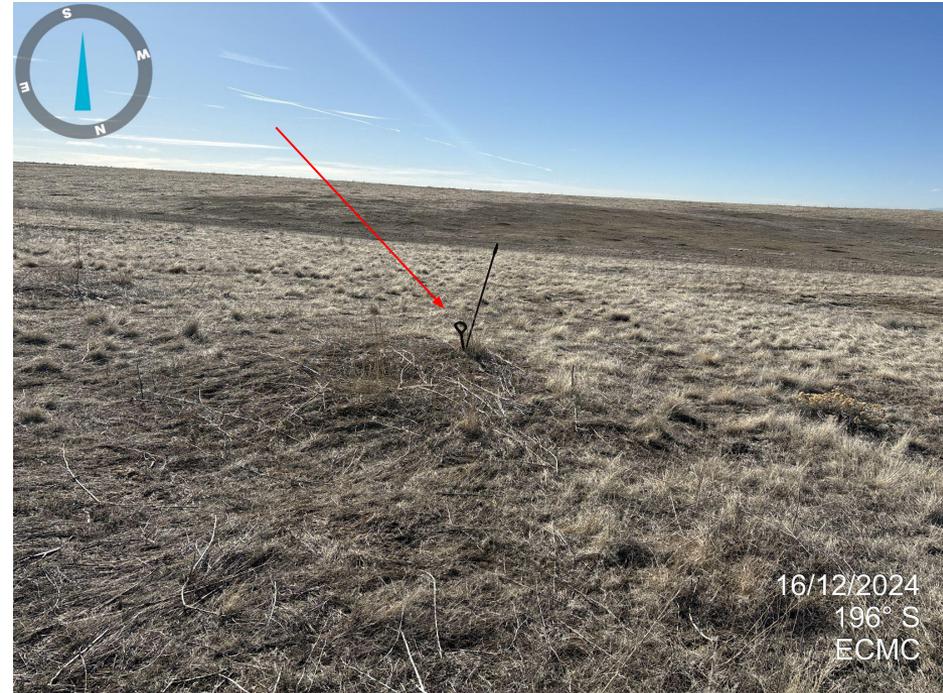
Photo 6. Looking south at southern edge of well location. Guyline anchor remains in place (red arrow).
