Final Reclamation and Stormwater Inspection

Operator: PDC ENERGY INC - 69175

Location ID: 331006

Inspection Photos
Location Name: Hankins-65N67W
Location ID: 331006

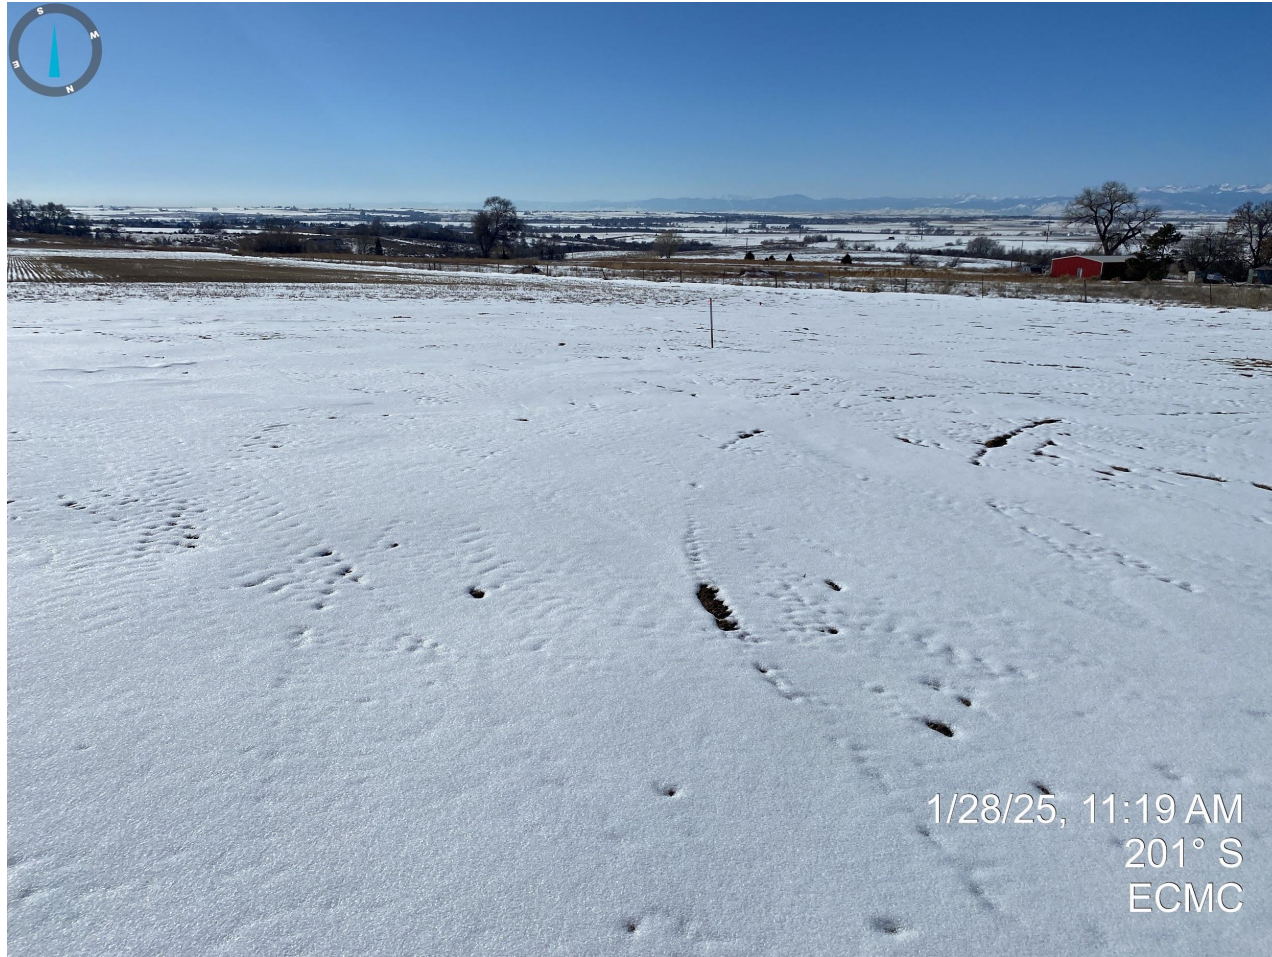
Photo 1. Facing south near the former meter shed location, south of WCR 54 (Location ID 306751). It appears that the meter sheds previously documented have been removed from the location.

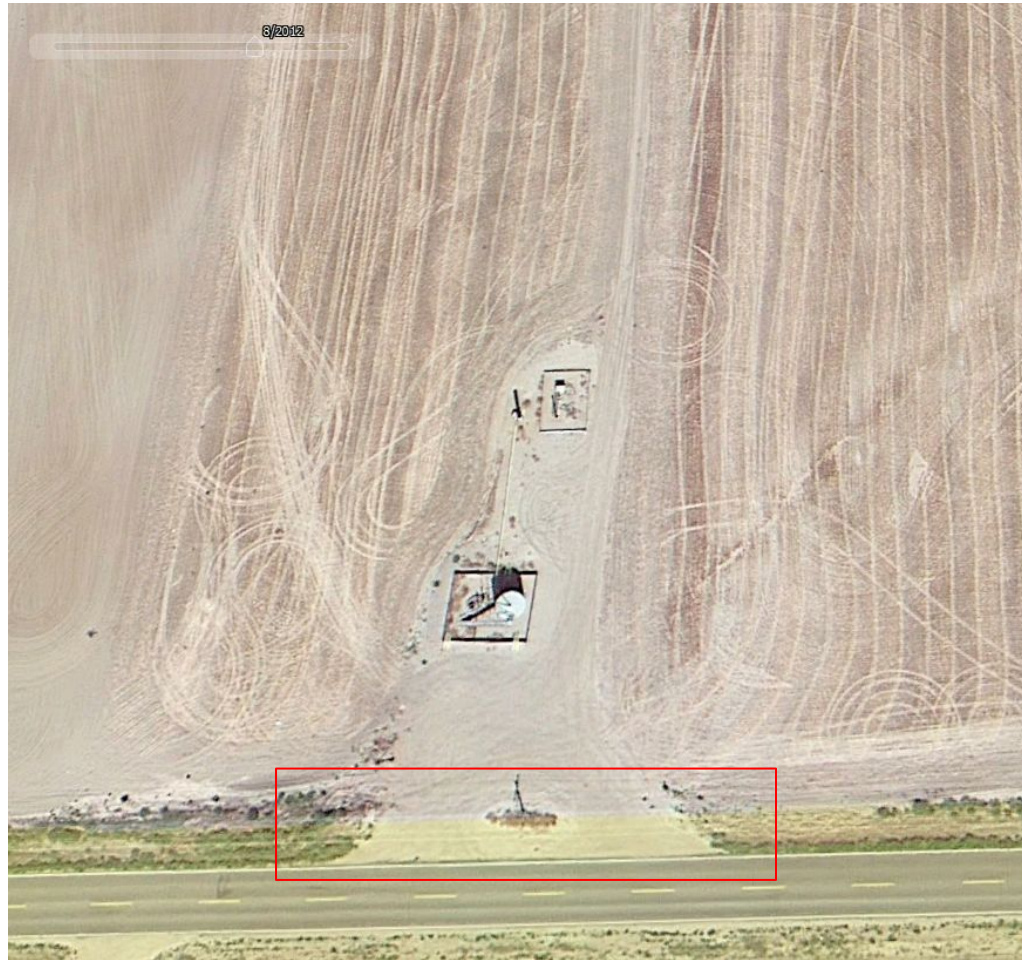
Photo 2. Google Earth aerial imagery (circa 08/2012). Red outline illustrates that the former tank battery had two access points off of WCR54 during active oil and gas operations.

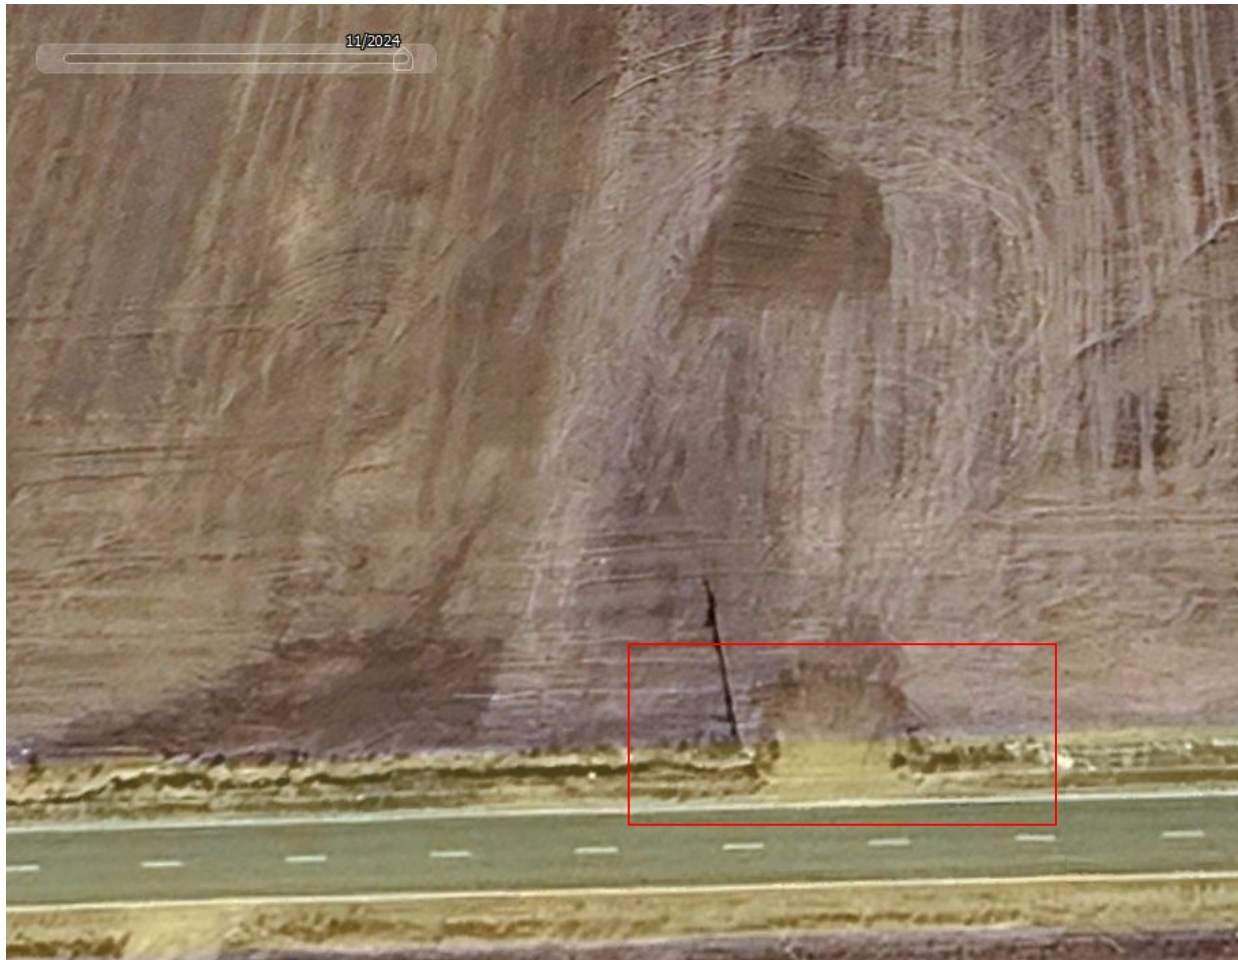
Photo 3. Google Earth aerial imagery (circa 11/2024) illustrating that a portion of the former access point has been reclaimed, but culvert and road base material remain. Additional reclamation activities are required.
