Final Reclamation and Stormwater Inspection

Operator: KERR MCGEE OIL & GAS ONSHORE LP -
47120

Location ID: 306751

Inspection Photos
Location Name: Callen - USX N-65N67W
Location ID: 306751

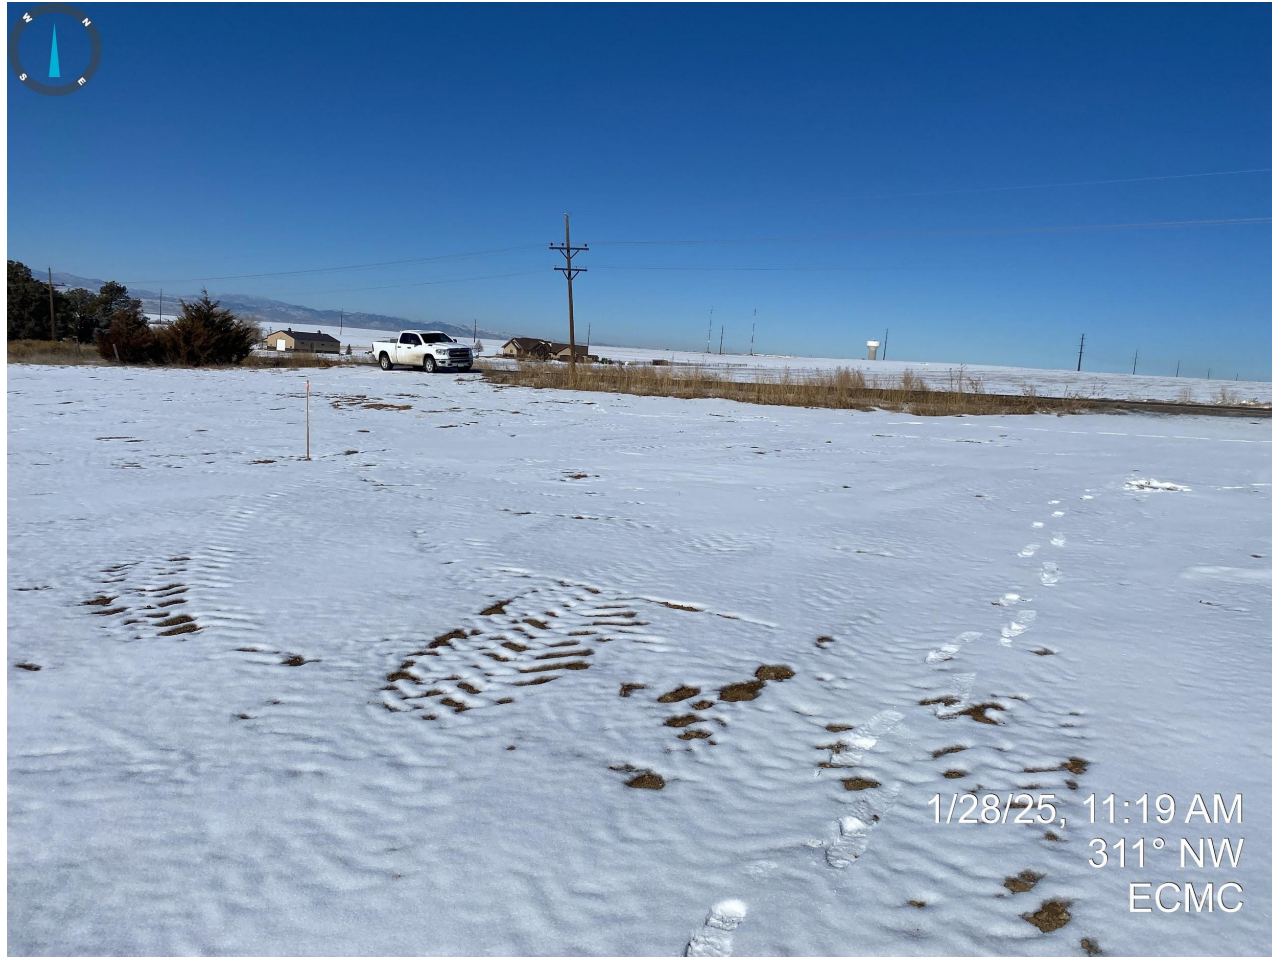
Photo 2. Facing northwest near the former meter shed location. It appears that all meter sheds have been removed from the location.

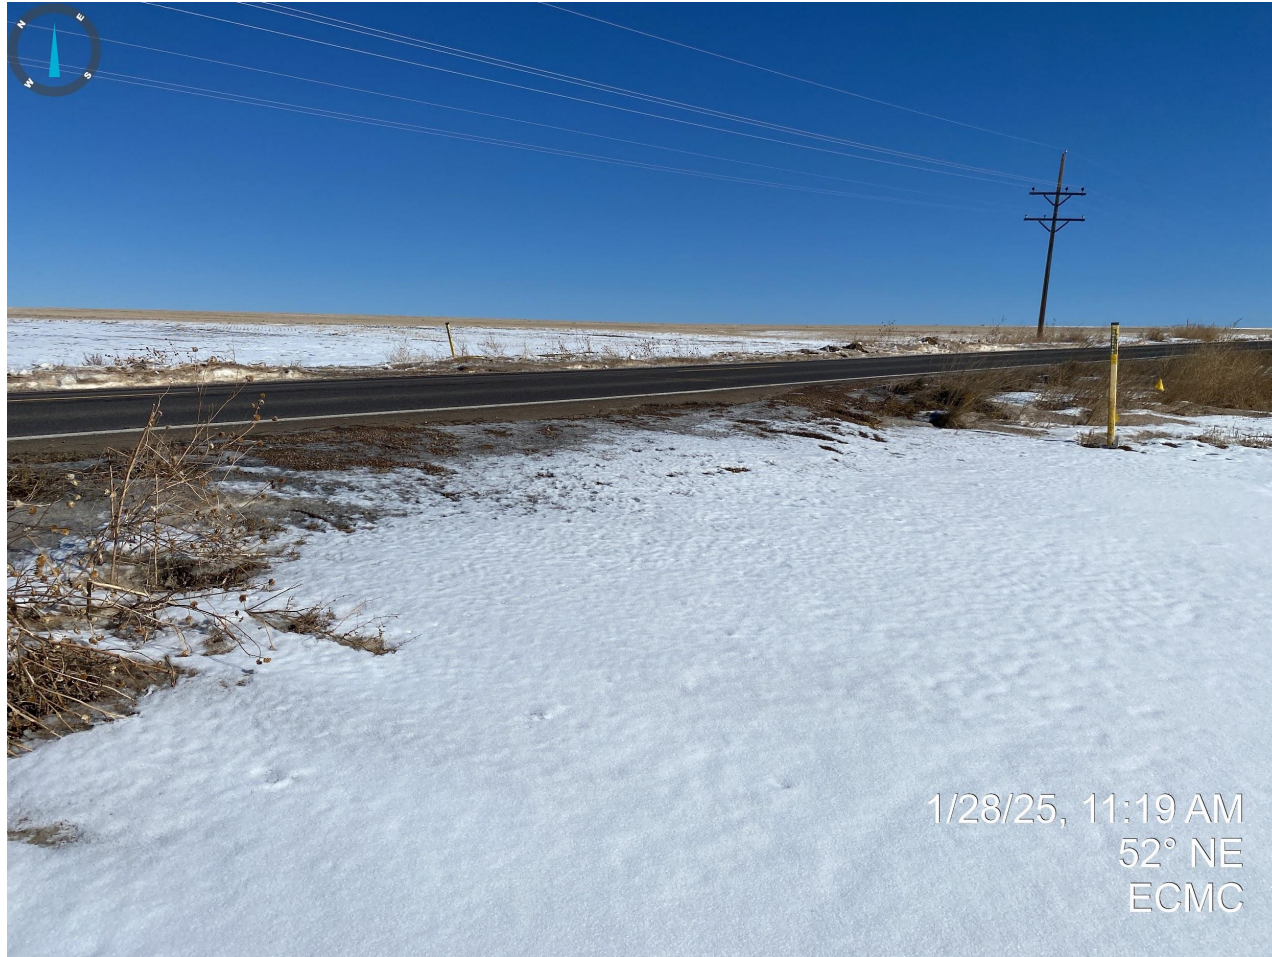
Photo 3. Facing northeast near the eastern tank battery entrance. Road base material and culvert remain.

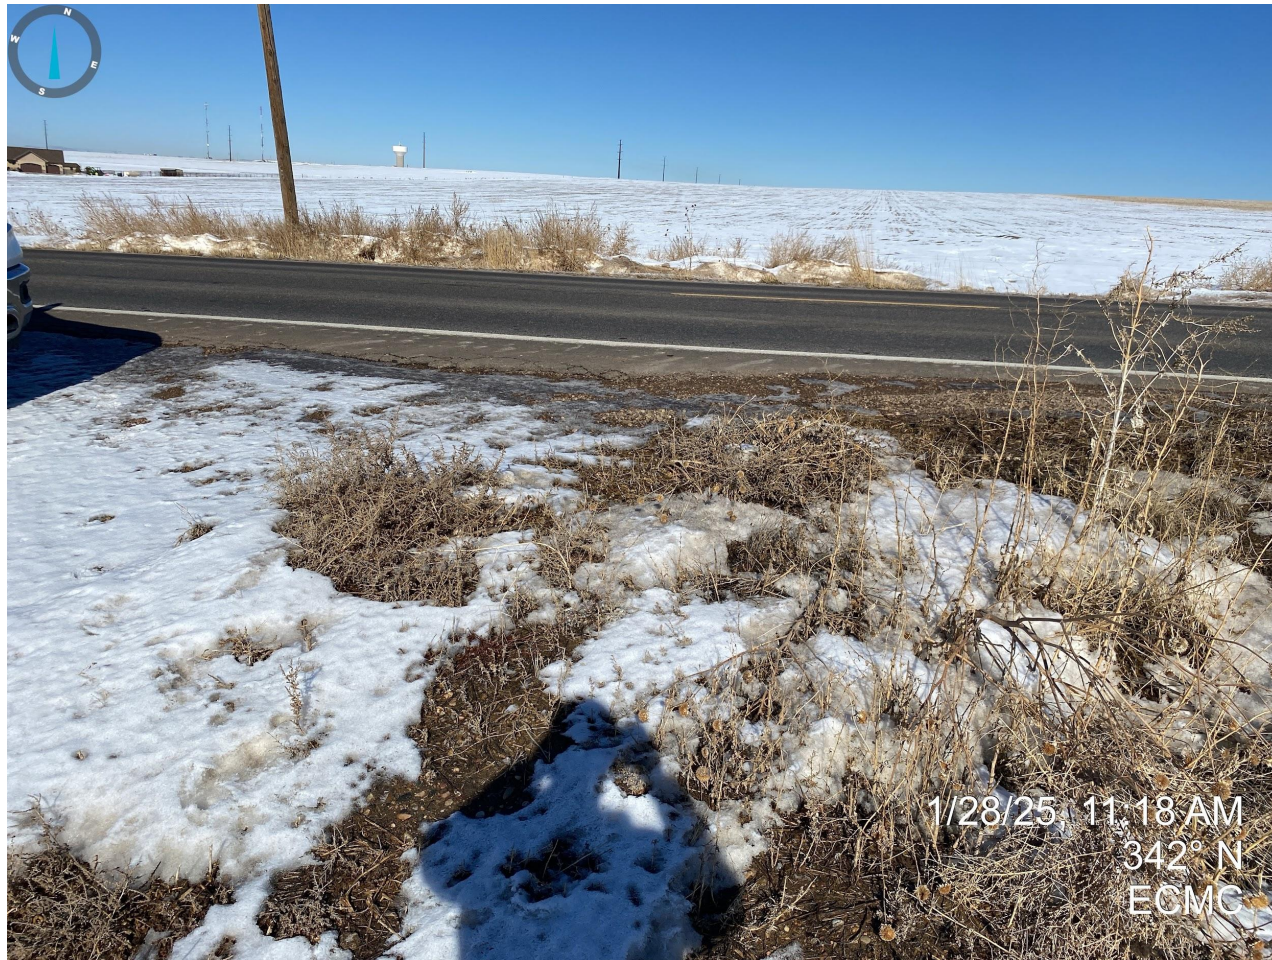
Photo 4. Facing north near the western tank battery entrance. Road base material and culvert remain.

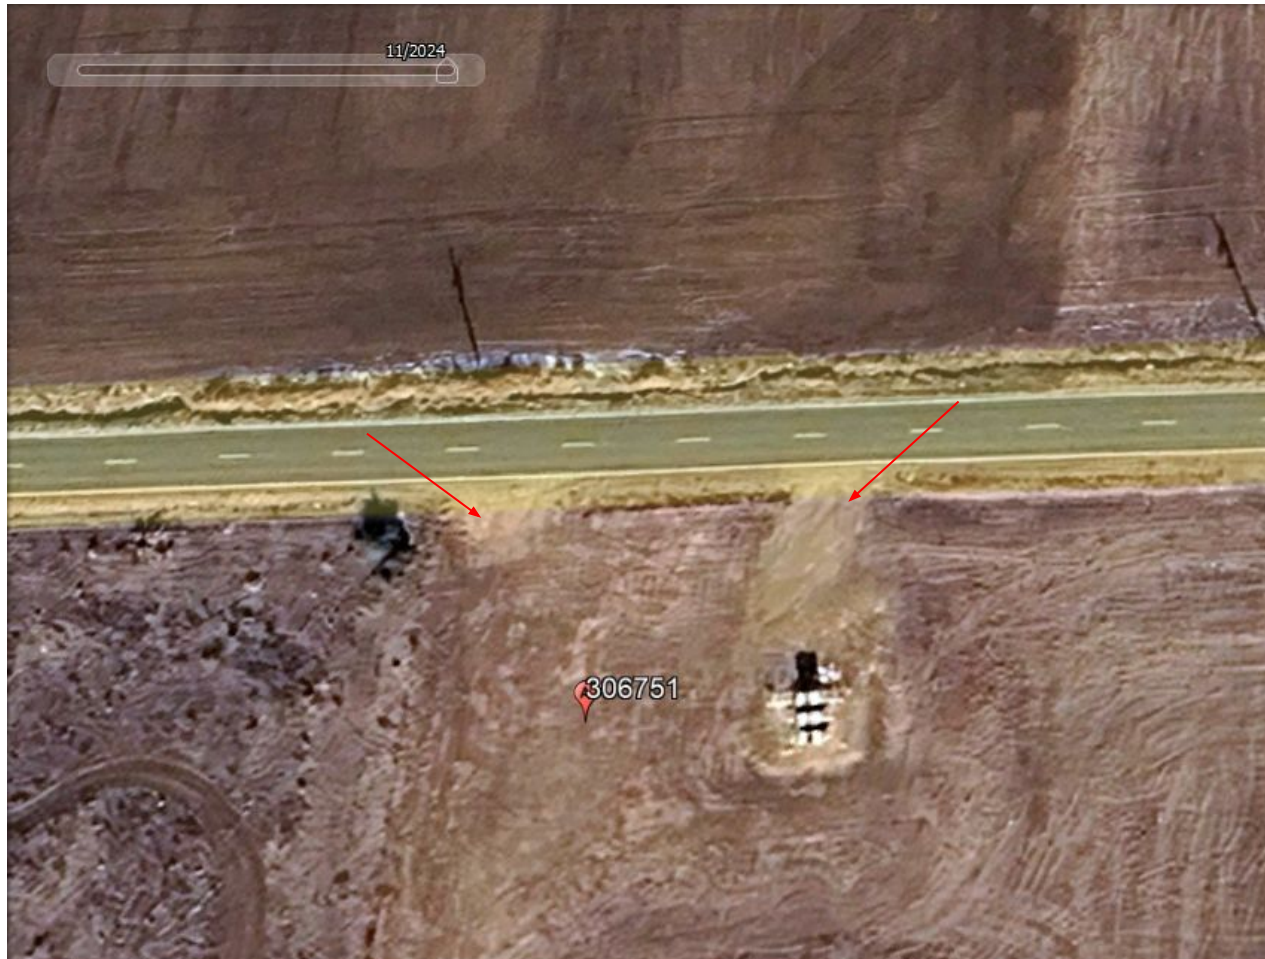
Photo 5. Google Earth aerial imagery (circa 11/2024) illustrating that the two tank battery entrances remain and will require additional reclamation activities. Meter sheds pictured have been removed at the time of this inspection.
