Additional Attachments (Optional)

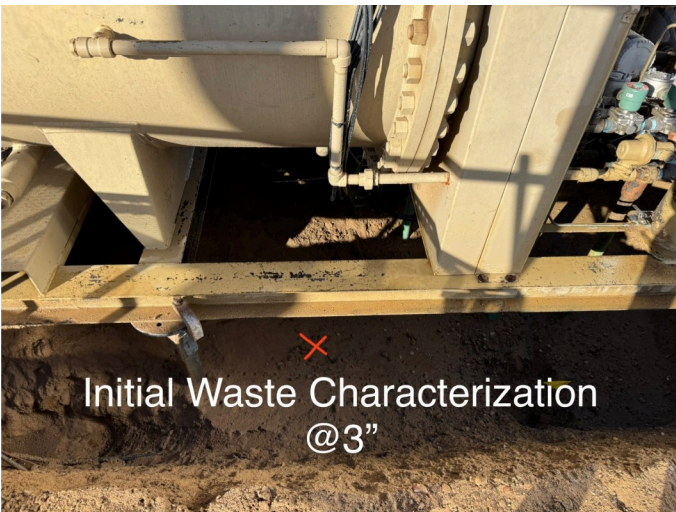
R1 - P1

#	Sample Date	Sample Time	Soil Sample ID	PID Readings	Visual	Olfactory	Equipment Type
R1	01/28/2025	02:10 PM	Initial Waste Characterization@3"	9999	HC Staining	HC Odor	Separator

facing north
