WELL NAME: LORENCITO 7-12, API #: 071-06663, INSP. # 716300417

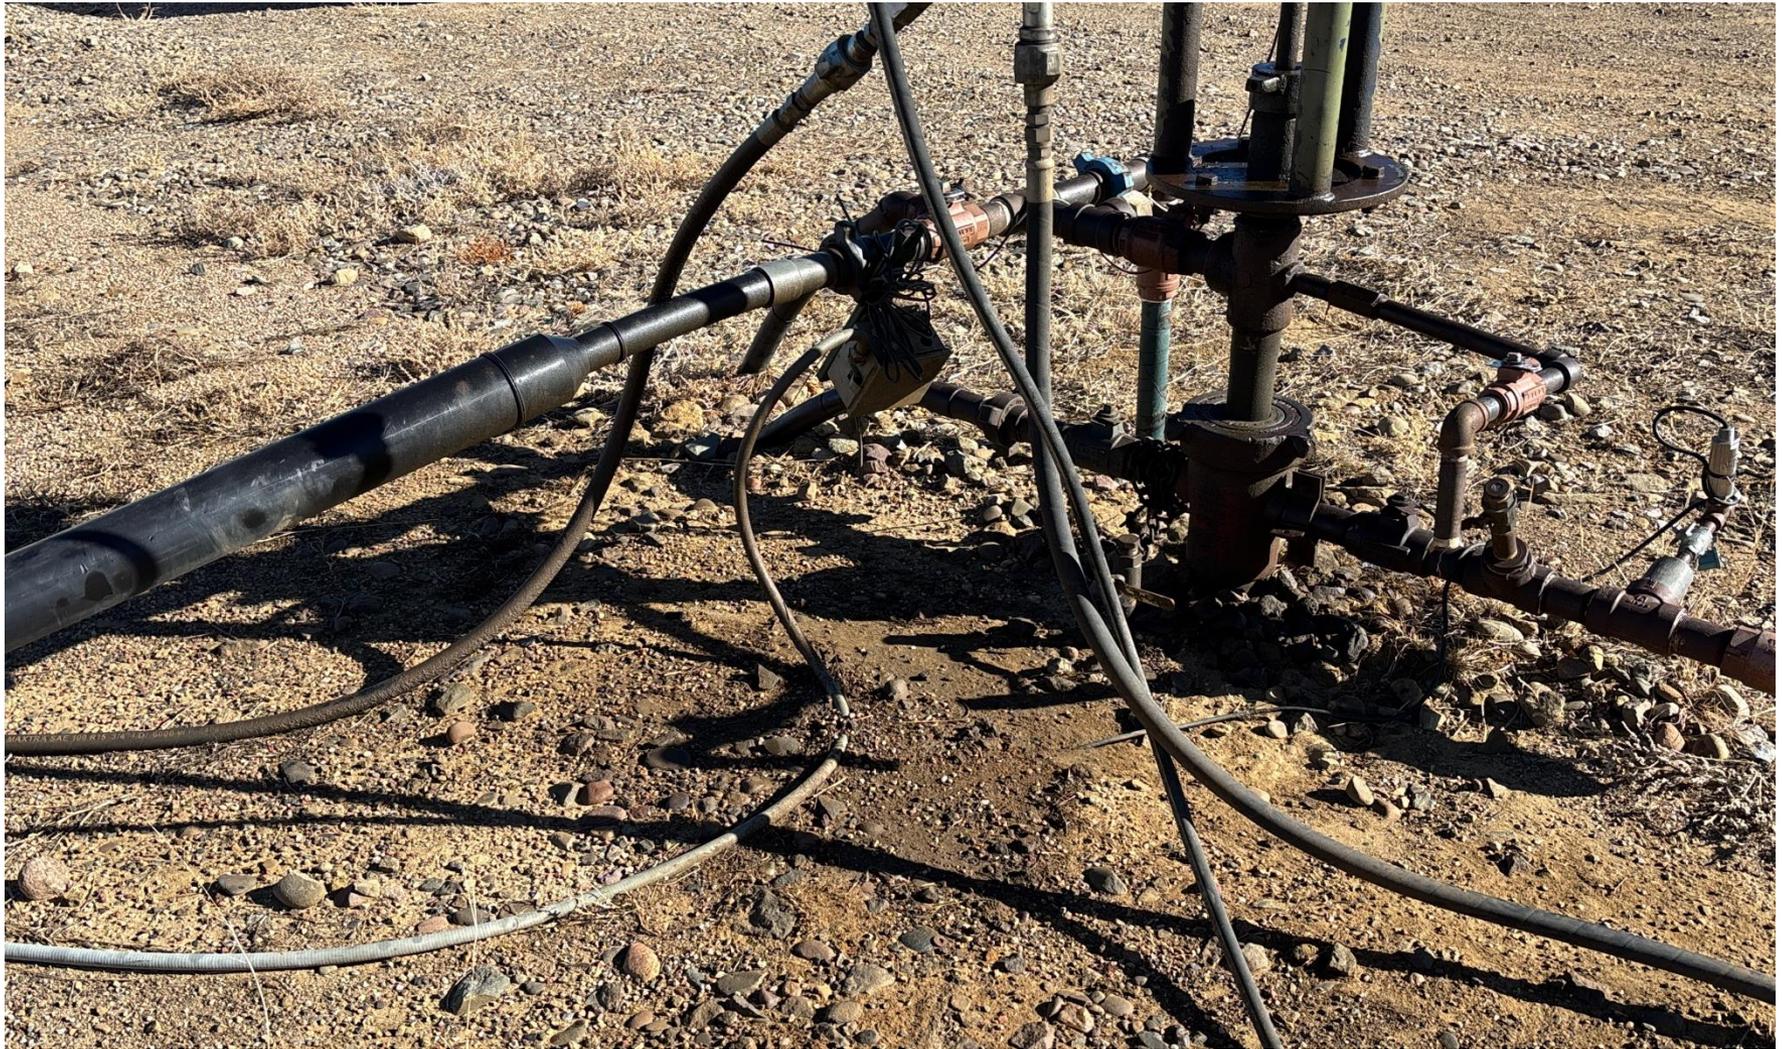
PHOTO 4: AREA OF IMPACTED SOIL AROUND WELLHEAD APPEARS TO BE FROM LEAKING DRIVEHEAD. Conduct maintenance on equipment, cleanup stained material and review self inspection processes. COMPLY WITH RULE 1002,(2).D. CA DATE 1-10-2025.
