WELL NAME: NAPOLEAN 12-10, API #: 071-09043, INSP. # 716300528

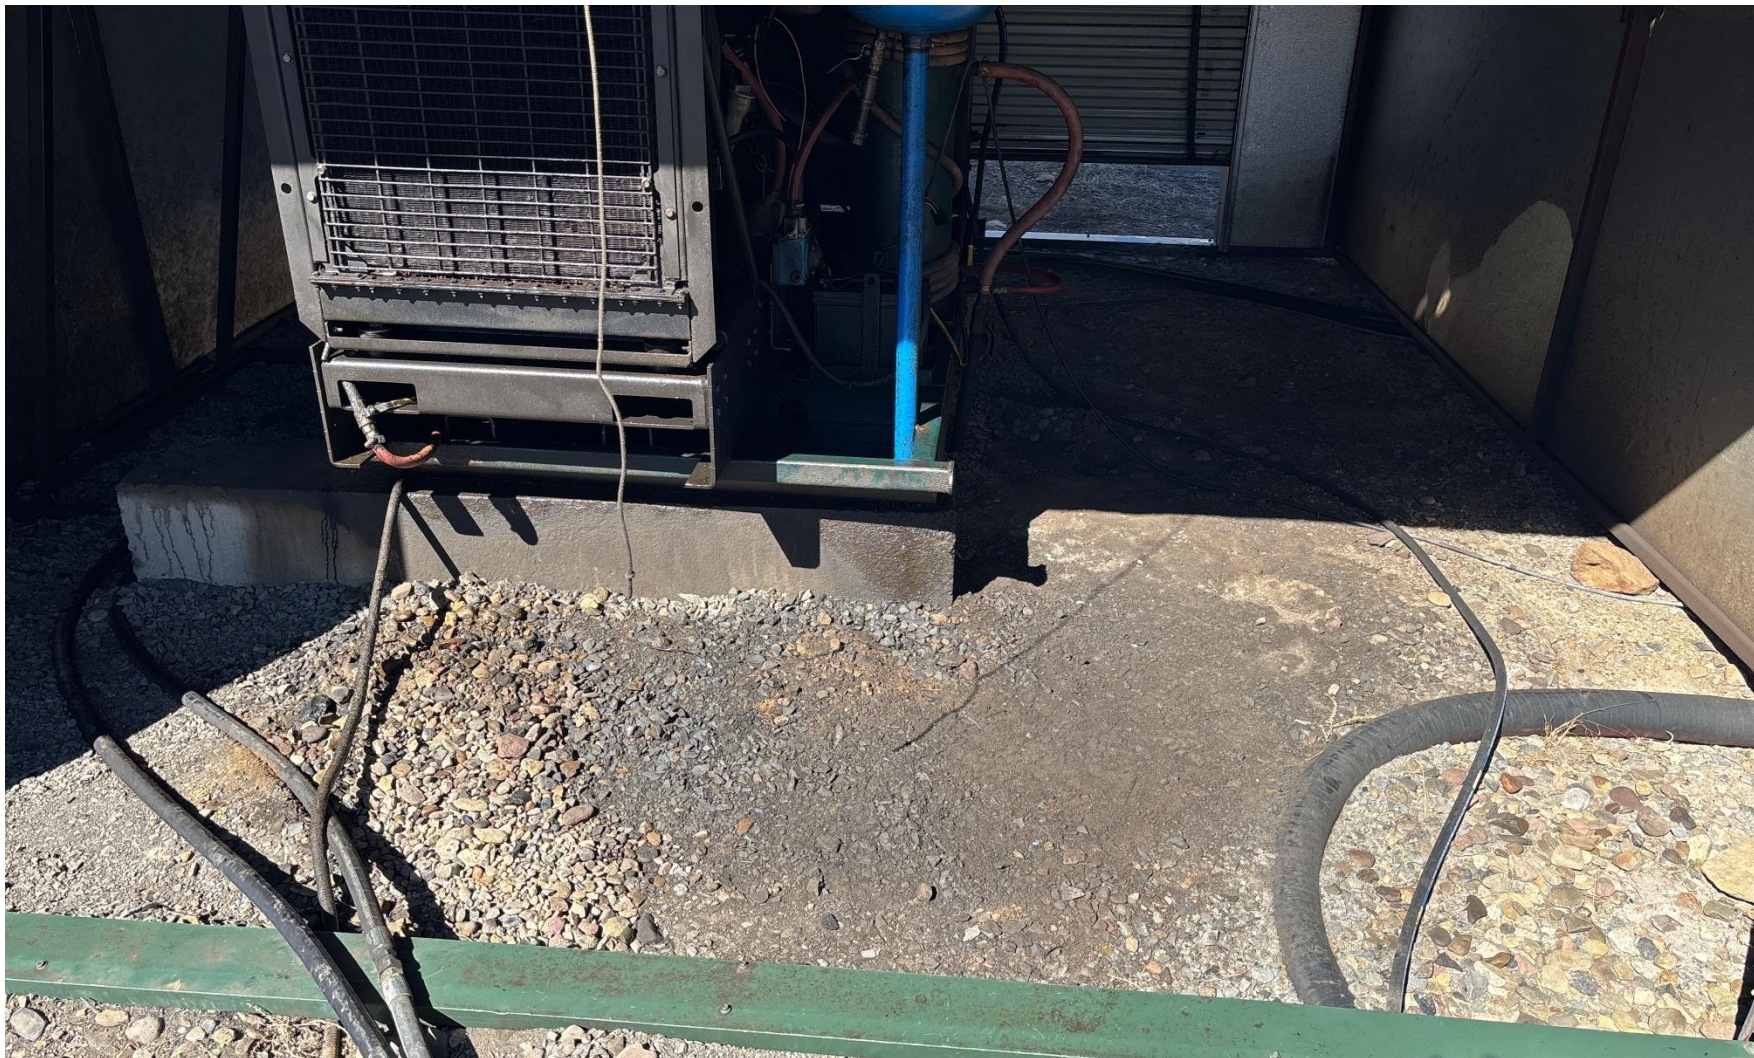
PHOTO 4: LARGE AREA OF IMPACTED SOIL AROUND COMPRESSOR INSIDE AND OUTSIDE OF SOUND MITIGATION SHED. Conduct maintenance on equipment, cleanup stained material and review self inspection processes. COMPLY WITH RULE 1002,(2).D. THIS IS THE SECOND NOTICE FOR THIS CA, IMMEDIATE ACTION IS REQUIRED (REPAIR LEAKING EQUIPMENT).

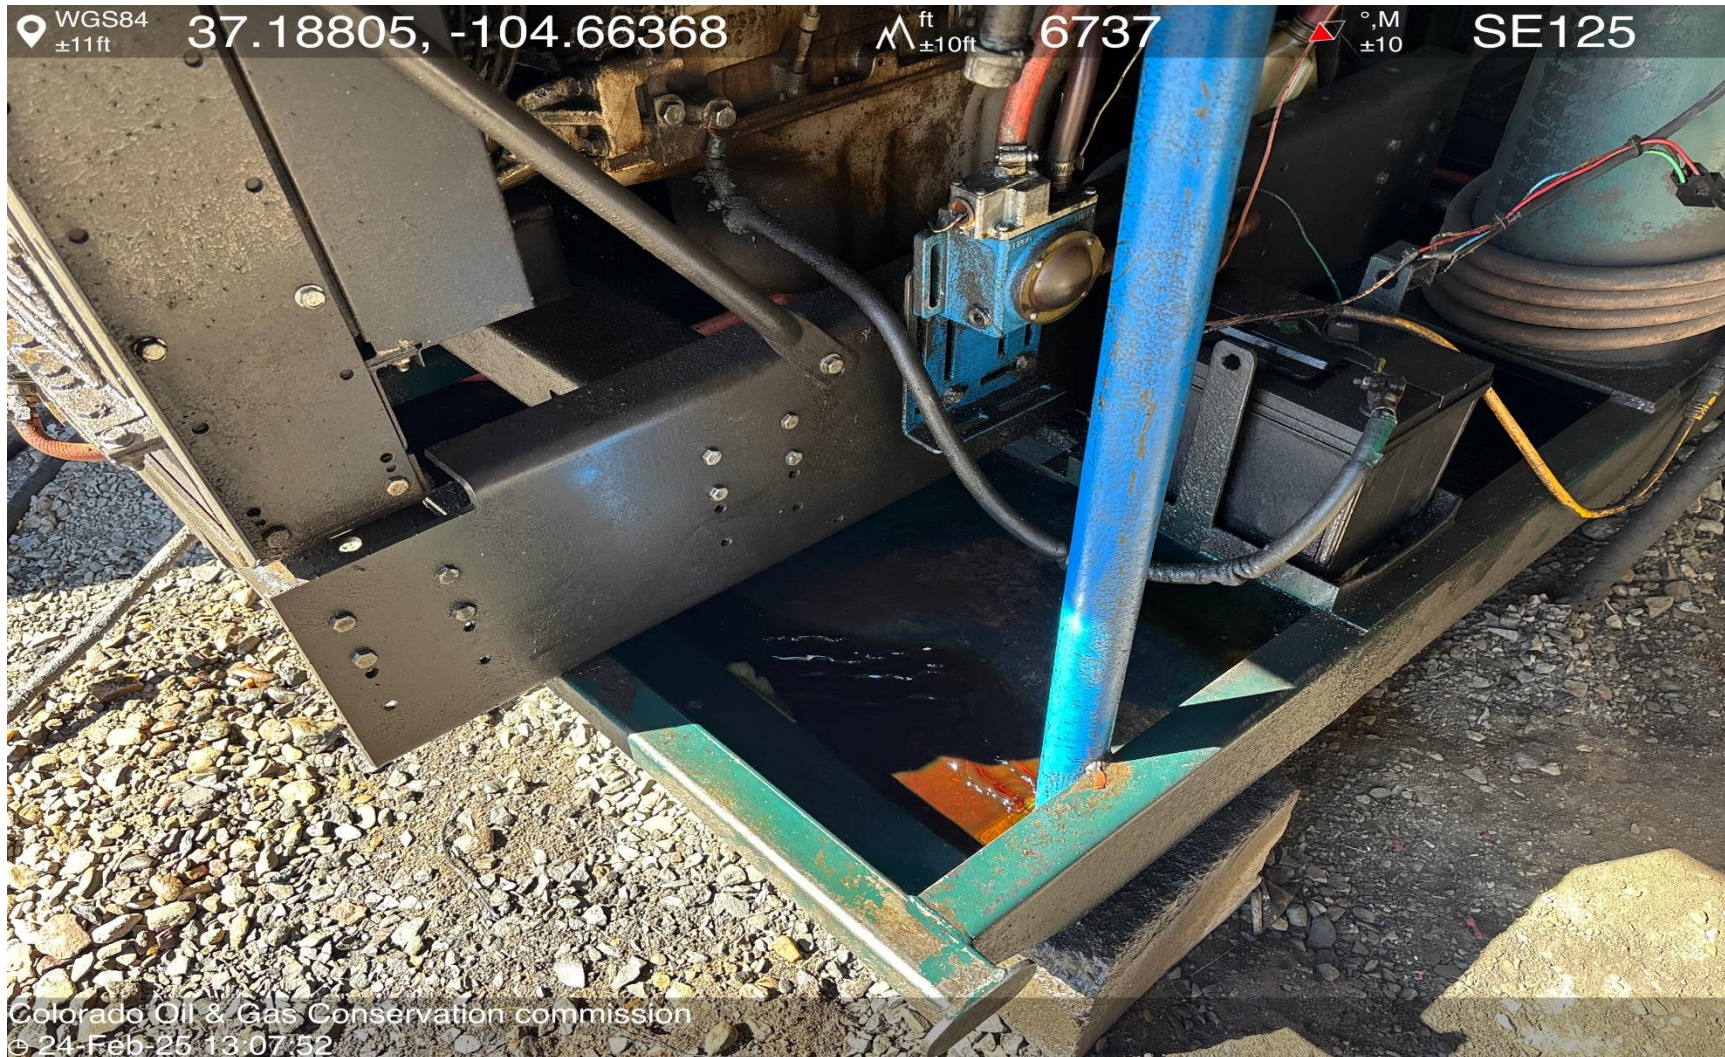
PHOTO 5: OILY WASTE IN ENGINE SKID. PHOTO 6: LEAKS ON COMPRESSOR MOTOR AND EQUIPMENT. Conduct maintenance on equipment, cleanup stained material and review self inspection processes. PER RULE 1002,(2).D. Comply with general provisions of the oil and gas act for wildlife protection AND SB-181. THIS IS THE SECOND NOTICE FOR THIS CA IMMEDIATE ACTION IS REQUIRED, EQUIPMENT MUST BE REPAIRED.

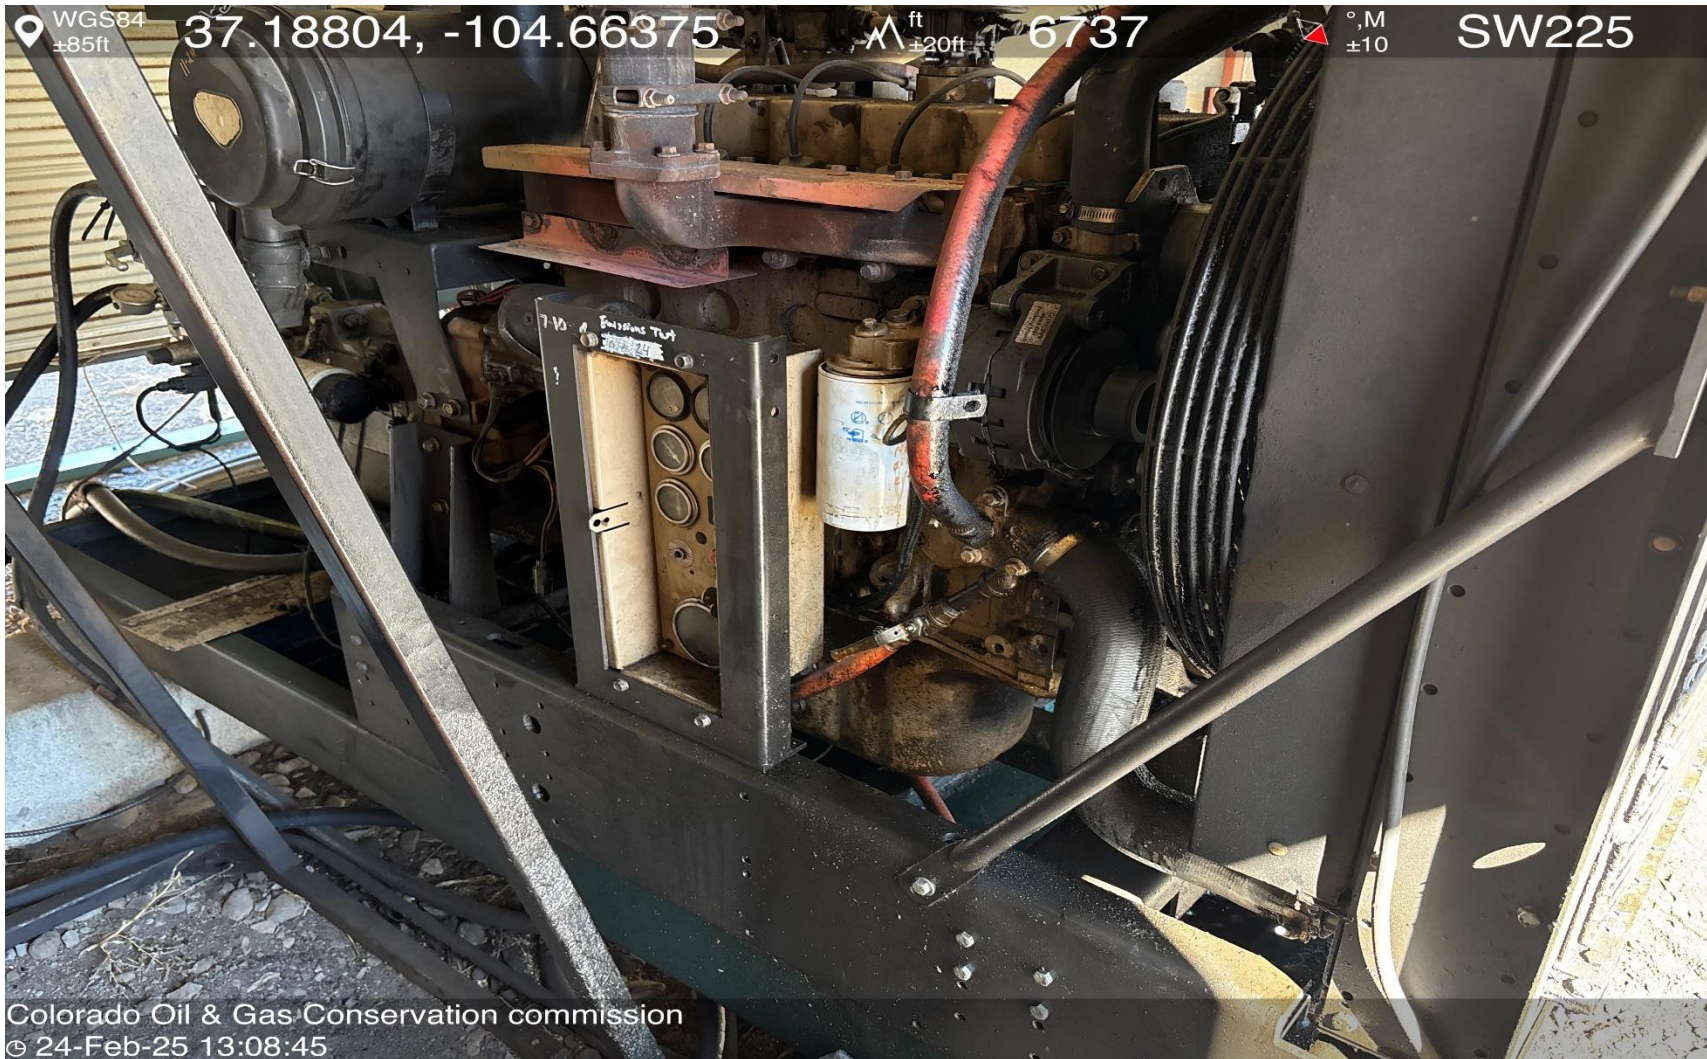
PHOTO 6: MOST OF THE ENTIRE MOTOR AND SKID IS COVERED WITH OIL.
