WELL NAME: IVANHOE 23-27, API #: 071-06722, INSP. # 716300572

COLORADO
Energy & Carbon Management
Commission
Department of Natural Resources

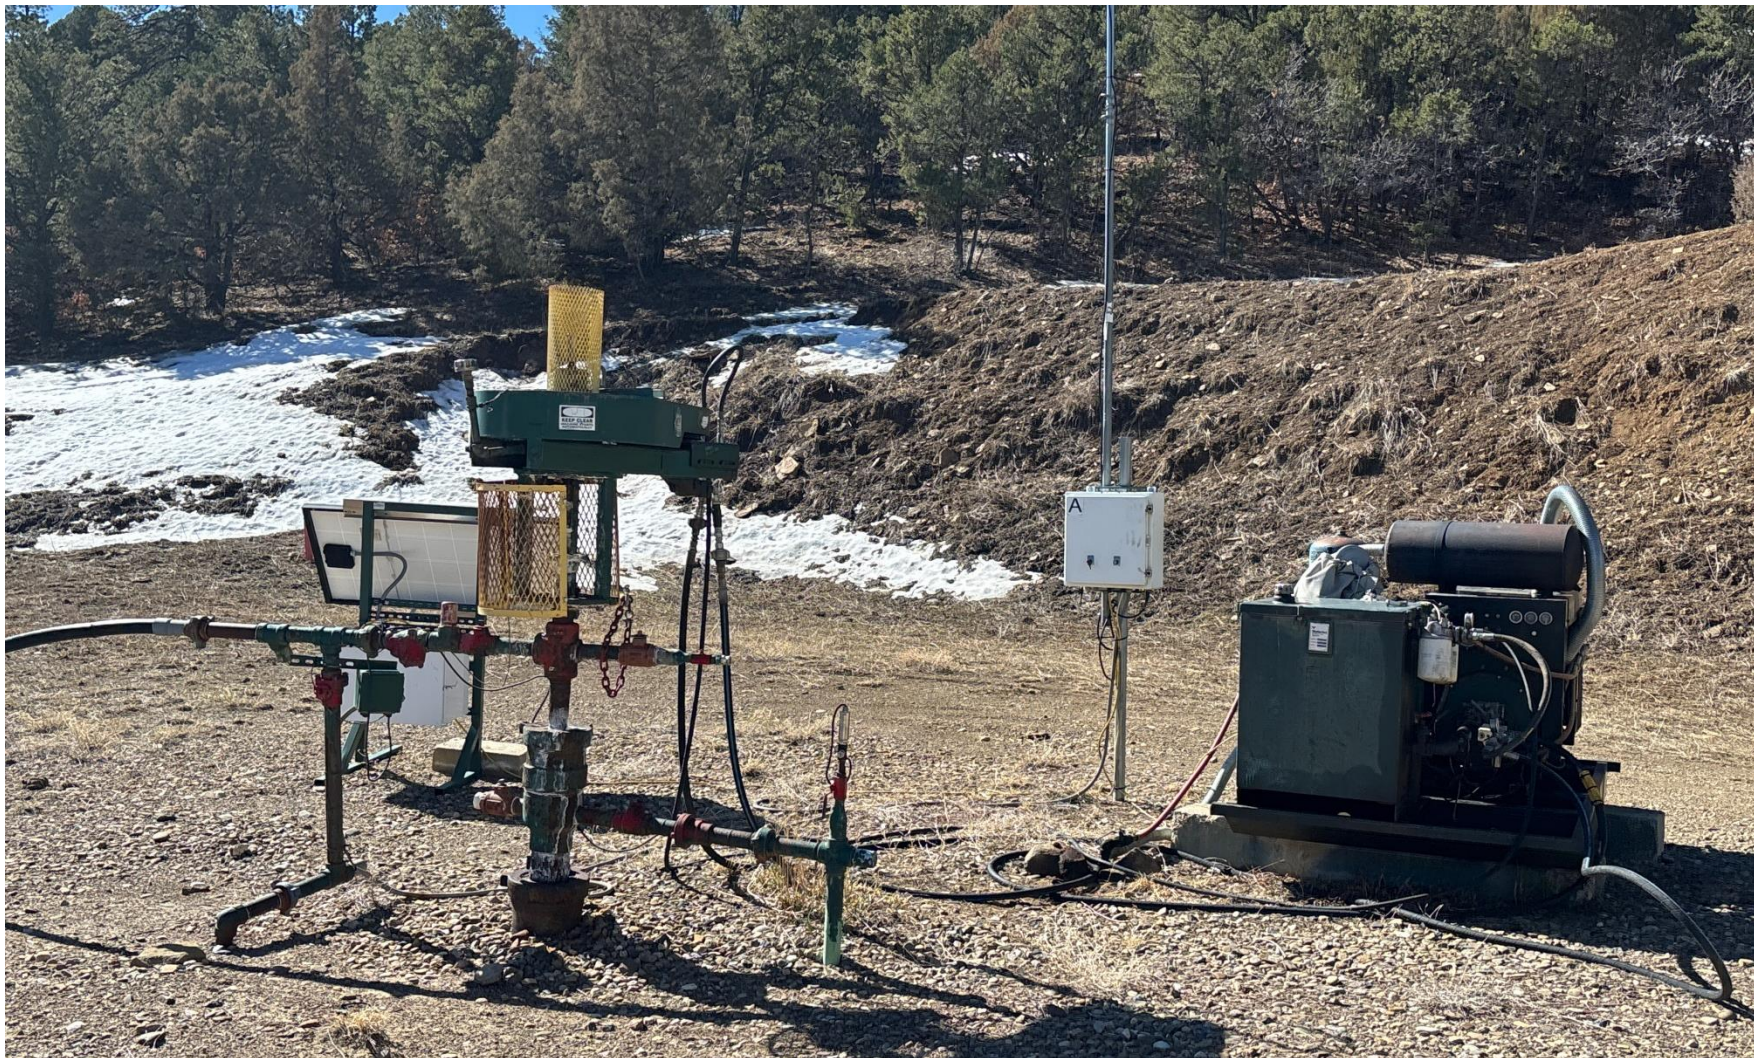
PHOTO 3: WELLHEAD AND EQUIPMENT.

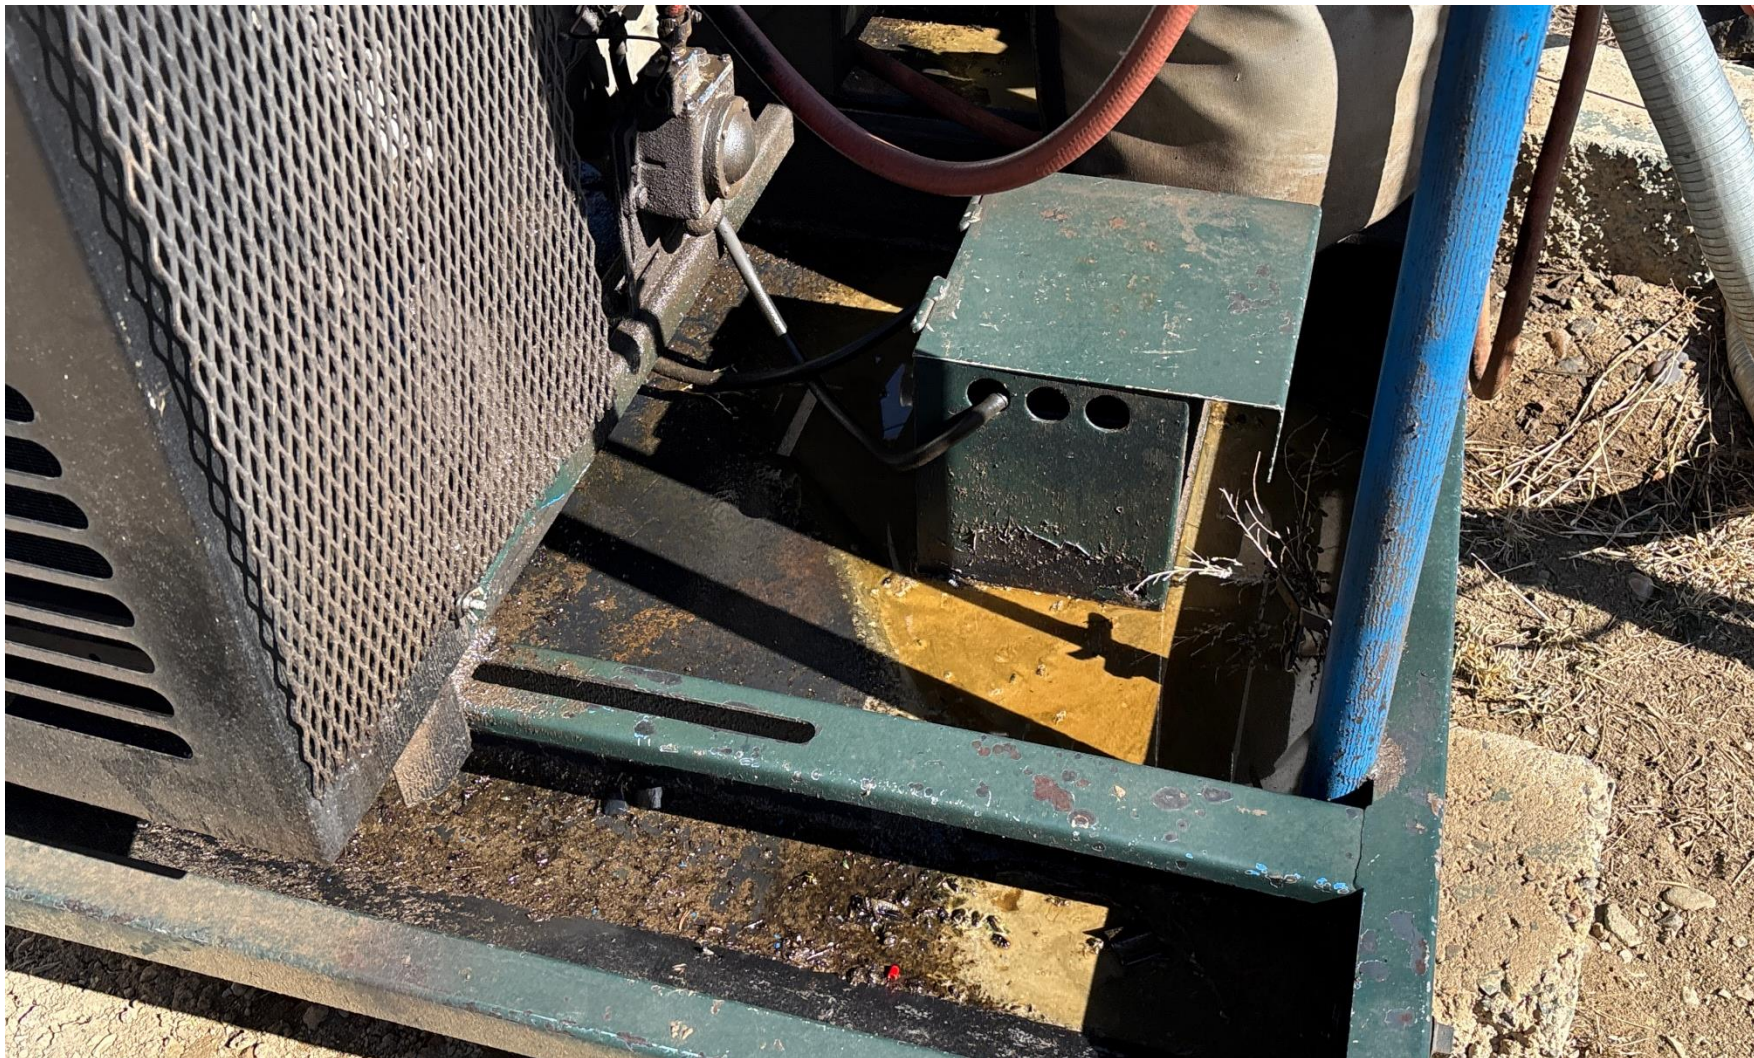
PHOTO 4: STANDING OILY WASTE INSIDE ENGINE SKID. DRAIN OILY WASTE REPAIR ALL LEAKS SOIL PER RULE 1002..(2).D & 1002.f.(2)B, Comply with general provisions of the oil and gas act for wildlife protection AND SB-181. 2/26/2025.

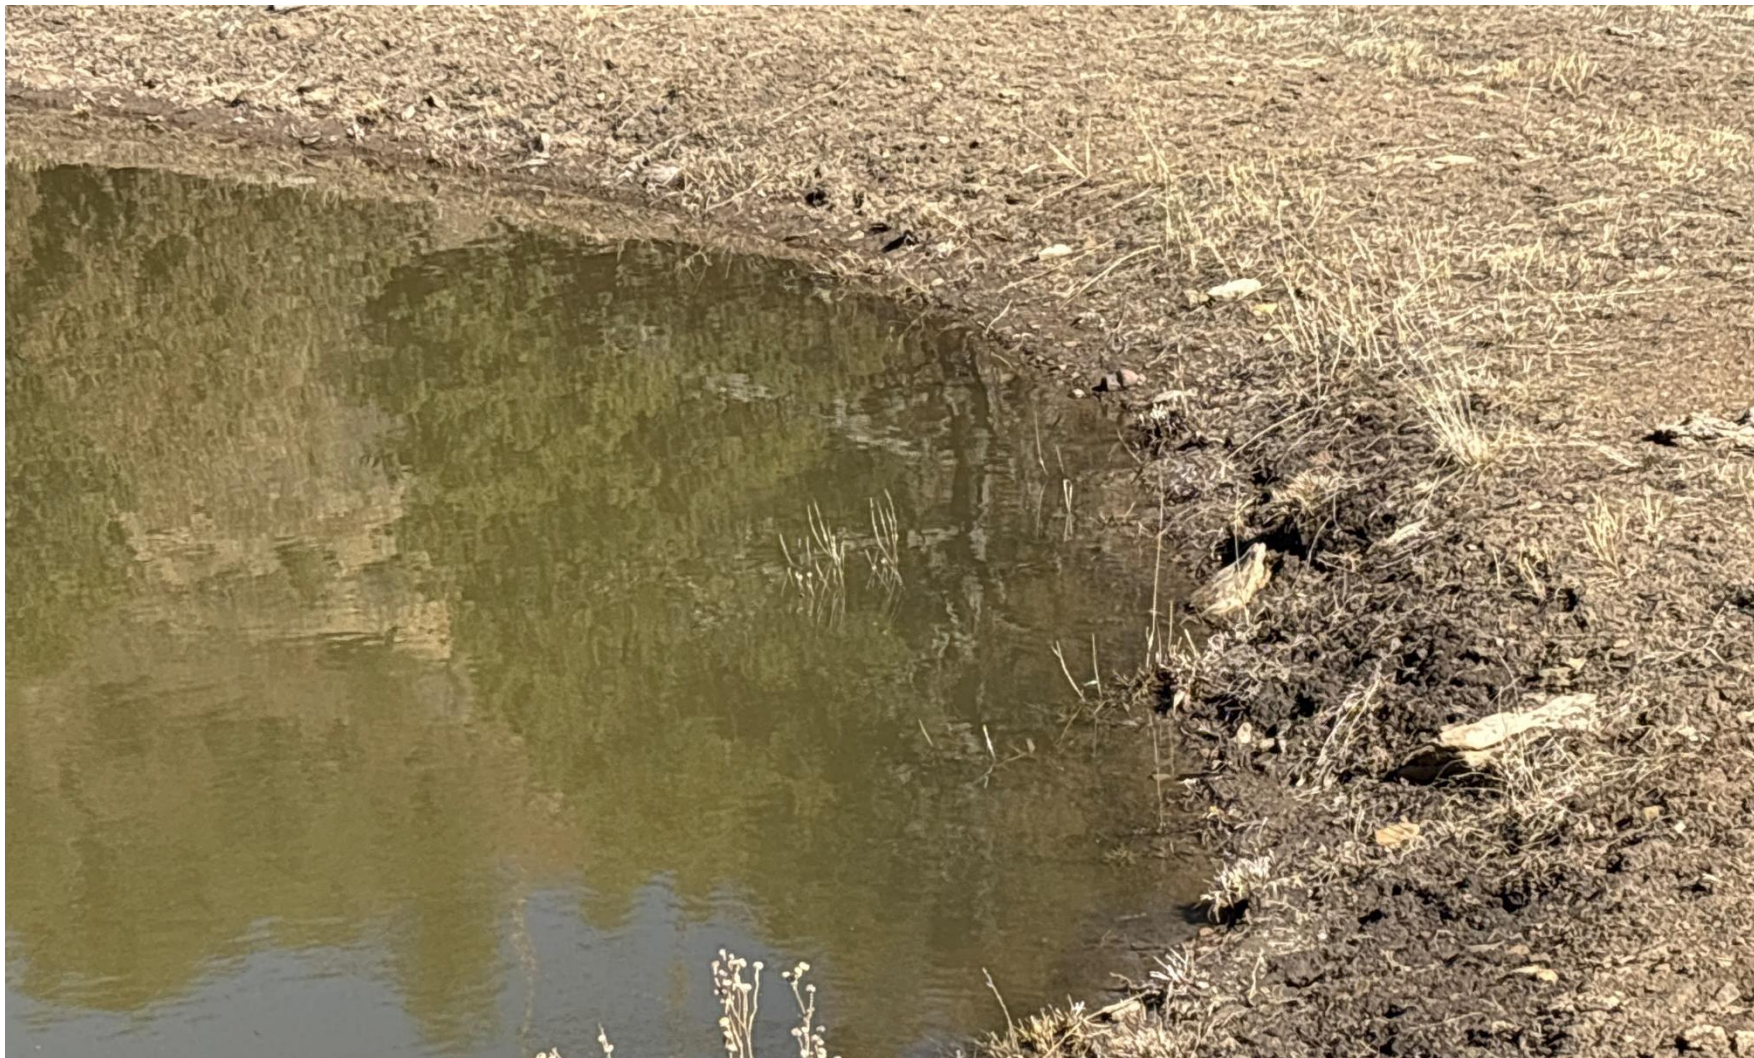
PHOTO 5: LESS THAN 2' FREEBOARD IN OFF SITE PRODUCED WATER POND AND THERE IS NO FREEBOARD MARKER. Install freeboard marker Lower fluid level so at least two feet of freeboard exists per Rule 909.c. DO TO ROAD CONTITIONS AND WELL IS NOT RUNNING IM EXTENDING CA TIME TO 48 HOURS. CA DATE 2/27/2025.

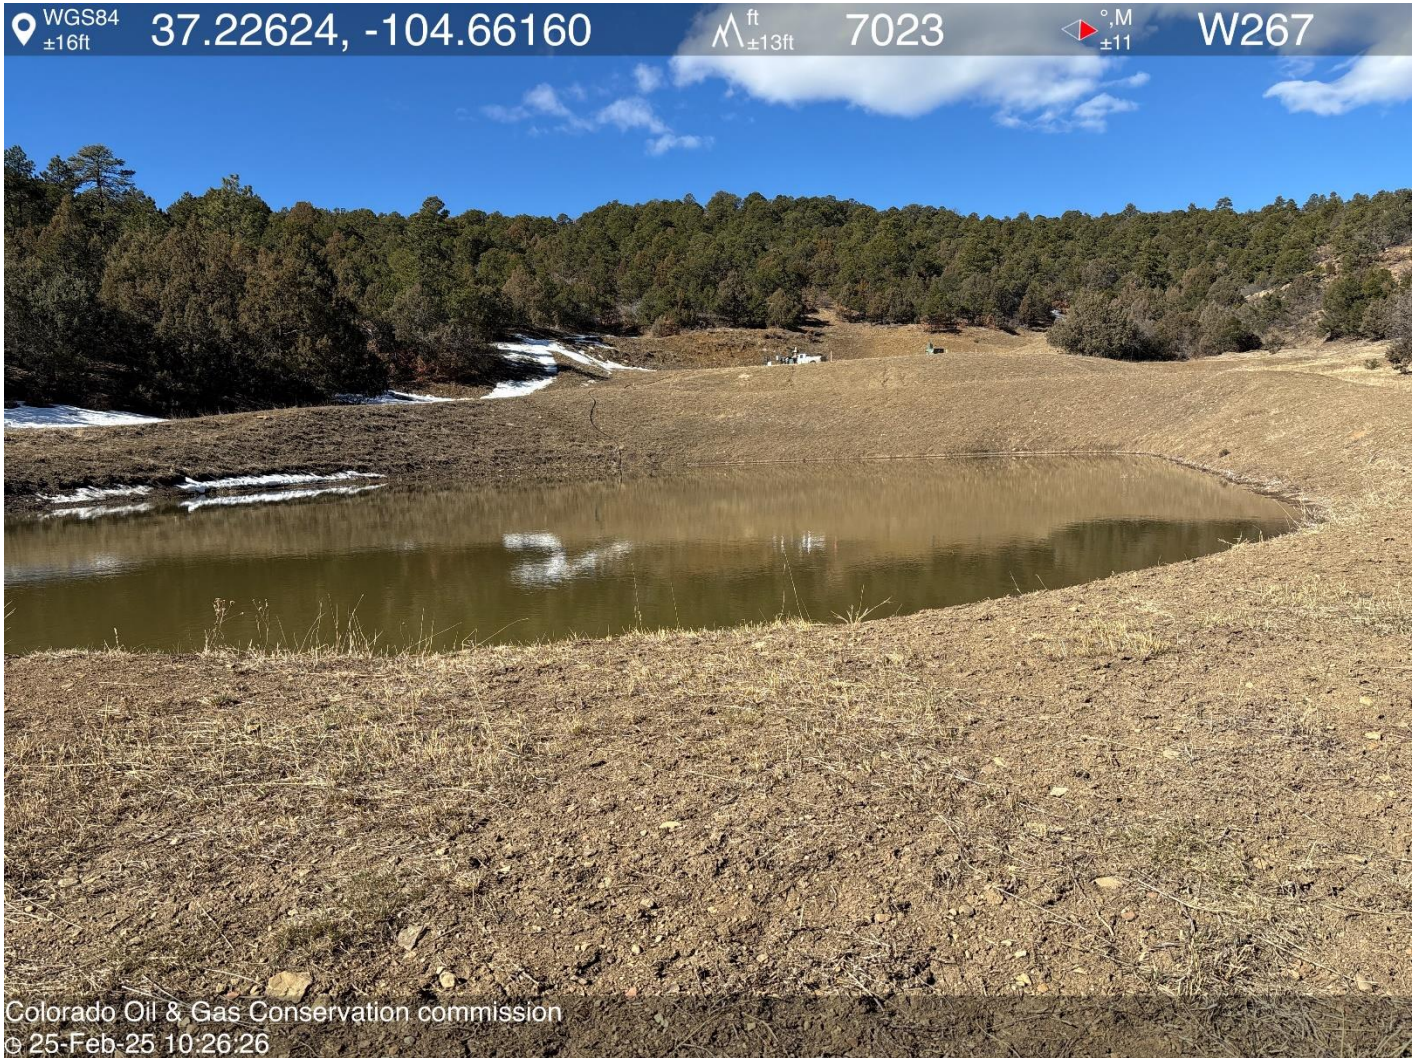
PHOTO 6: LESS THAN 2' FREEBOARD IN OFF SITE PRODUCED WATER POND AND THERE IS NO FREEBOARD MARKER. Install freeboard marker Lower fluid level so at least two feet of freeboard exists per Rule 909.c. DO TO ROAD CONTITIONS AND WELL IS NOT RUNNING IM EXTENDING CA TIME TO 48 HOURS. CA DATE 2/27/2025.
