# Final Reclamation and Stormwater Inspection

Operator: PDC ENERGY INC - 69175

Location ID: 319933

Well Name: CHAMPLIN 117 G #4

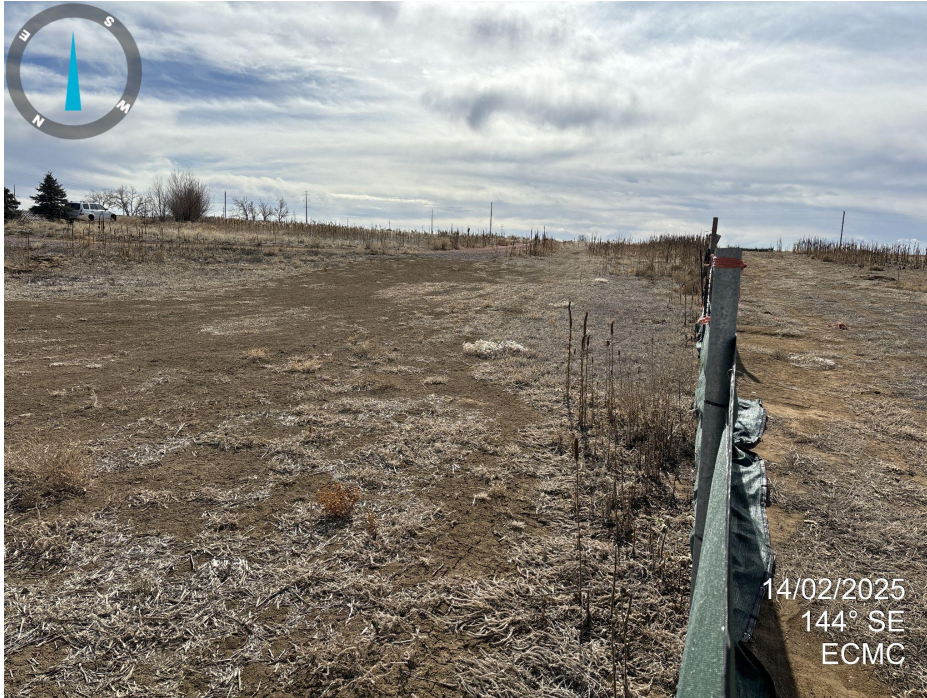
**Photo 1.** Looking south towards access road. It appears that gravel was removed from the well location and that reclamation work was conducted. The remaining access road is being used as a driveway.

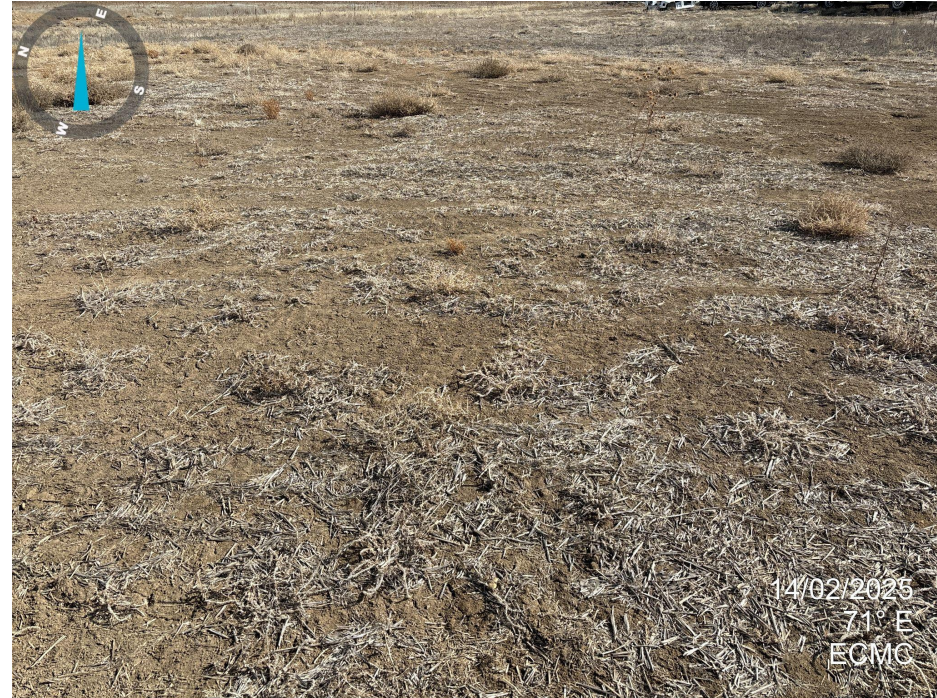
**Photo 2.** Looking east across well location. There appears to be remains of crimped straw on location. There is poor vegetative establishment. Undesirable weeds Russian Thistle and Kochica are present on location.

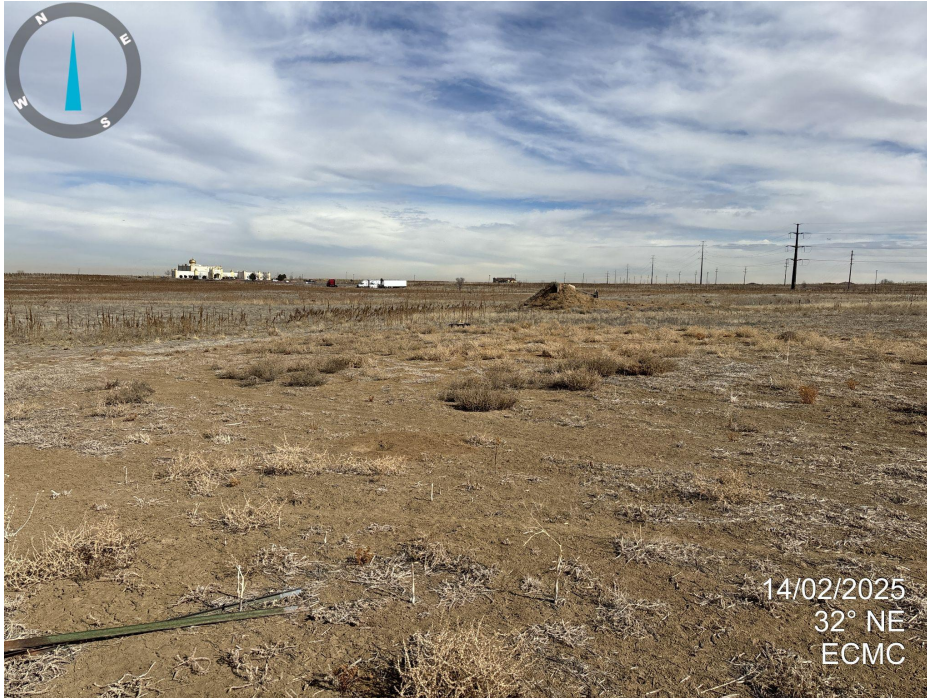
**Photo 3.** No oil and gas equipment remains on location. List C noxious weed mullein was not present on location at time of inspection but is present adjacent to the location. The t-posts in this image appear to be related to landowner fencing.

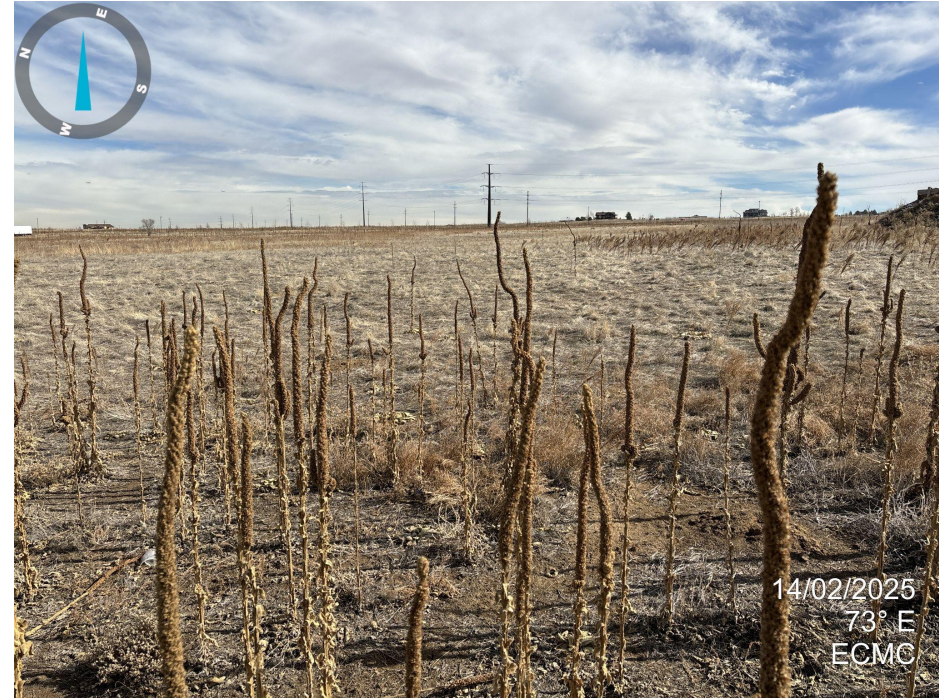
**Photo 4.** Reference vegetation to the north of the well location.
