Hilcorp Energy Company

ALLISON UNIT 19
FORMATION DK/MV
LATITUDE N 37.00225
LONGITUDE W 107.5616
NE/SW, 800' FSL & 1849' FWL
SEC.24 T032N R007W
LEASE NO. FEE
API NO. 05-067-05008
LA PLATA COUNTY, COLORADO
EMERGENCY CONTACT (505) 324-5170 OR 911
NO SMOKING NO TRESPASSING

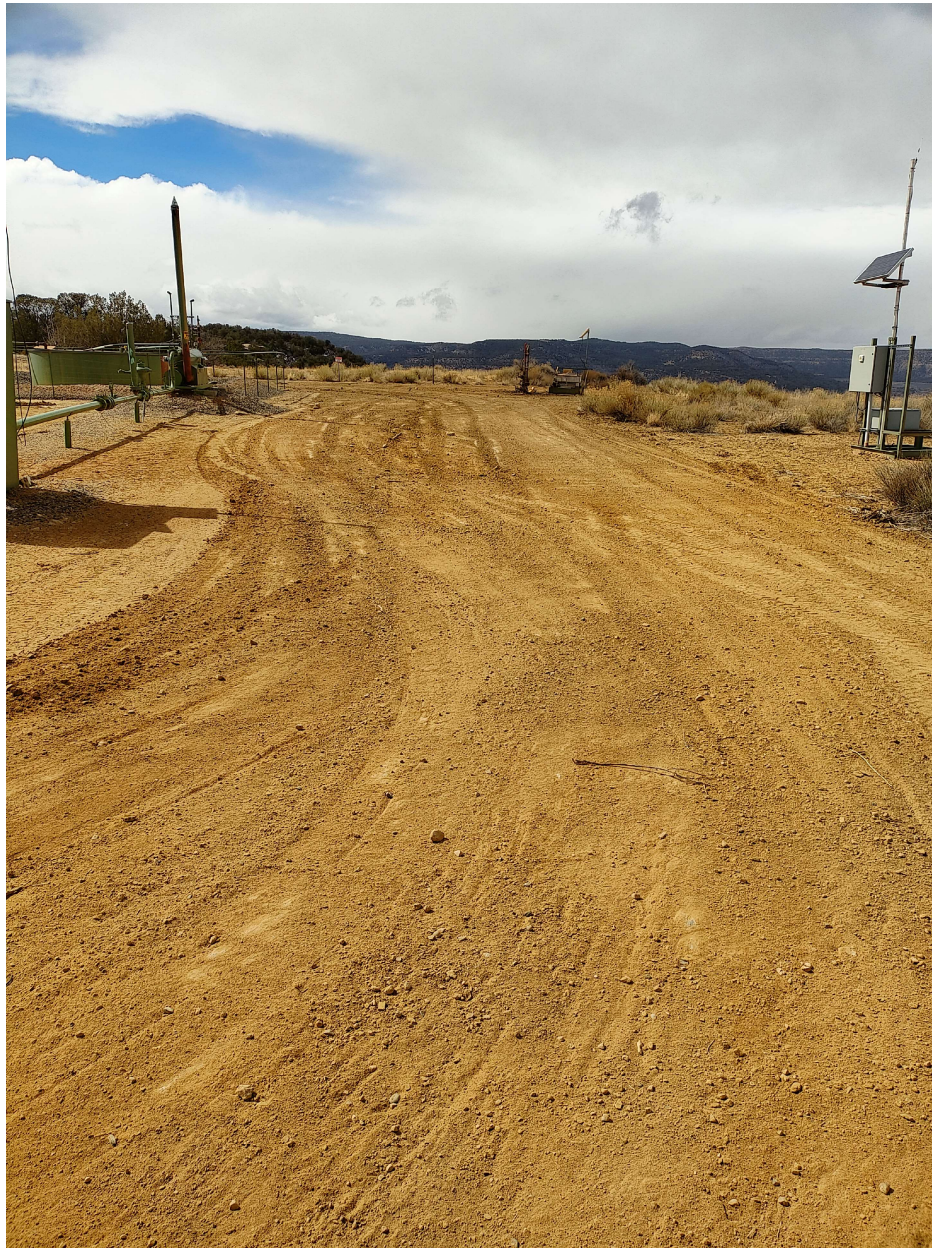
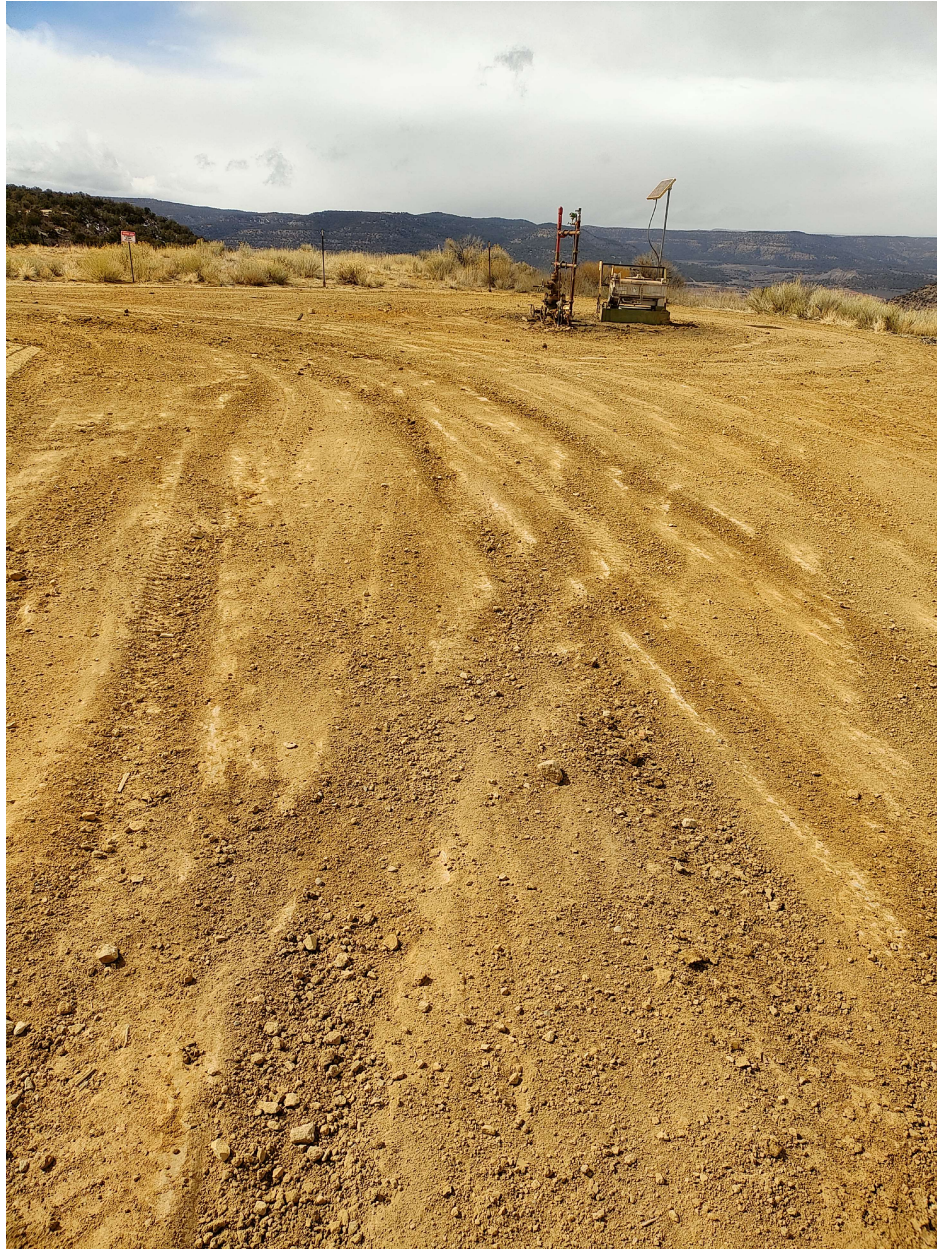
Comment: Rutting observed on the active pad; stabilization/grading is needed to minimize degradation to the active pad.

Corrective Action: Comply with rule 1002f. Install or repair required BMPs.
