# Final Reclamation Inspection

Operator: BONANZA CREEK ENERGY OPERATING COMPANY LLC- 8960

Location ID: 423225

Inspection Photos  
Location Name: State Whitetail 44-1  
Location ID: 423225

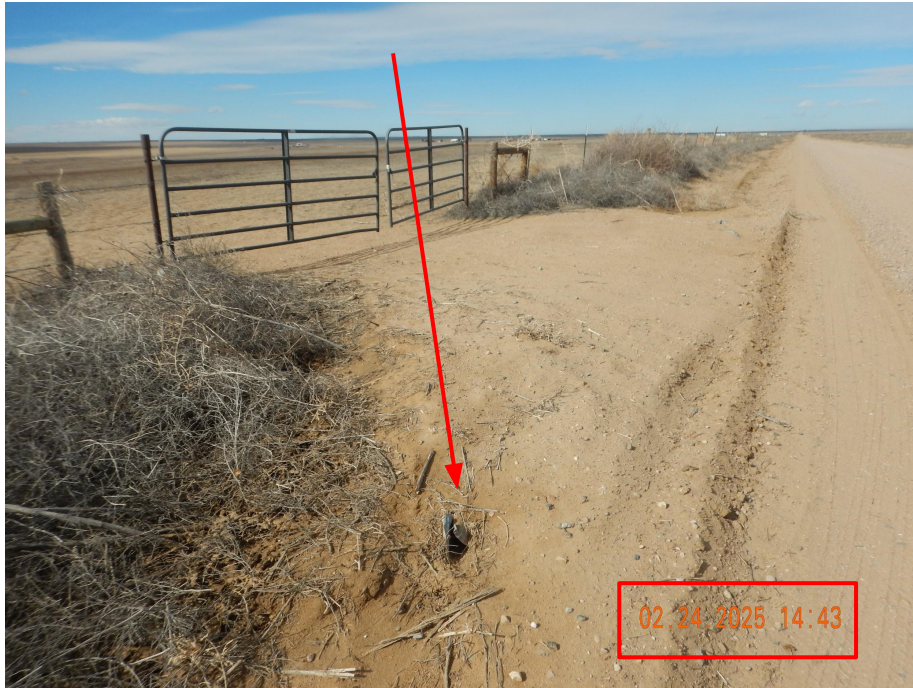
**Photo 1.** Photo taken from the well location entrance of CR85 on February 24, 2025, facing North. Photo illustrates the culvert has not been removed per Rule 1004.a.

**Photo 3.** Photo taken by the Operator on March 11, 2025 from the well location entrance of CR85, facing Northwest. Photo illustrates that the Operator removed the culvert per Rule 1004.a.

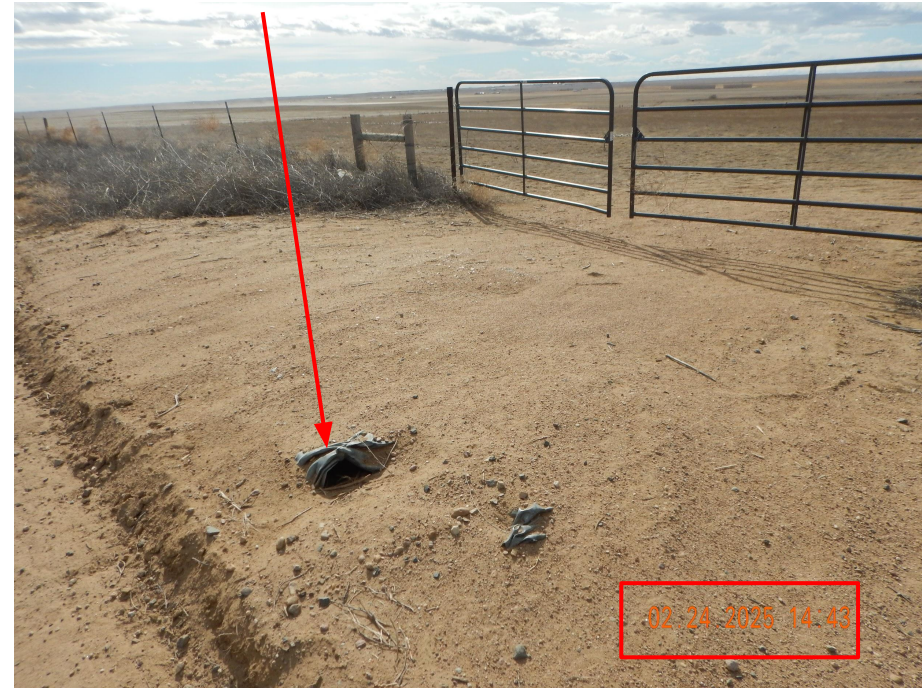
**Photo 2.** Photo taken from the well location entrance of CR85 on February 24, 2025, facing South. See comments under Photo 1.
