Final Reclamation Inspection

Operator: KERR MCGEE OIL & GAS ONSHORE LP - 47120

Location ID: 336085

Inspection Photos
Location Name: CHAMPLIN 86 AMOCO
O-61N68W
Location ID: 336085

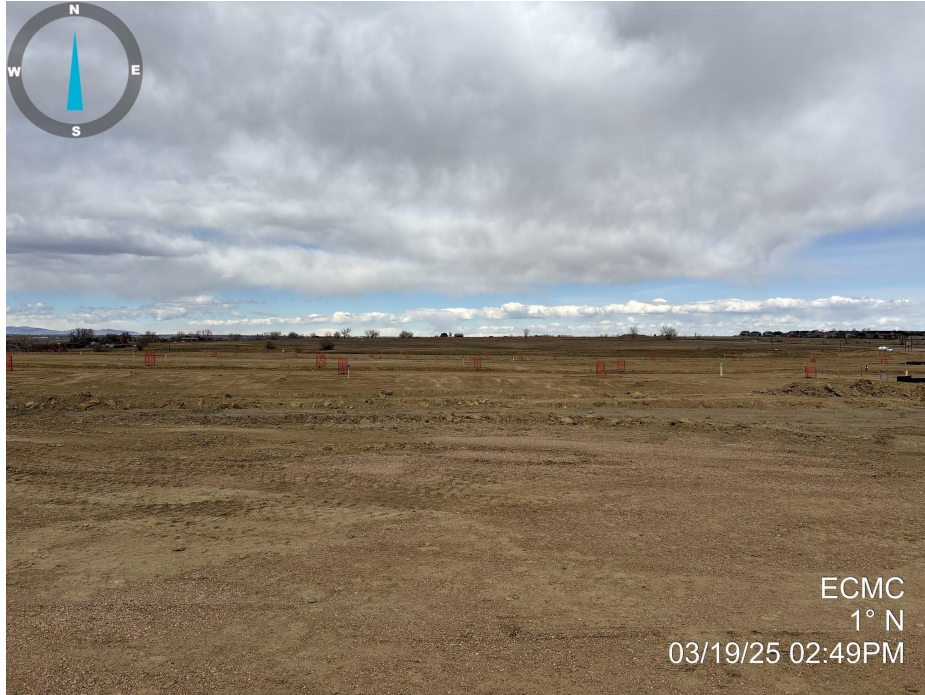
Photo 3. Photo taken from the multi-well location, facing North. Photo illustrates that the well location is contained within a land use change from cropland to a residential development.

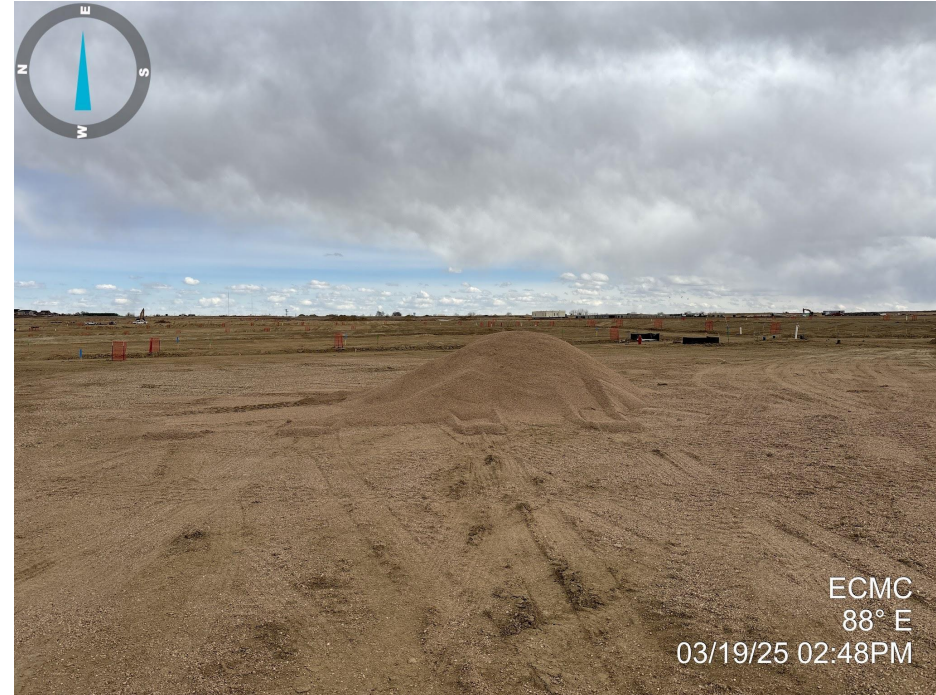
Photo 4. Photo taken from the multi-well location, facing East. See comments under Photo 3.

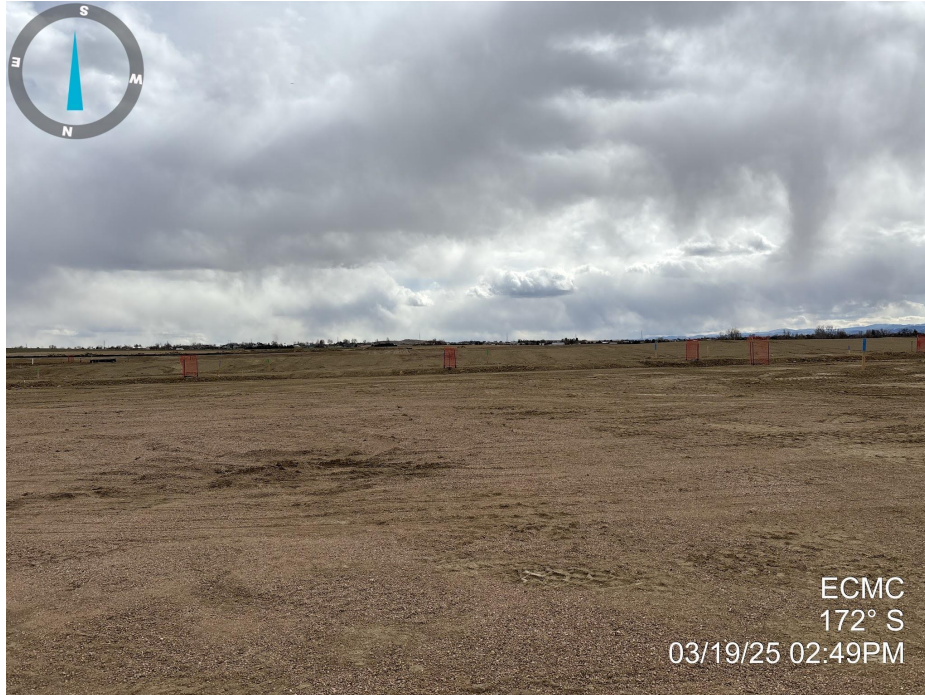
Photo 5. Photo taken from the multi-well location, facing South. See comments under Photo 3.

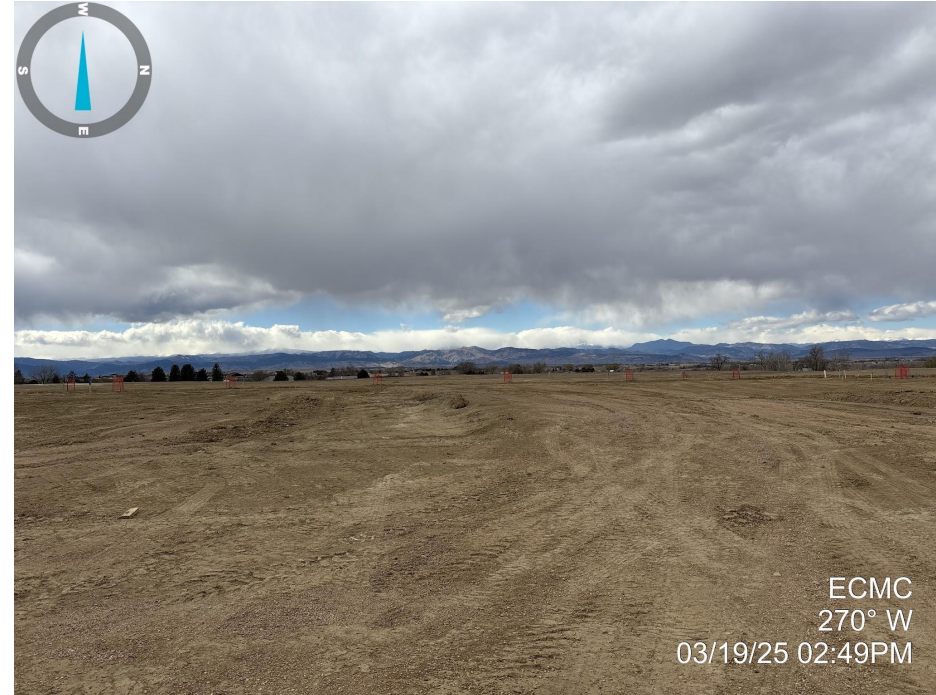
Photo 6. Photo taken from the multi-well location, facing West. See comments under Photo 3.
