Facility Closure Investigation and Environmental Summary

MDM 33-14 Wellhead

ECMC Remediation Project #32449

Weld County, Colorado

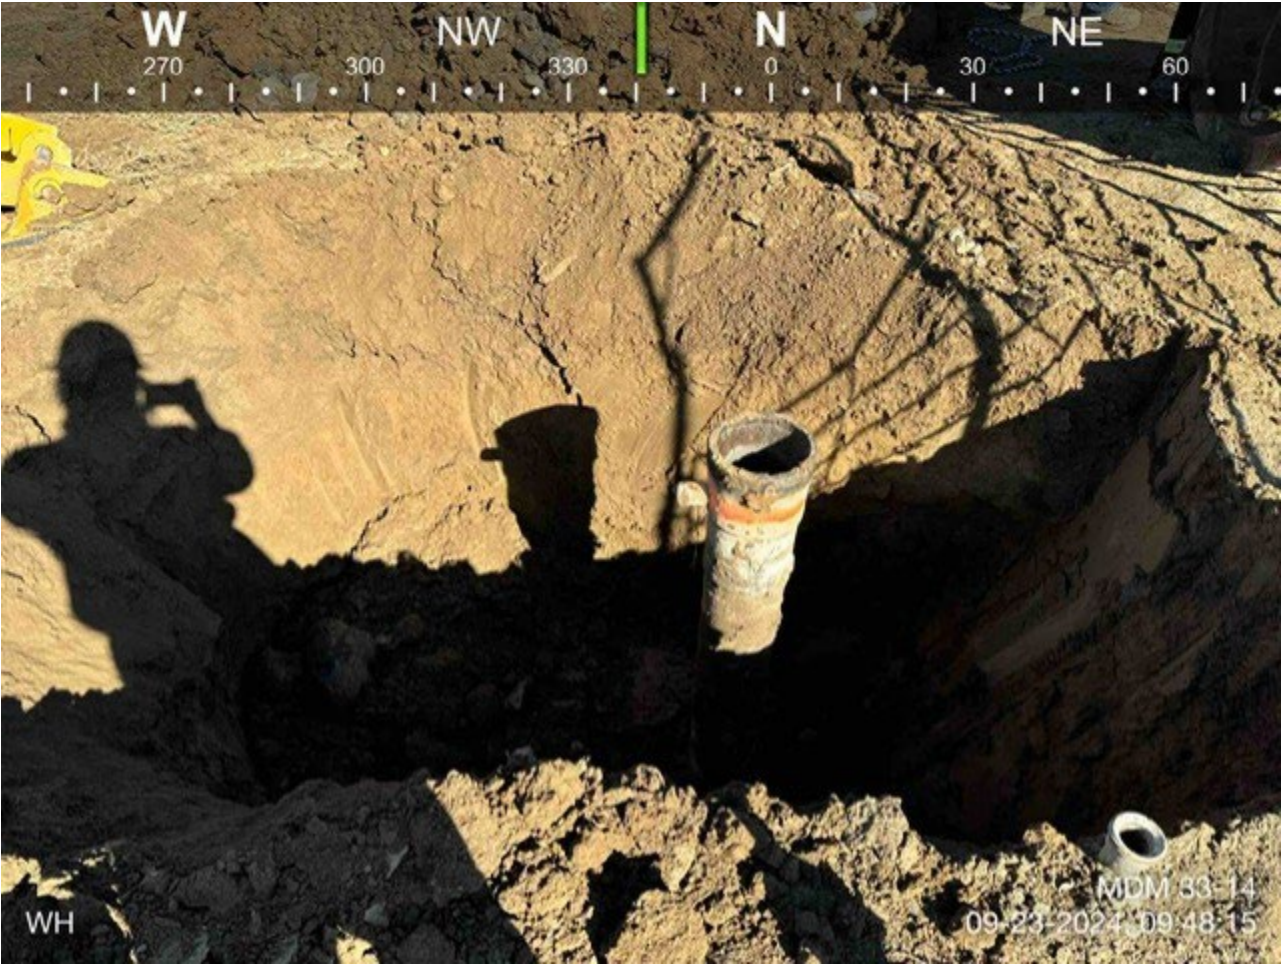
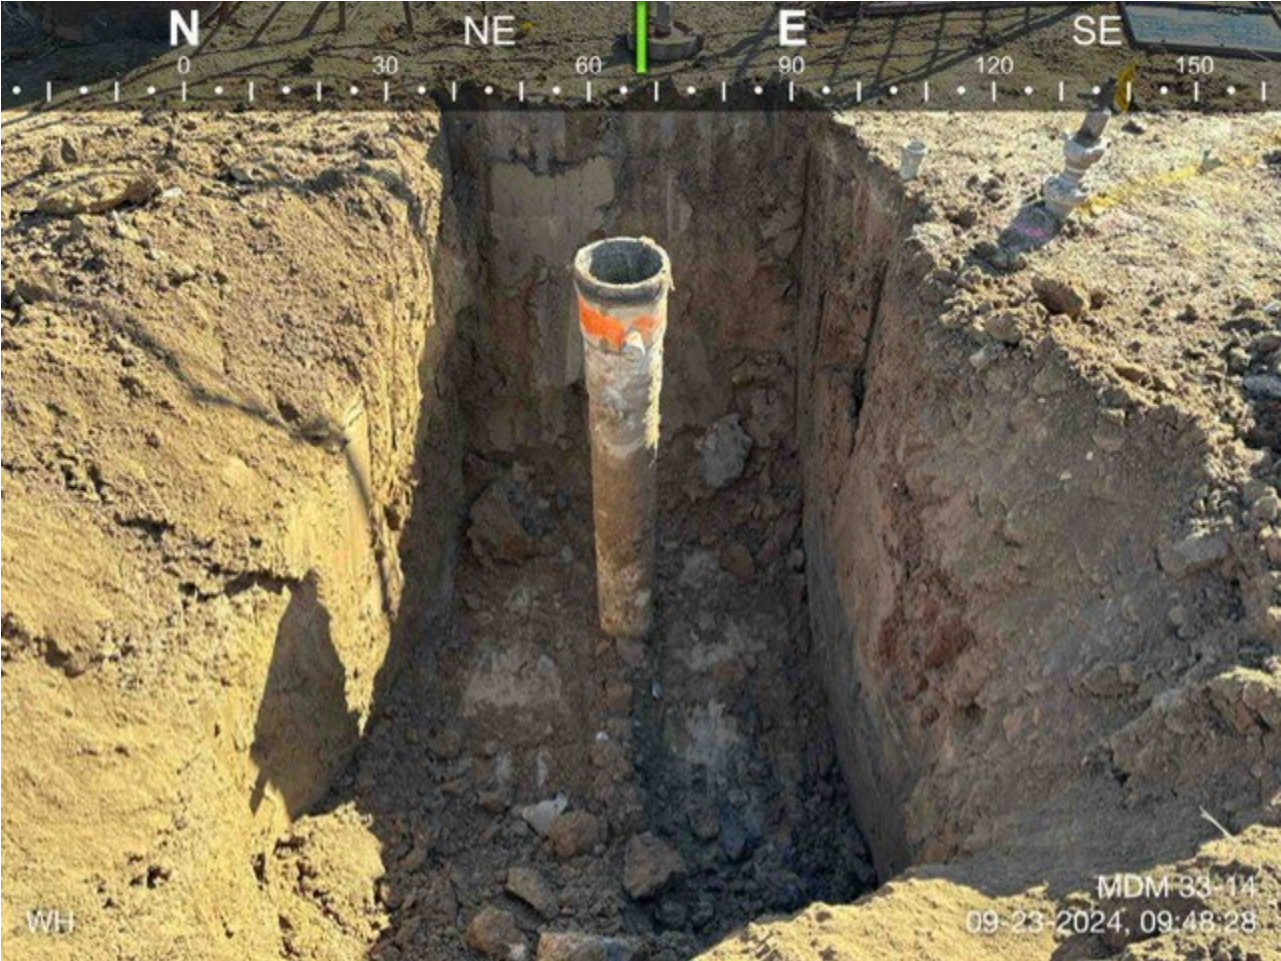
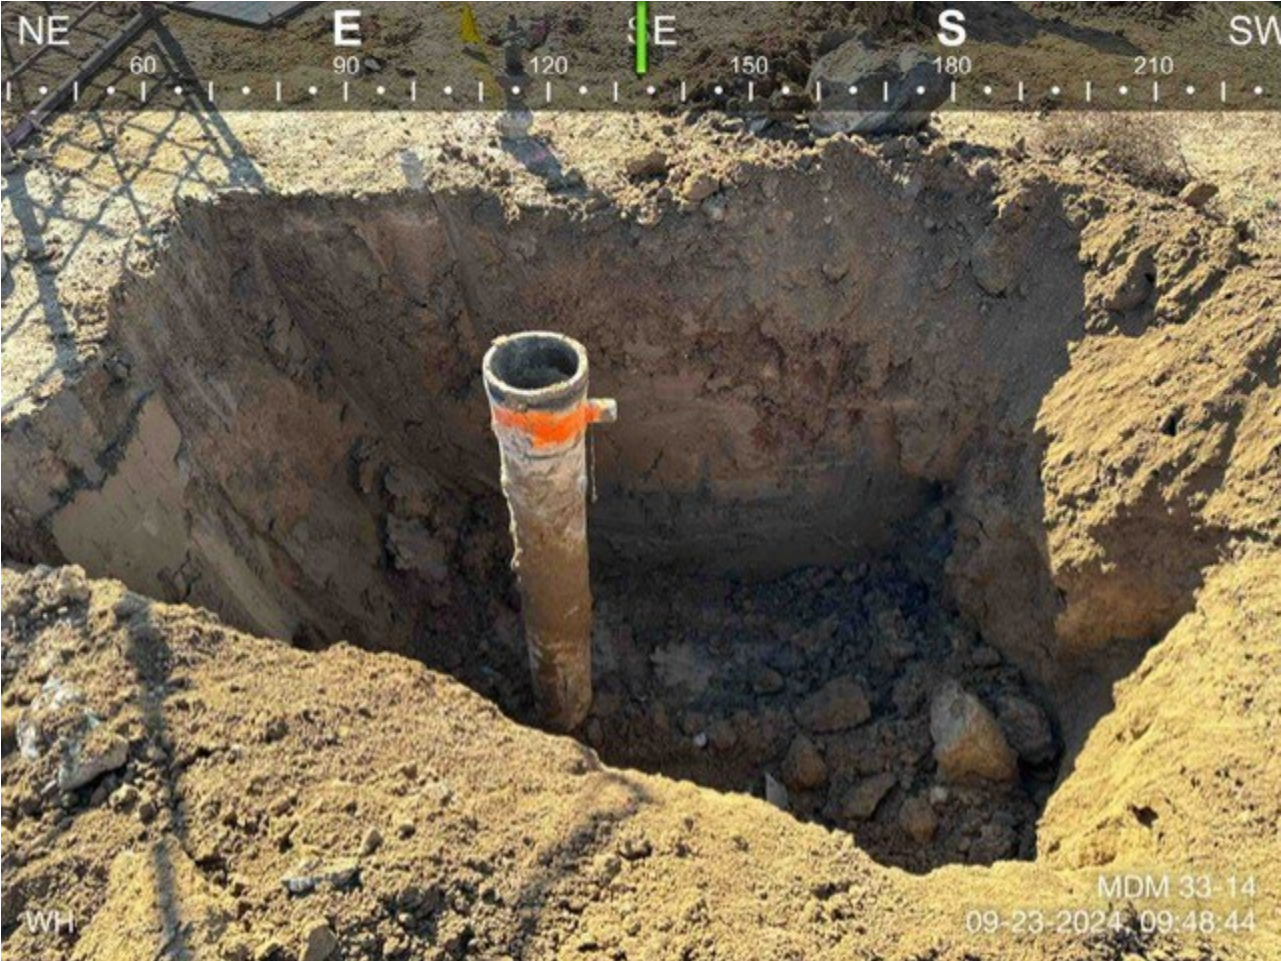
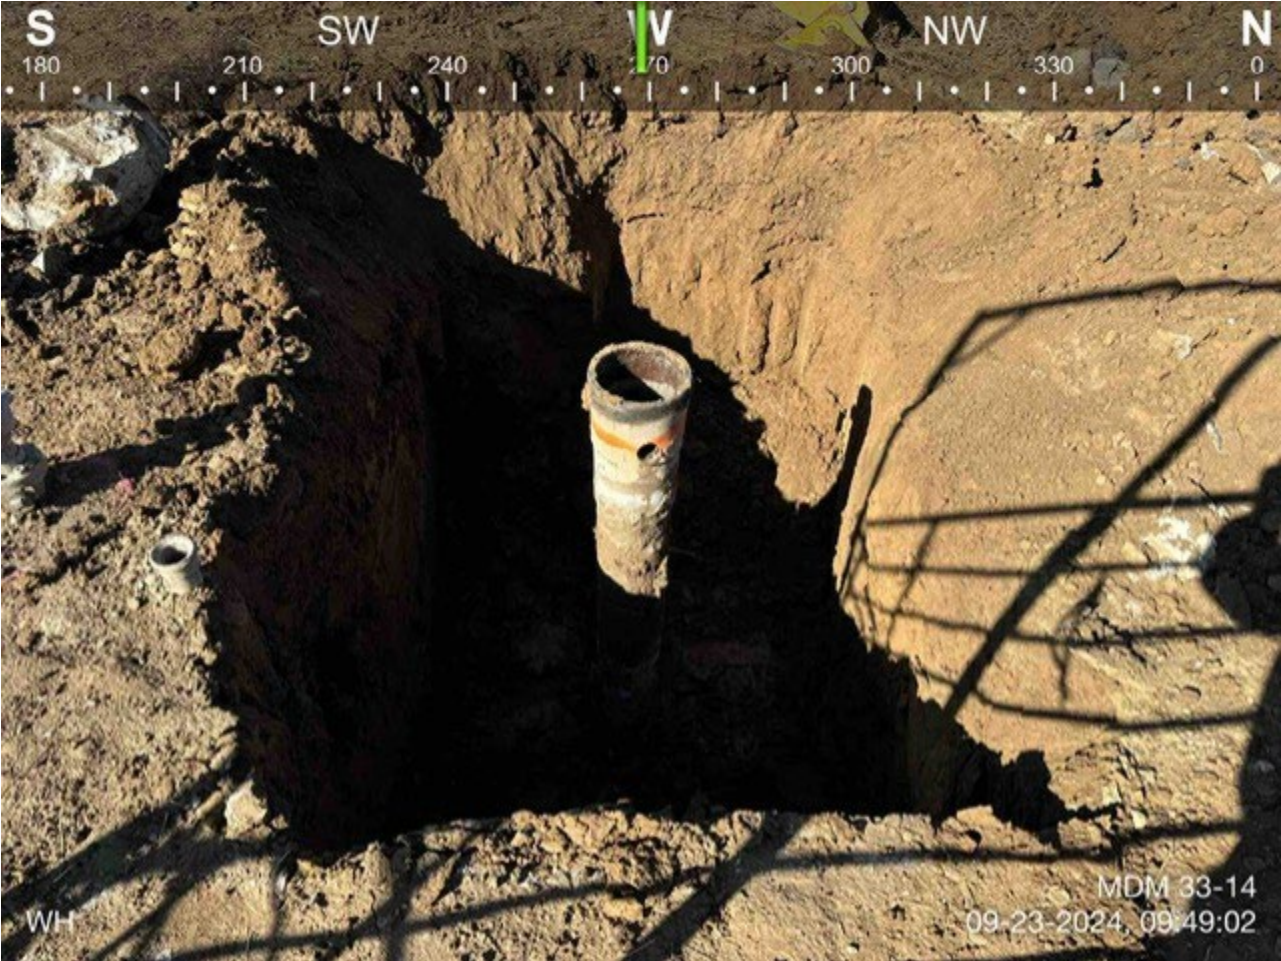
MDM 33-14 Wellhead Photographic Log

Wellhead(s)									
Well API	05-123-21330								
Age	5/30/03 - spud date								
Condition of surface around wellhead	Good								
PID Readings	1.1-2.1ppm								
Condition of subsurface (staining present)	Good								
PID Readings	2.1ppm								
Sample taken? Location/Sample ID#	WH01@6, FLR01@4								
Photo Number(s)	1-4								
Other observations regarding wellheads:									
Summary									
Was impacted soil identified? <input checked="" type="radio"/> No Yes - less than 10 cubic yards Yes - more than 10 cubic yards									
Total number of samples field screened: 5				Total number of samples collected: 5					
Highest PID Reading: 2.1ppm				Total number of samples submitted to lab for analysis: 2					
If more than 10 cubic yards of impacted soil were observed:									
Vertical extent:				Estimated spill volume:					
Lateral extent:				Volume of soil removed:					
Is additional investigation required?
