<u>Company</u>	SCOUT	
<u>Field Name</u>	RANGELY	
<u>Location</u>	NESW Section 14,T2N,R103W, 6TH P.M.	
<u>Short Name</u>	AMC38	
<u>County & State</u>	Rio Blanco, CO	
<u>API No.</u>	05-103-06322	10 3/4" casing patch
<u>Updated by</u>	Austin Mayer	7" casing patch from
<u>Date of Diagram</u>	4/9/2025	Tight 7" casing @ 31
<u>Kelly Bushing</u>	5,506'	
<u>Ground Level</u>	5,496'	
<u>Spud Date:</u>	4/12/1948	
<u>Completion Date:</u>	5/26/1948

Casing Leak Details

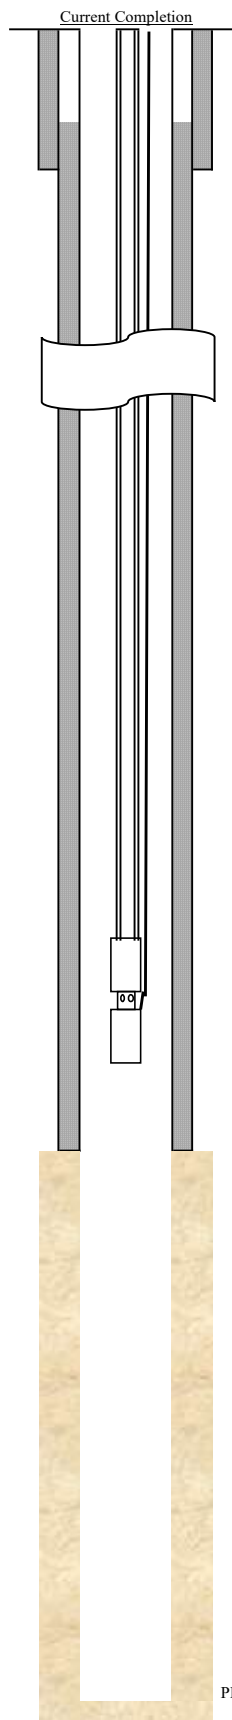
10 3/4" casing patch from surface to 329' (6/77)
7" casing patch from surface to 525' (6/77)
Tight 7" casing @ 311' (3/94)

Upper Perf _____
Lower Perf _____
Open Hole 6312-6657

T/Niobrara	2400
B/Niobrara	2580
T/Frontier	3340
T/Frontier 1st Sand	3425
T/Mowry	3619
T/Dakota	3699
T/Morrison	3792
T/Curtis	4493
T/Entrada	4600
T/Carmel	4741
T/Navajo	4796
T/Chinle	5430
T/Shinarump	5540
T/Moenkopi	5630
T/L Moenkopi	5859
T/L Weber	6305

PBTD: 6,657'
TD: 6,657'
