Final Reclamation and Stormwater Inspection

Operator: NOBLE ENERGY INC - 100322

Location ID: 389727

Inspection Photos
Location Name: Emerald Unit 1-35
Location ID: 389727

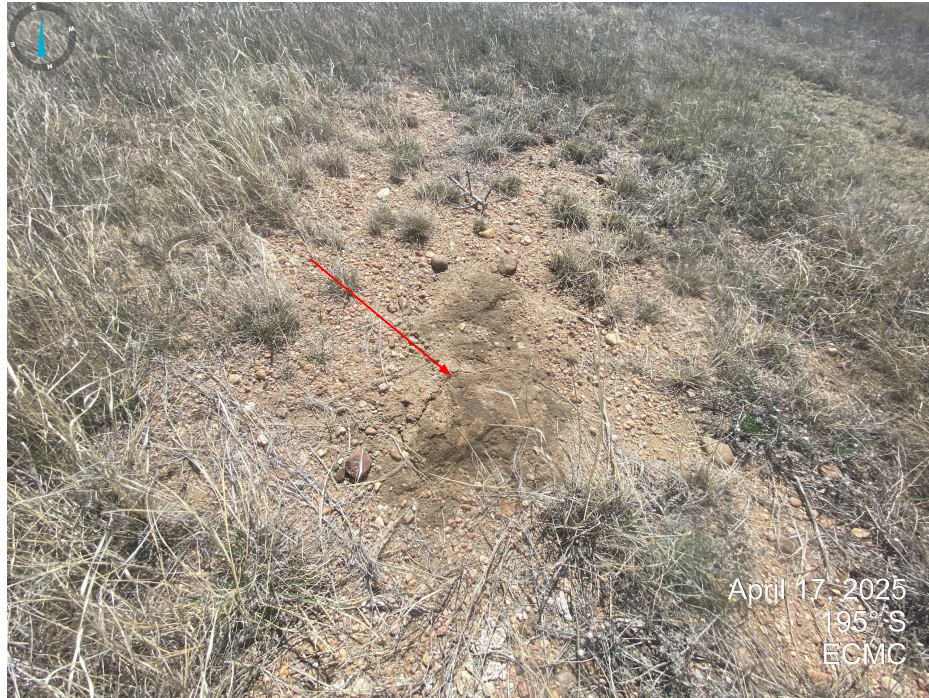
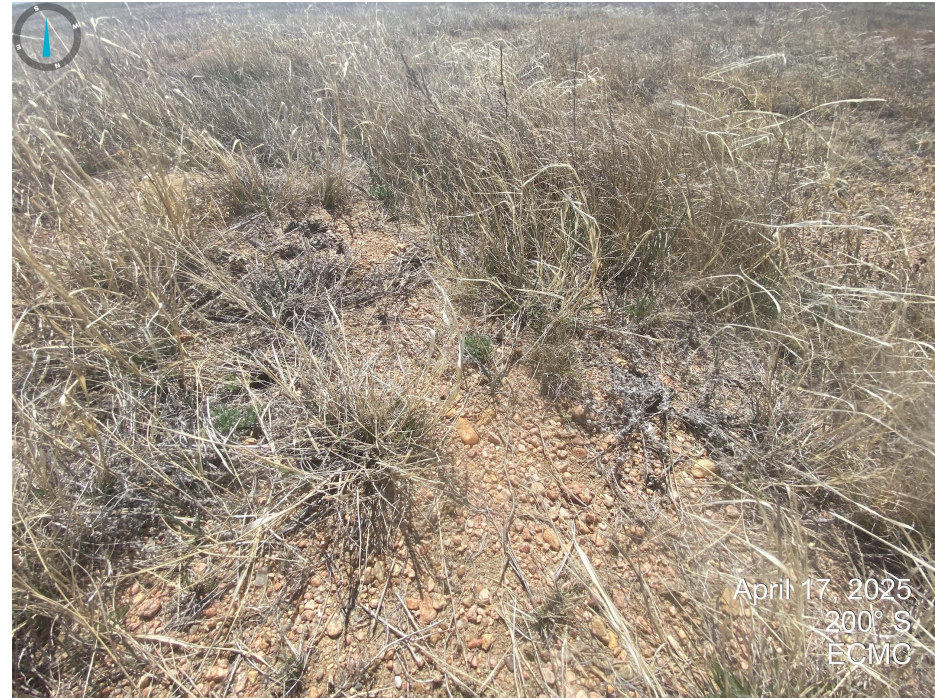
Photos 1 & 2. Apparent stained soils and road base material observed around the former well location.

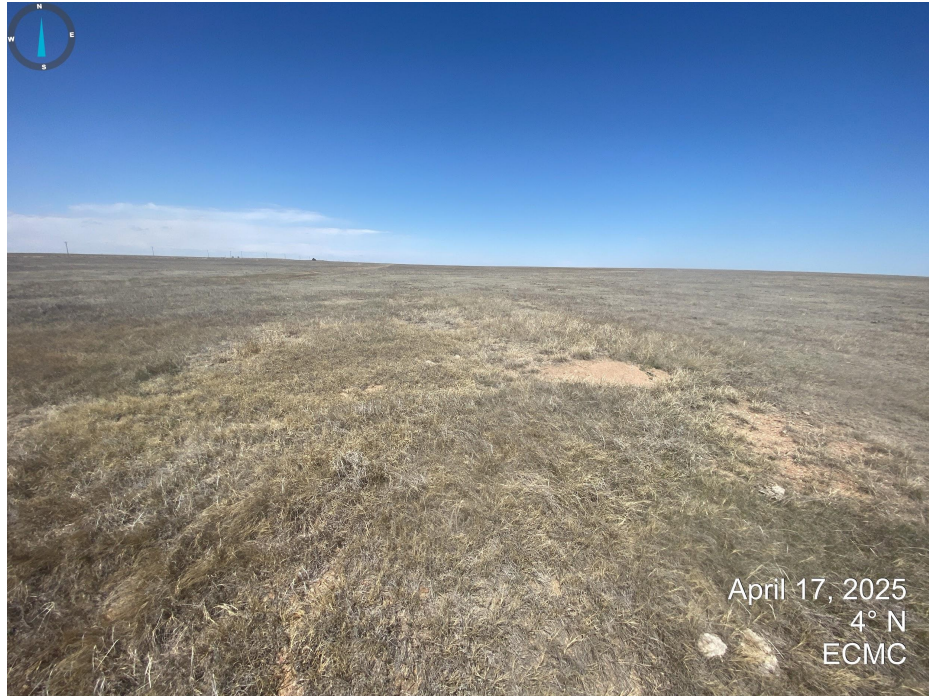
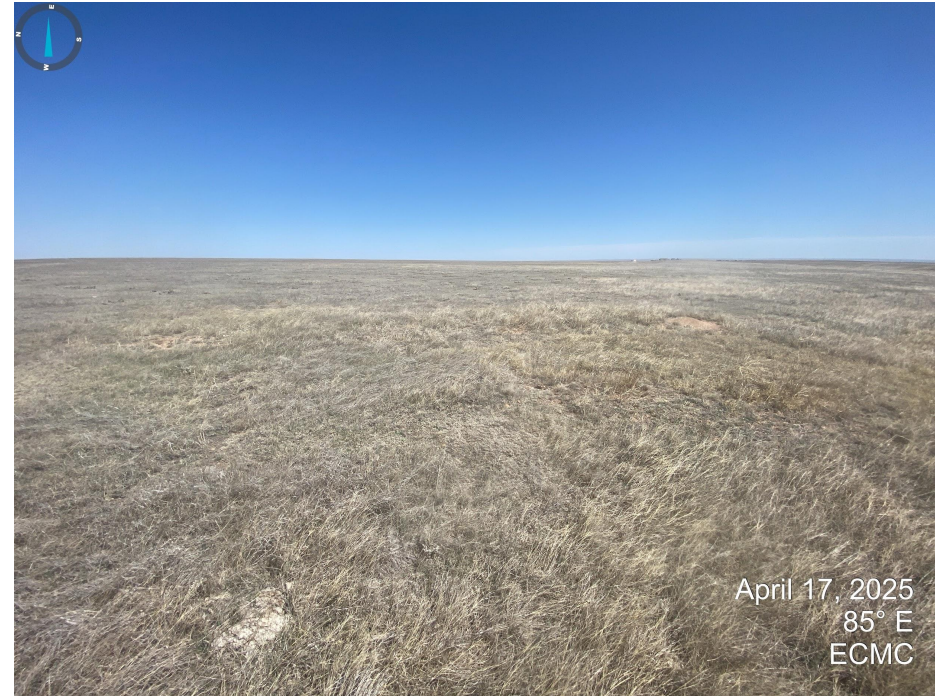
Photos 3 & 4. Additional reclamation activities are required as the former well location has evidence of contour/grading issues and the presence of road base material.

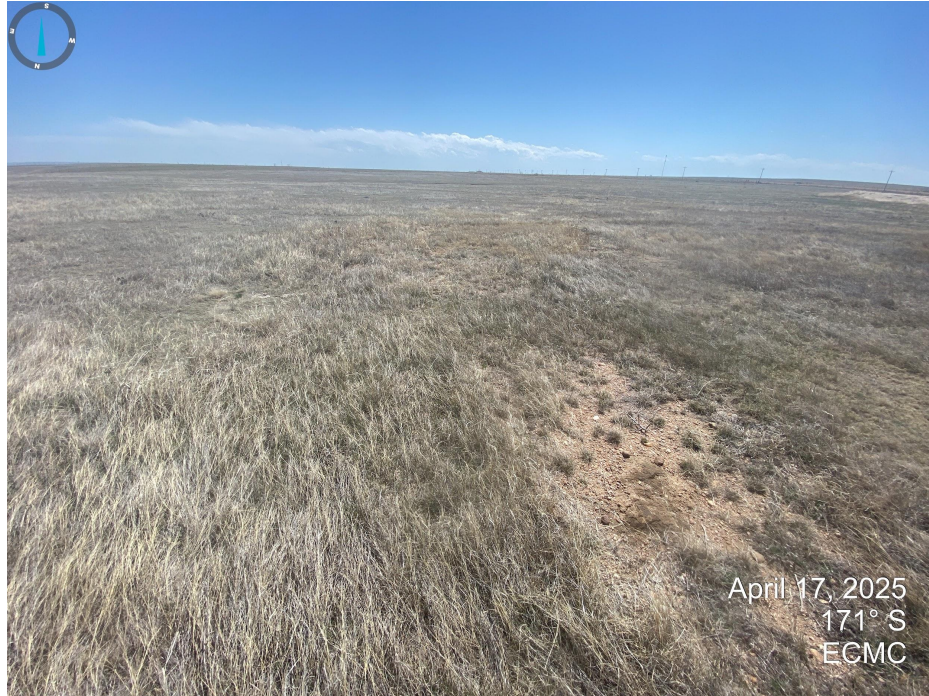
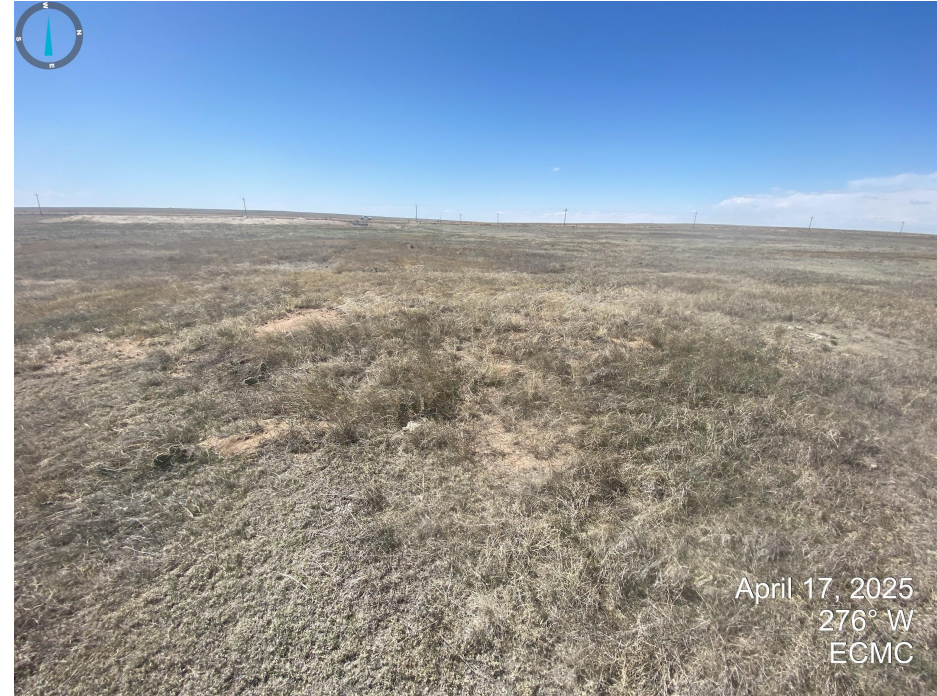
Photos 5 & 6. Additional reclamation activities are required as the former well location has evidence of contour/grading issues and the presence of road base material.

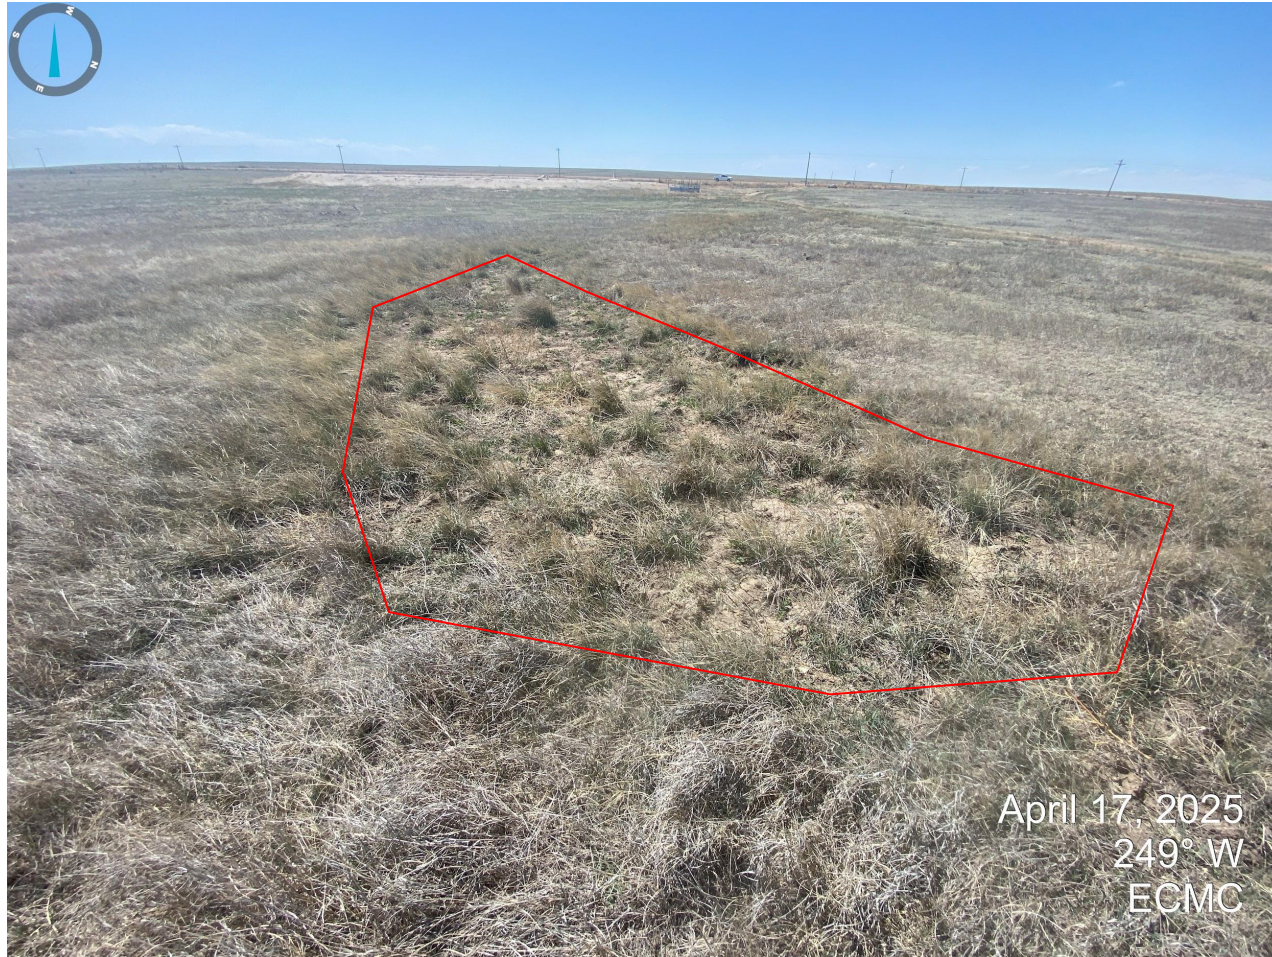
Photo 7. A subsidence (approximated by red outline) observed west of the former well location.
