Operator: BONANZA CREEK ENERGY OPERATING CO.

Location Name: ANTELOPE M-31

Inspection: 718700266

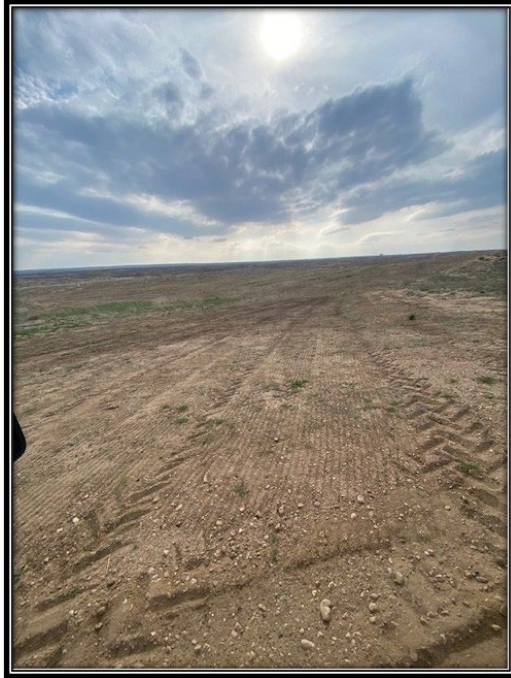
Exhibit A

CA: This location does not comply with Rule 1004. During this inspection, it was observed that the location appears to have been contoured and graded to reflect adjacent topography. The former tank battery and well locations consist primarily of unstabilized/bare soils and debris from undesirable vegetation (russian thistle/tumbleweeds). A Colorado List C Noxious Weed (cheatgrass) was also observed to be growing throughout the disturbance areas and will require management. Additional reclamation activities are required to comply with Rule 1004. Comply with Rule 1004. Reseed disturbance areas using a seed mixture requested by the surface owner, or a mixture prescribed by the local county NRCS. Establish vegetation with total perennial, non-invasive uniform plant cover of at least eighty (80) percent of reference area levels. Ensure erosion controls are implemented to stabilize the seeded soil. Operator shall continue to monitor and manage this site until the location meets Rule 1004 standards, including stormwater and weed management.

CA Resolution: Operator has addressed the vegetation issue in order to comply with Rule 1004. This location has been inter-seeded. Additional crimped straw mulch was decided against in order to minimize disturbance to new seedlings and existing perennial grasses that were observed
