Final Reclamation and Stormwater Inspection

Operator: EXTRACTION OIL & GAS INC - 10459

Location ID: 459452

Well Name: Kallsen 24-9 #1, Madison 23-9/

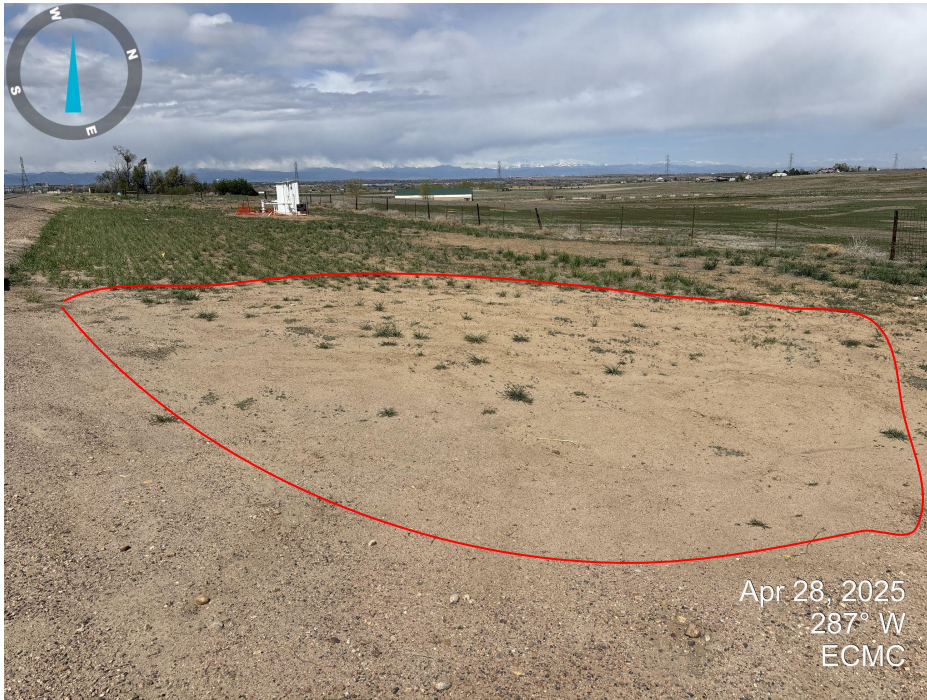
Photo 1. Looking west across the tank battery location. On the east side of the location there is a large bare patch near the road (red circle).

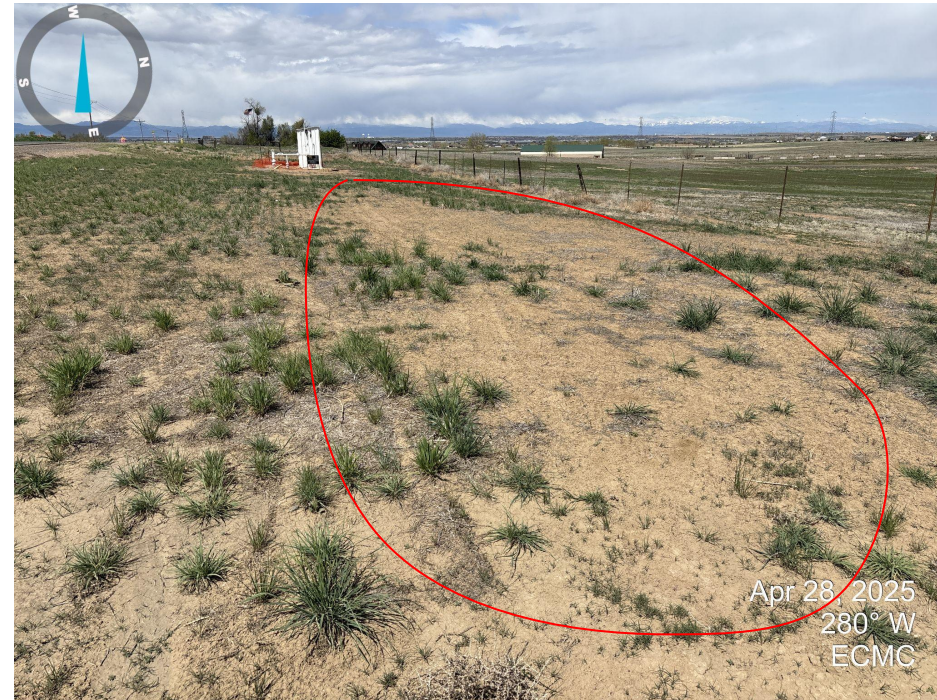
Photo 2. Looking west across the location on the north side. It appears there is some desirable vegetation establishment. Some portions of the location have lower vegetation establishment (red circle).

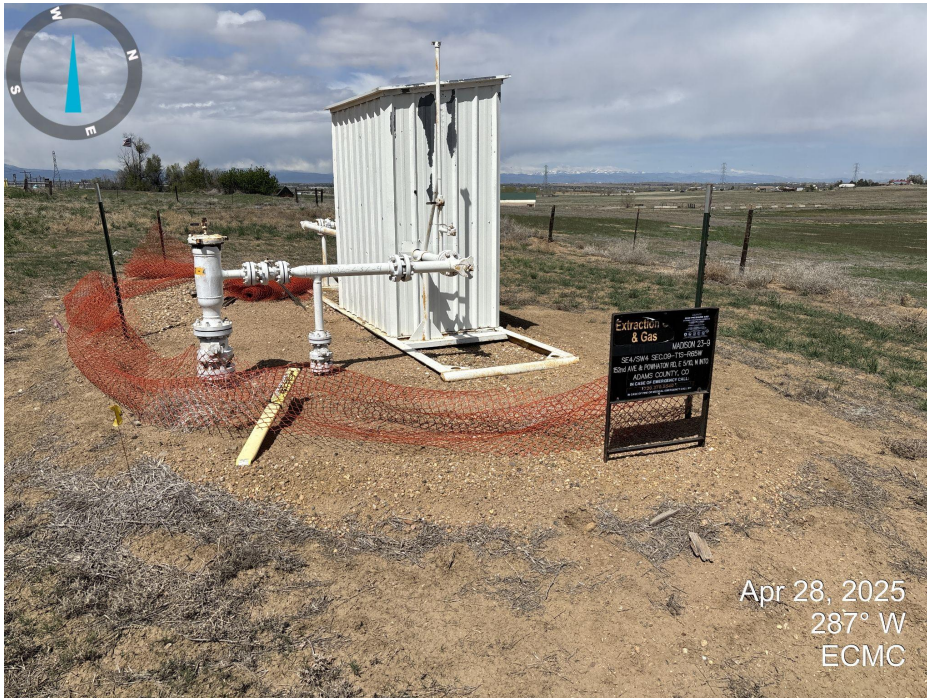
Photo 3. Meter shed remains on location.

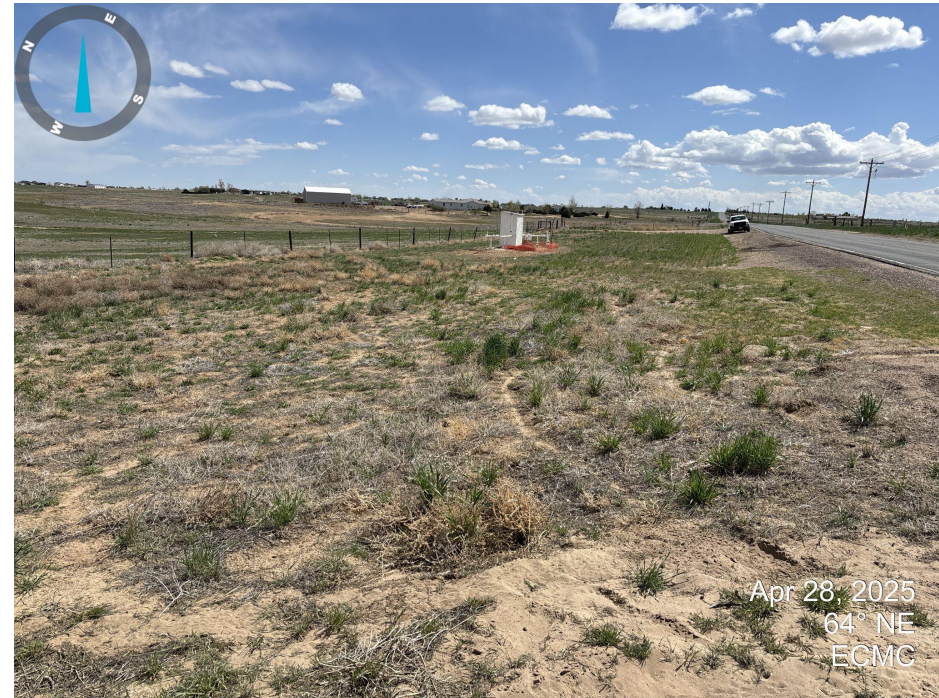
Photo 4. Looking east across the location. Undesirable weed Russian Thistle is present on location. The west side of the location appears to have lower vegetation establishment.
