# BROWN-61N68W/5NENW (336359): Wellhead Cut/Cap

Crestone Peak Resources (10633)

# BROWN 31-5 and 5-3 Common Line (12324165,12319070\_FL): Off-Location Flowline Decommission

# BROWN-61N68W/5NENW (336359): ¼ Mile Buffer - Wildlife and Hydrology Map

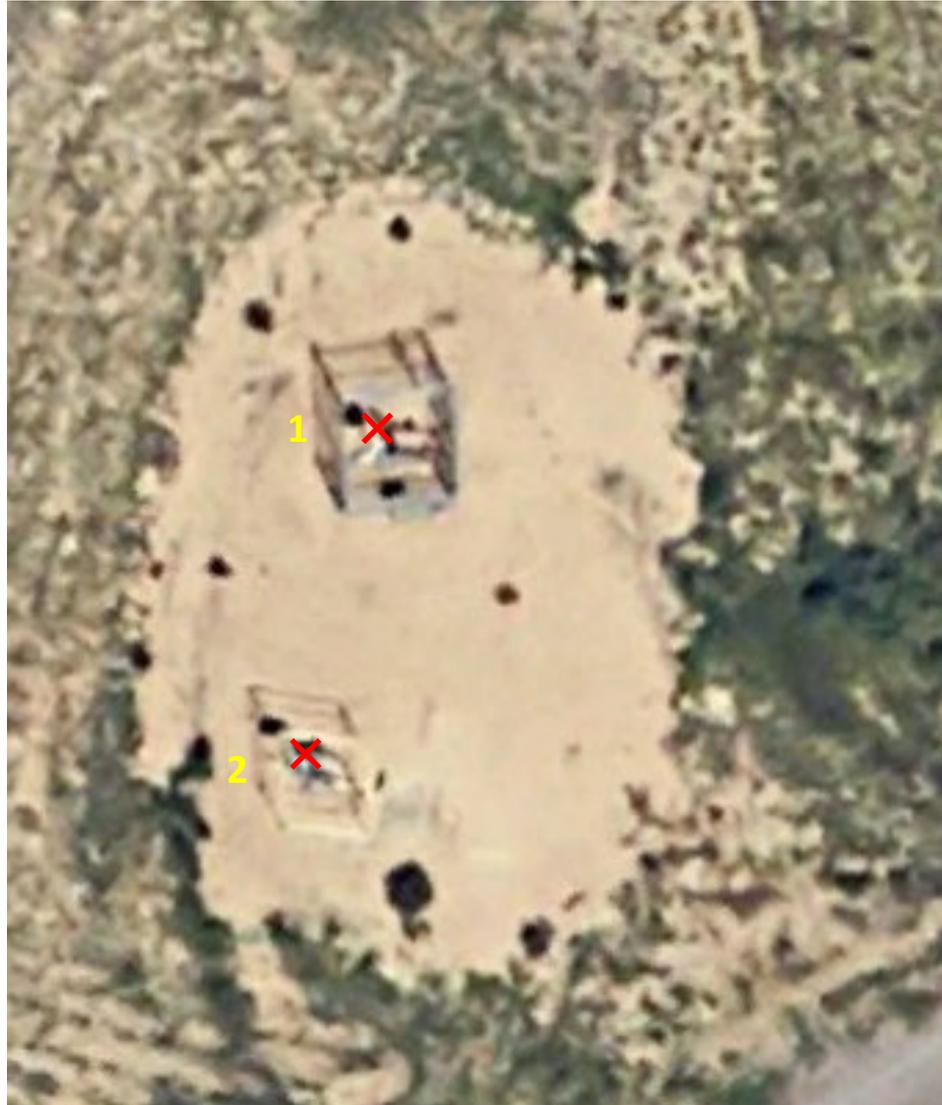
Equipment to be Removed		
Legend	Equipment On-Site	# Pieces of Equipment
1	BROWN 31-5 (05-123-24165) 40.086450, -105.029190	1
2	BROWN 5-3 (05-123-19070) 40.086383, -105.029207	1

**Legend**  
Site Investigation Points  
X Visual Inspection and Soil Sample

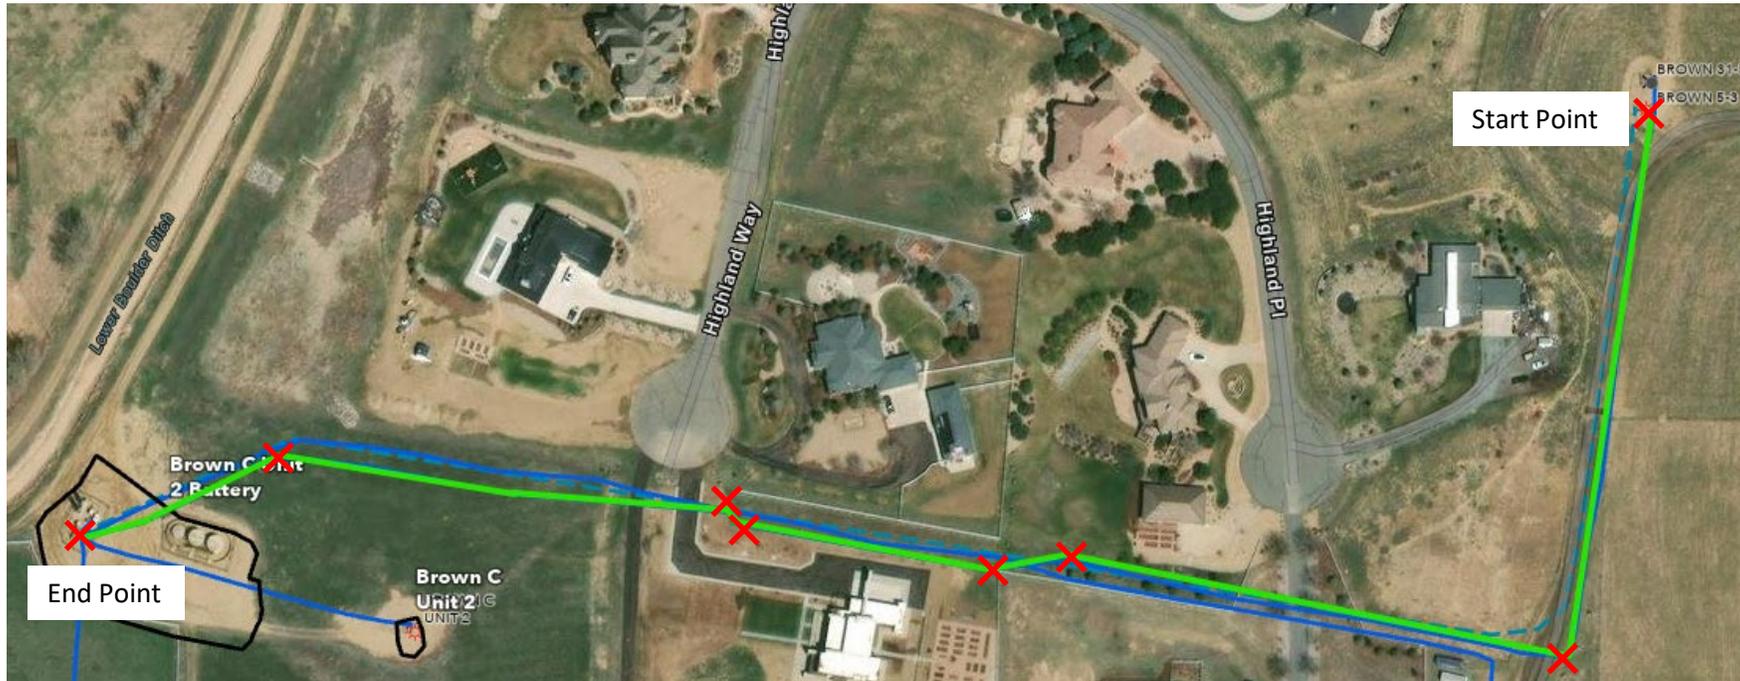
Flowline Unique OperFeatID	Line Type	Start Location	Start Location Latitude/Longitude	End Location	End Location Latitude, Longitude (Cut Point)	Approx. Length to Decommission (ft)
12324165,12319070_FL	Multiphase	Tie-In	40.086369, -105.0291785	Separator	40.085267, -105.034557	1990

## Site Investigation Points

✗ Visual Inspection and Soil Sample

Potholes will be dug every 250 feet along the flowline path. These observation points will be photographed and field screened. Additional soil samples will be collected when flowline repairs are observed, changes in flow direction, or when there is a change in the flowline material type.

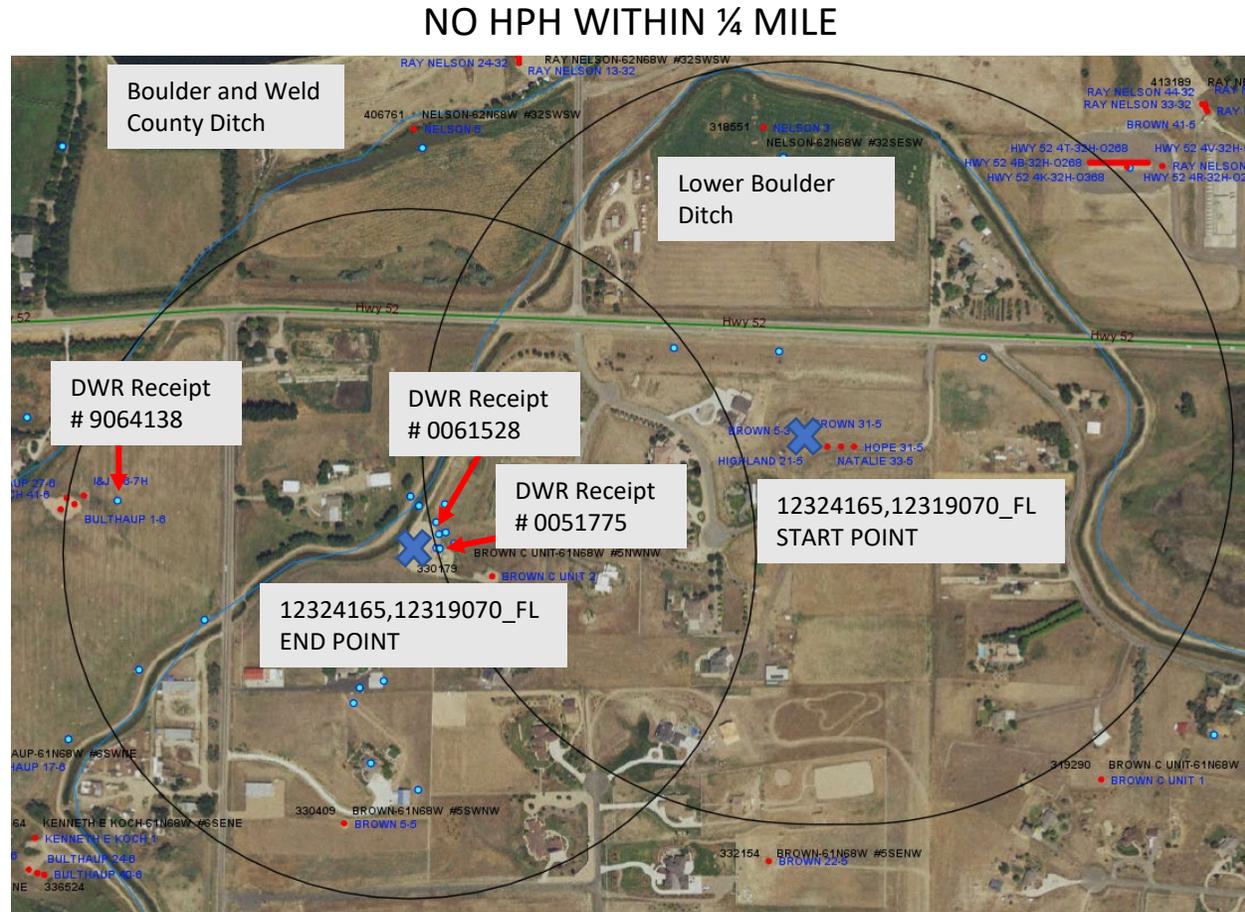
Receptor	DWR Receipt (Permit)	Distance (ft)	Direction	Well Depth(ft)	Static Water Level (ft)
Monitoring Well	0051775 (51775-MH)	On Pad	On Pad	17	Not Recorded
Monitoring Well	0061528 (61528-MH)	On Pad	On Pad	15	Not Recorded
Lower Boulder Ditch	N/A	60	NW	Surface	Surface
Domestic Well	9064138 (39514-)	1120	NW	95	8
Boulder and Weld County Ditch	N/A	1270	NW	Surface	Surface
