**Operator: BONANZA CREEK ENERGY OPERATING
COMPANY**

Location Name: North Platte T-23 Pad

Loc ID: 470863

Inspection: 707603673

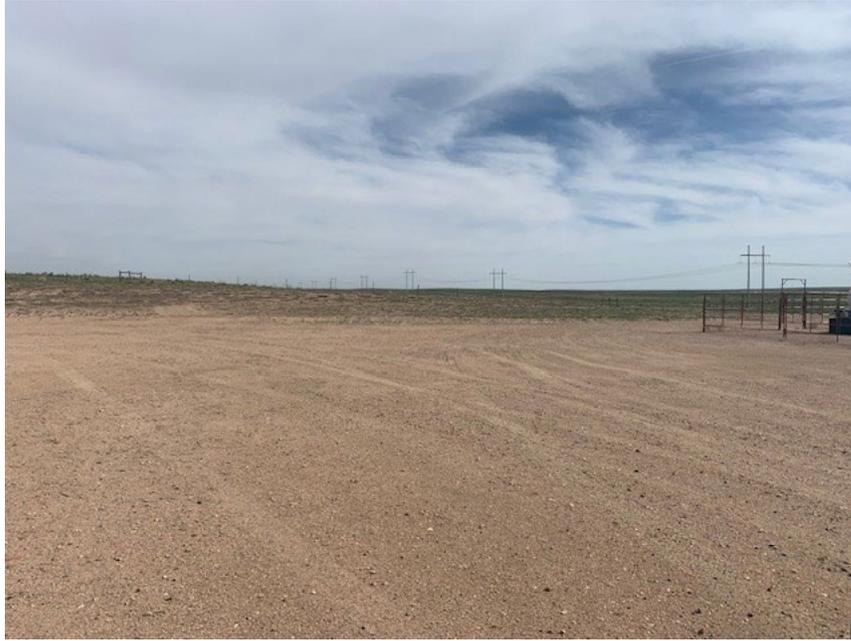
Exhibit A

CA: Unnecessary equipment at Location site. See Northeast side of Location site. Unnecessary equipment includes: Frac tank w/ spill pad. Refer to Rule 606 for guidance. Remove unnecessary equipment from Location site. Comply with Rule 606. Corrective Action date: 03/21/2025. (30 days). See photo(s) #1, 2, 3. *Please attach photo(s) to FIRR to verify Corrective Action(s) have been resolved.

CA Resolution: Operator has removed the equipment in order to comply with Rule 606.
